SEPTEMBER 1979

Name Of Dam: TOMS CREEK DAM
Location: WISE COUNTY, VIRGINIA
Inventory Number: VA. NO. 19510

PHASE I INSPECTION REPORT

NATIONAL DAM SAFETY PROGRAM

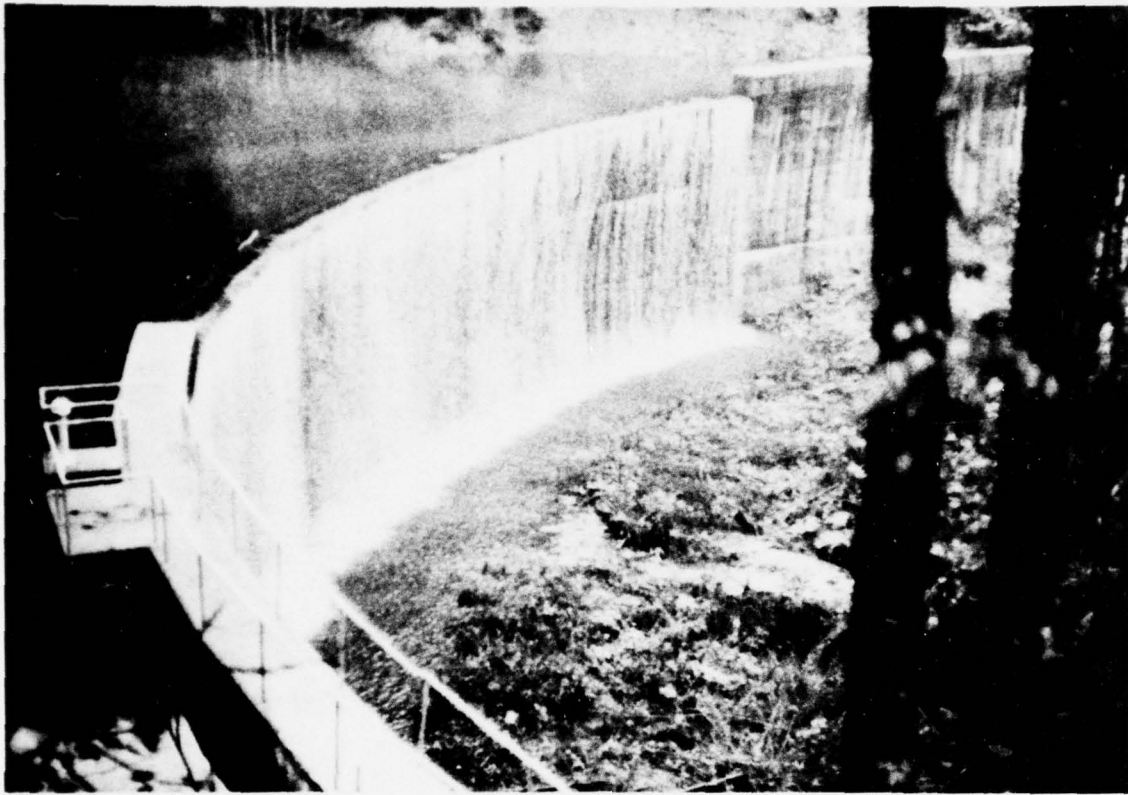
OVERVIEW PHOTOGRAPH

Overall, the dam appeared to be in very good condition at the time of the inspection. The actual structure appears to be similar to the design drawings.
