Name Of Dam: HUNTING CAMP DAM
Location: BLAND COUNTY, VIRGINIA
Inventory Number: VA. NO. 02101

PHASE I INSPECTION REPORT

NATIONAL DAM SAFETY PROGRAM

BY
SCHNABEL ENGINEERING ASSOCIATES, P.C./
J. K. TIMMONS AND ASSOCIATES, INC.

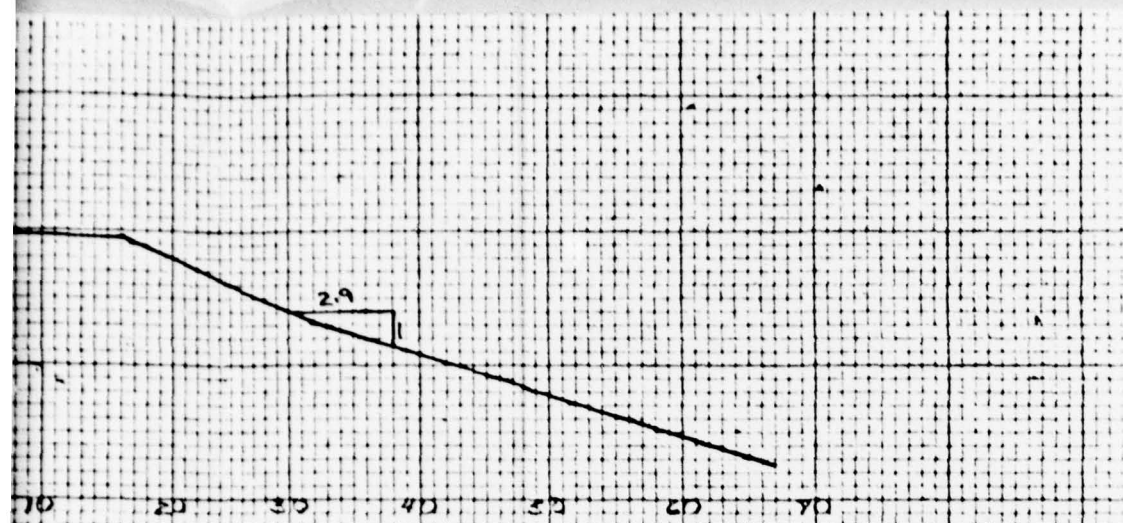
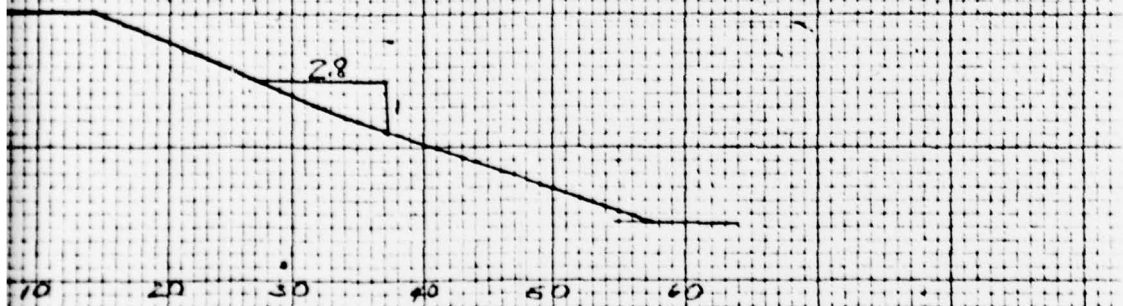
X-SECTIONS
 HUNTING CAMP DAM
 8/24/79
 H.C.M. Scale: 1"=10'

Comparison of design drawings with field inspection data indicates the dam was constructed slightly different than designed. The embankment appears to be 70 ft[±] shorter than specified and the right emergency spillway is approximately 10 ft[±] narrower than shown. Also the left emergency spillway outfall is not as close to the embankment toe as shown on Plate 2, Appendix I, but several hundred feet below the embankment. Embankment slopes of about 2.5 horizontal to 1 vertical were measured during the inspection rather than the 3:1 design slopes. A later survey made by the Owner measured 2.7:1[±] upstream slopes and 2.9:1[±] downstream slopes.
