Name Of Dam: MIDDLETON DAM
Location: LEE COUNTY, VIRGINIA
Inventory Number: VA. NO. 10501

PHASE I INSPECTION REPORT

NATIONAL DAM SAFETY PROGRAM

BY
SCHNABEL ENGINEERING ASSOCIATES, P.C./
J. K. TIMMONS AND ASSOCIATES, INC.

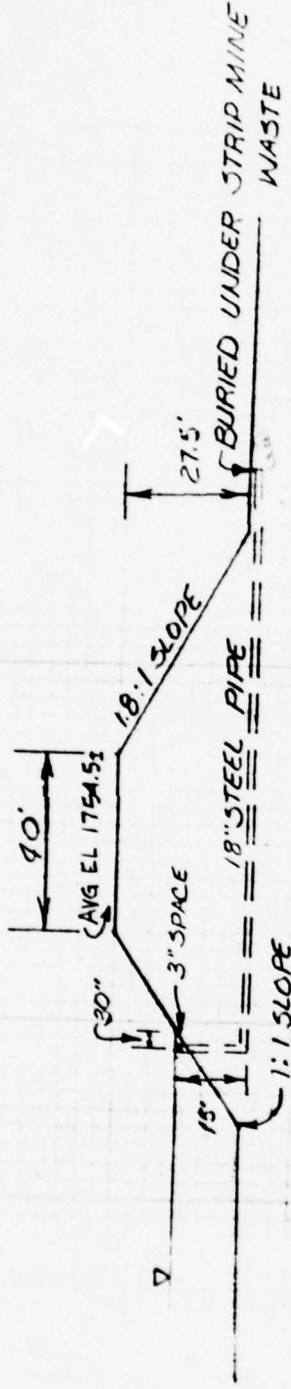
PLATE 3

The emergency spillway is a rock channel with a bottom width of 14 ft and a crest elevation of 1740.3 M.S.L. The emergency spillway is located on the right end of the dam with side slopes of about 1:1 and 2:1 (See Plate 3, Appendix I). The left side of the emergency spillway is on a 2:1 slope and is in a fill section. The right side of the emergency spillway is in a cut section of a 1:1 slope.
