HLH ROTOR BOX BEAM FATIGUE TEST

M. Hanson

September 1979

APPLIED TECHNOLOGY LABORATORY  
U. S. ARMY RESEARCH AND TECHNOLOGY LABORATORIES (AVRADCOM)  
Fort Eustis, Va. 23604

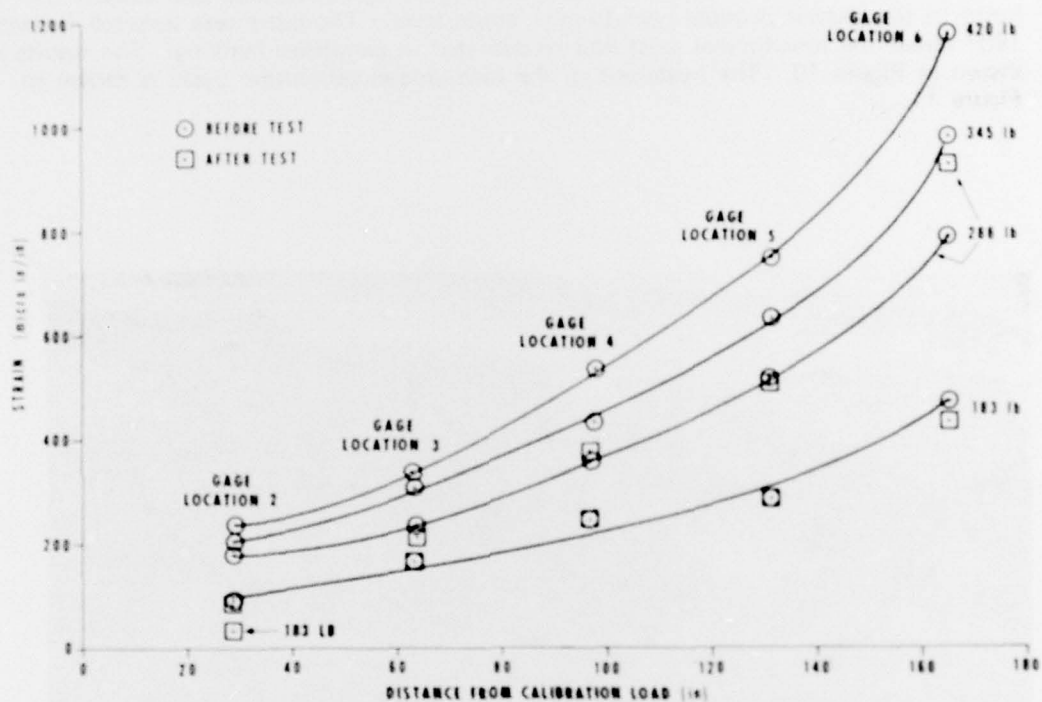
Figure 7. Calibration data for box beam.

The beam was cantilevered at the reaction end by installing a vertical support just in-board of the pivot location and was calibrated by applying an actuator load in the downward direction. Strain gage readings were recorded at several different load levels. The results of the calibration are shown in Figure 7.

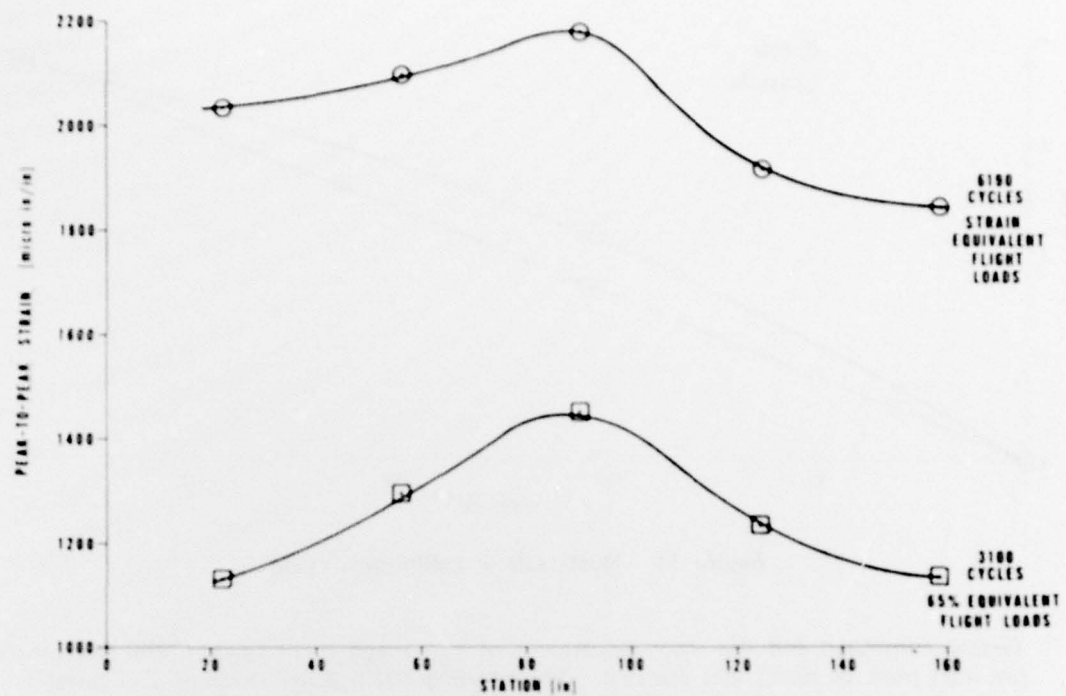
Figure 9. Bending strain distribution.

The test resumed at the strain equivalent of high-speed flight loads, and after 6000 cycles the machine was shut down by an axial deflection limit detector. Inspection revealed a transverse fatigue crack 26 inches from the reaction end of the beam on the bottom flange in the chordwise direction. The crack area was too hot to touch. The crack originated at a manufacturing flaw (wrinkle) and extended approximately 3 inches past the end of the surface wrinkle (see Figure 8). The bending strain distributions after 3100 cycles at a low loading condition and after 6000 cycles at an equivalent flight loading condition are shown in Figure 9.

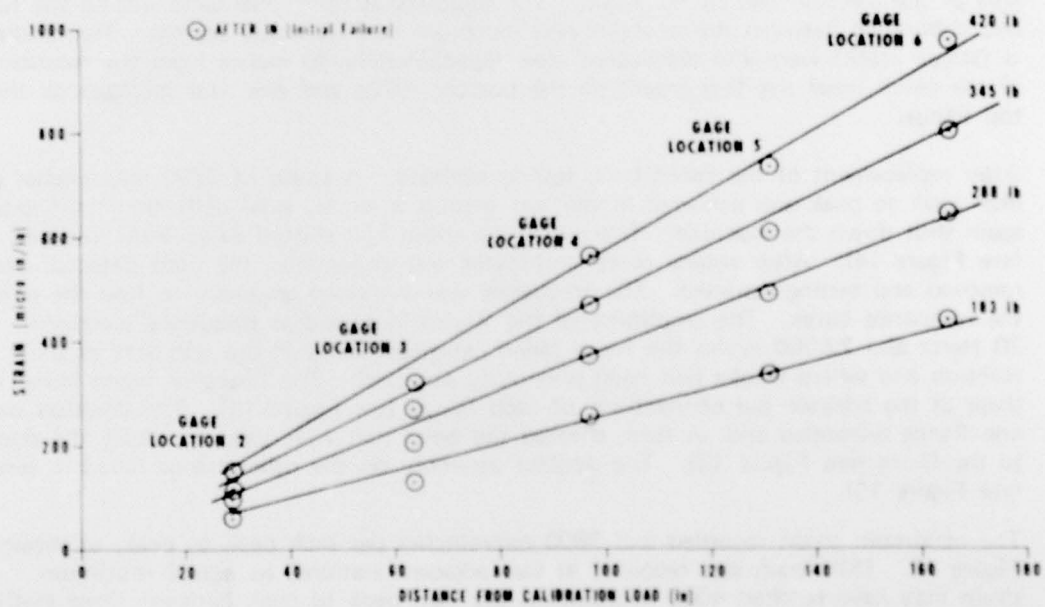
Figure 10. Recalibration data for box beam.

At this point it was decided to abandon the original test procedure and subject the beam to the highest possible peak-to-peak strain level. The beam was inverted (rotated 180° about the longitudinal axis) and recalibrated in cantilever bending. The results are shown in Figure 10. The hysteresis in the load-unload calibration cycle is shown in Figure 11.

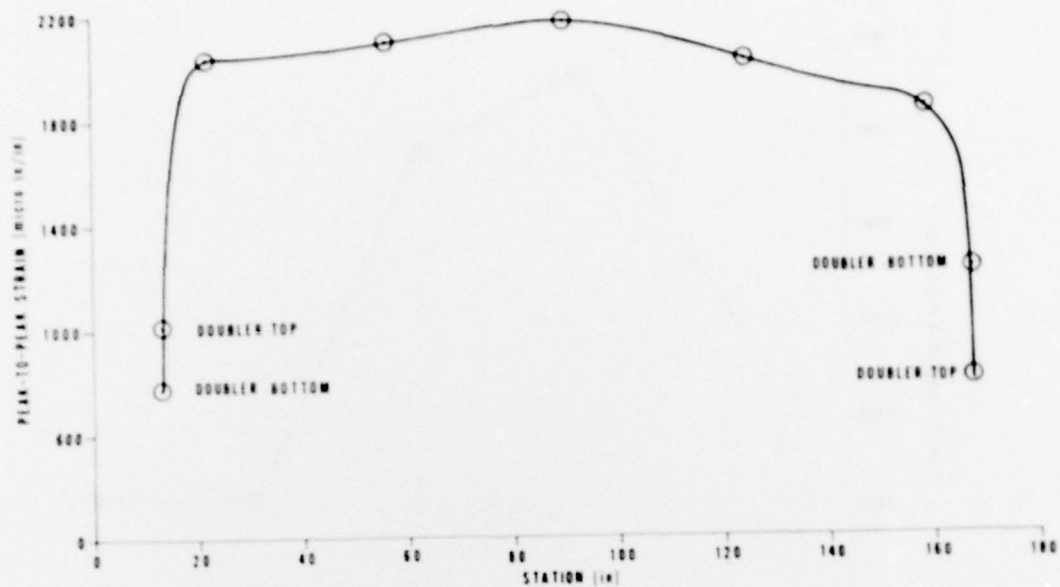
Figure 12. Bending strain distribution (9,000 cycles).

Testing continued and the strain equivalent of high-speed flight loads (2200 microinches per inch peak to peak) was reached. The bending strain distribution at this point is shown in Figure 12. At approximately 16,000 cycles the bending amplitude was increased and a strain of 3400 microinches per inch peak to peak was recorded (see Figure 13). At this point a bolt in the test fixture failed, causing the test to be stopped. The crack previously discovered had become charred and had propagated to the corner of the beam and 2 inches up the side (web) of the beam. Smoke was also observed in the grip area at the reaction end of the beam. The doublers at both ends were hot to the touch, and debonding between the doublers and the beam had obviously started. Two additional fatigue cracks were also discovered, one approximately 40 inches from the reaction end of the beam (near the first crack) on the bottom flange and one near midspan on the top flange.

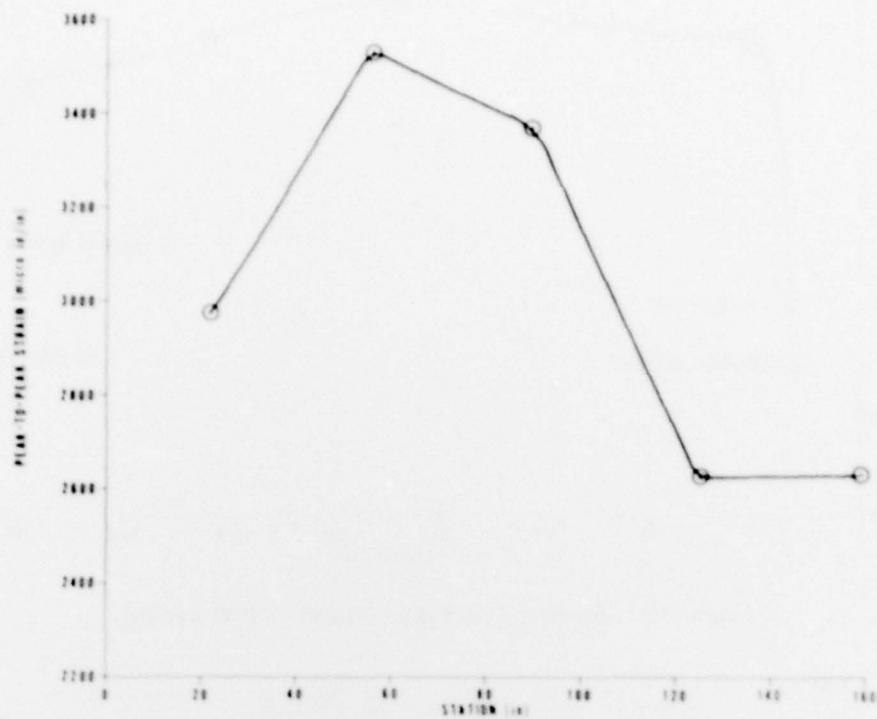
Figure 14. Bending strain distribution (18,000 cycles).

After replacement of the failed bolt, testing resumed. A strain of 3500 microinches per inch peak to peak was achieved in the test section when an axial deflection limit detector again shut down the machine. The maximum strain had shifted away from midspan (see Figure 14). After several more shutdowns and inspections, the limit detector was removed and testing resumed. The frequency was increased gradually to find the peak of the resonance curve. The amplitude of the strains increased as frequency increased. At 20 Hertz and 22,000 cycles the beam failed catastrophically in the grip area at the reaction end where smoke had been previously observed. The fiberglass beam failed in shear at the adapter pin connections of each flange (see Figure 15). The doublers on one flange debonded and, in turn, sheared the bolts that were used to secure the doublers to the beam (see Figure 16). The doubler assembly on the other flange failed in tension (see Figure 15).

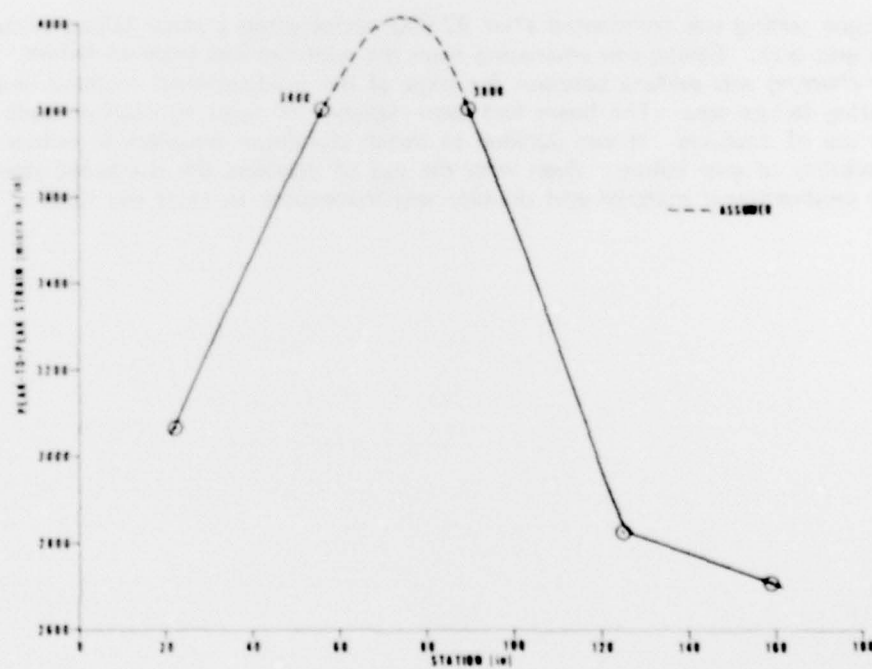
Figure 17. Bending strain distribution (22,000 cycles).

The maximum strain recorded was 3800 microinches per inch peak to peak, as shown in Figure 17. This strain was recorded at two adjacent stations, so actual maximum strain may have reached 4000 microinches per inch peak to peak between those stations.
