# CONCRETE AND ROCK TESTS, REHABILITATION WORK, MARSEILLES DAM, ILLINOIS WATERWAY CHICAGO DISTRICT

Richard L. Stowe

Structures Laboratory  
U. S. Army Engineer Waterways Experiment Station  
P. O. Box 631, Vicksburg, Miss. 39180

September 1979

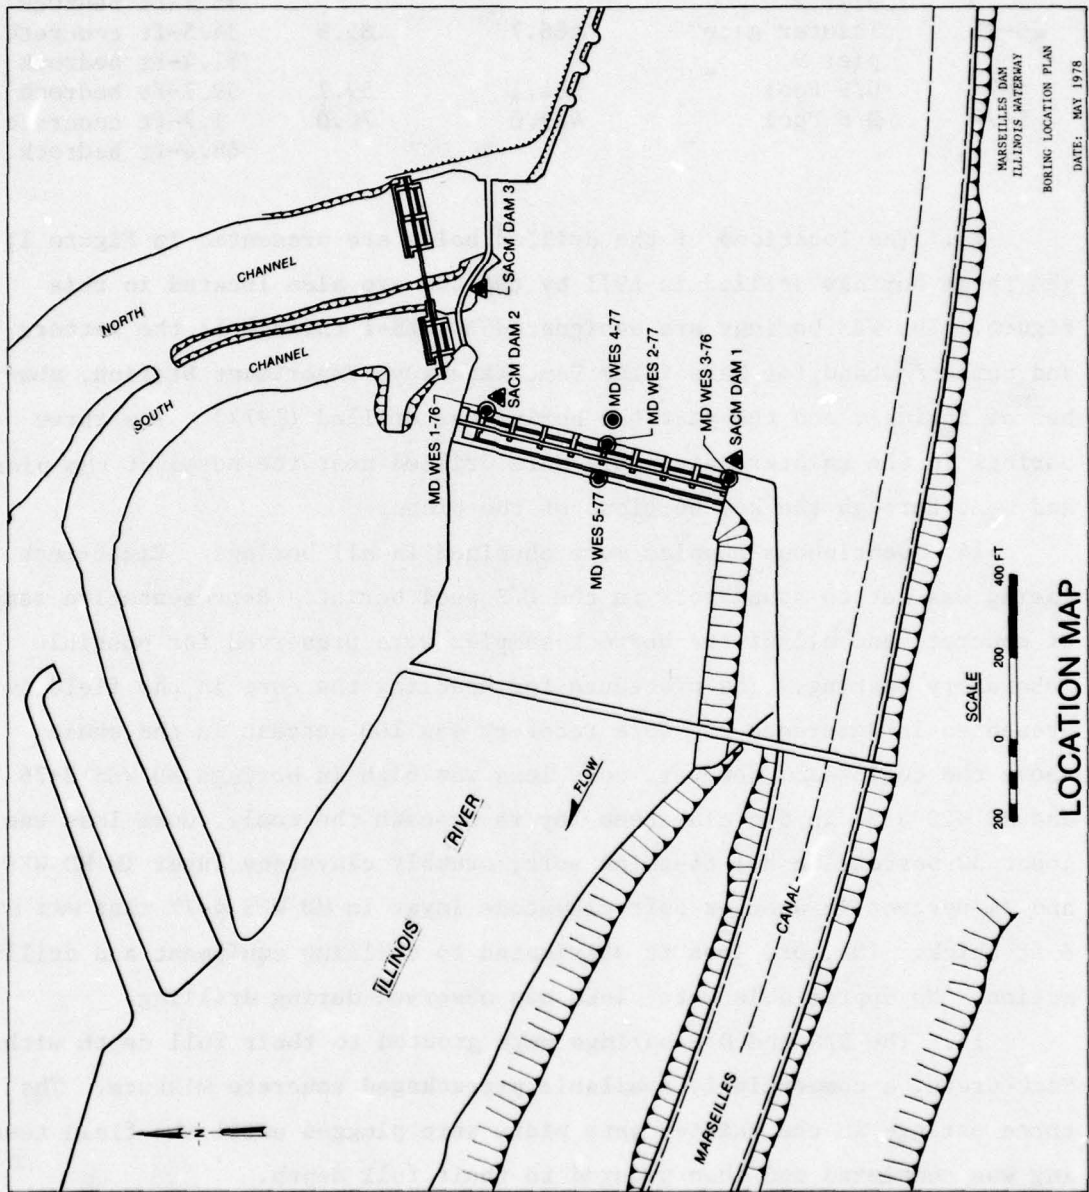
FIGURE 1

13. The locations of the drilled holes are presented in Figure 1; the three borings drilled in 1971 by the CDO are also located in this figure. The WES borings are designated MD WES-1 through 5; the letters and numbers stand for Marseilles Dam, Waterways Experiment Station, number of borings, and the year the boring was drilled (1977). The three borings in the tainter gate piers were drilled near the noses of the piers and went through the key sections of the piers.

LOCATION MAP

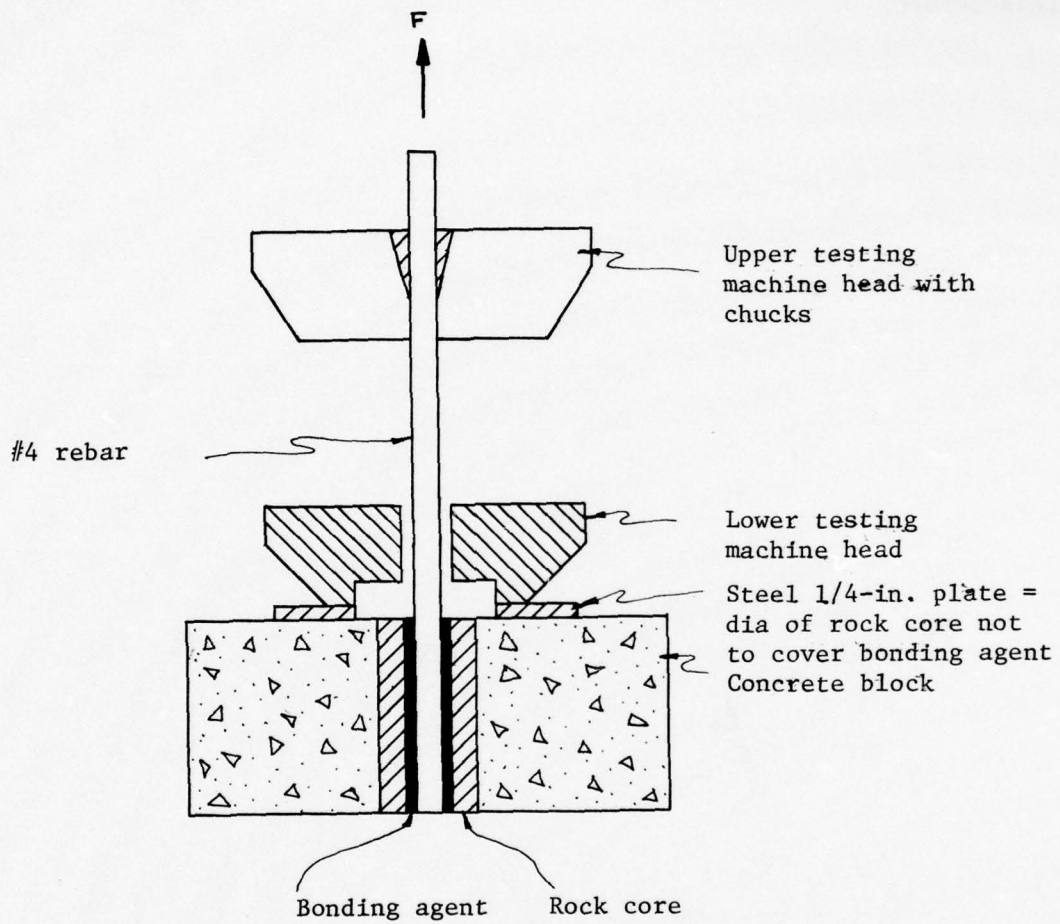
40. The rebar pullout resistant test is sketched in Figure 2. A 6-in.-diameter by 12-in.-long shale core was placed upright in a 12-in.-high by 30-in.-diameter mold. A concrete mixture having the average compressive strength of the rock (the 2 zones of rock within the first 25 ft of shale had strengths of 430 and 2160 psi) was placed into the mold embedding the core to its full length. The concrete portion served two purposes. First, it acted as a resistance block allowing the rebar to be pulled, and second, it served as a host material in case the core instead of the rebar was pulled out.

41. After the concrete had cured and attained the desired strength, a 1-in.-diameter hole was drilled in the center of the shale core. A diamond thin-wall bit was used resulting in a smooth-walled borehole. A No. 4 rebar was grouted the full depth of the core using a commercially available premix grout for anchoring bolts and dowels. Grout strength at test time was about 4000 psi. After the grout attained desired strength, the bars were pulled using the setup depicted in Figure 2. Total weight of the suspended specimen was taken into account in calculating the bond stress.

Figure 2 . Section showing test configuration for the reinforcing bar pullout tests.
