Failure Analysis and Resin Evaluation of IUS SRM-1 92-inch Prototype Motor Case

Prepared by R. W. FILLERS, J. F. WARD, and P. K. GRANT
Materials Sciences Laboratory
The Aerospace Corporation
El Segundo, Calif. 90245

28 September 1979

Interim Report

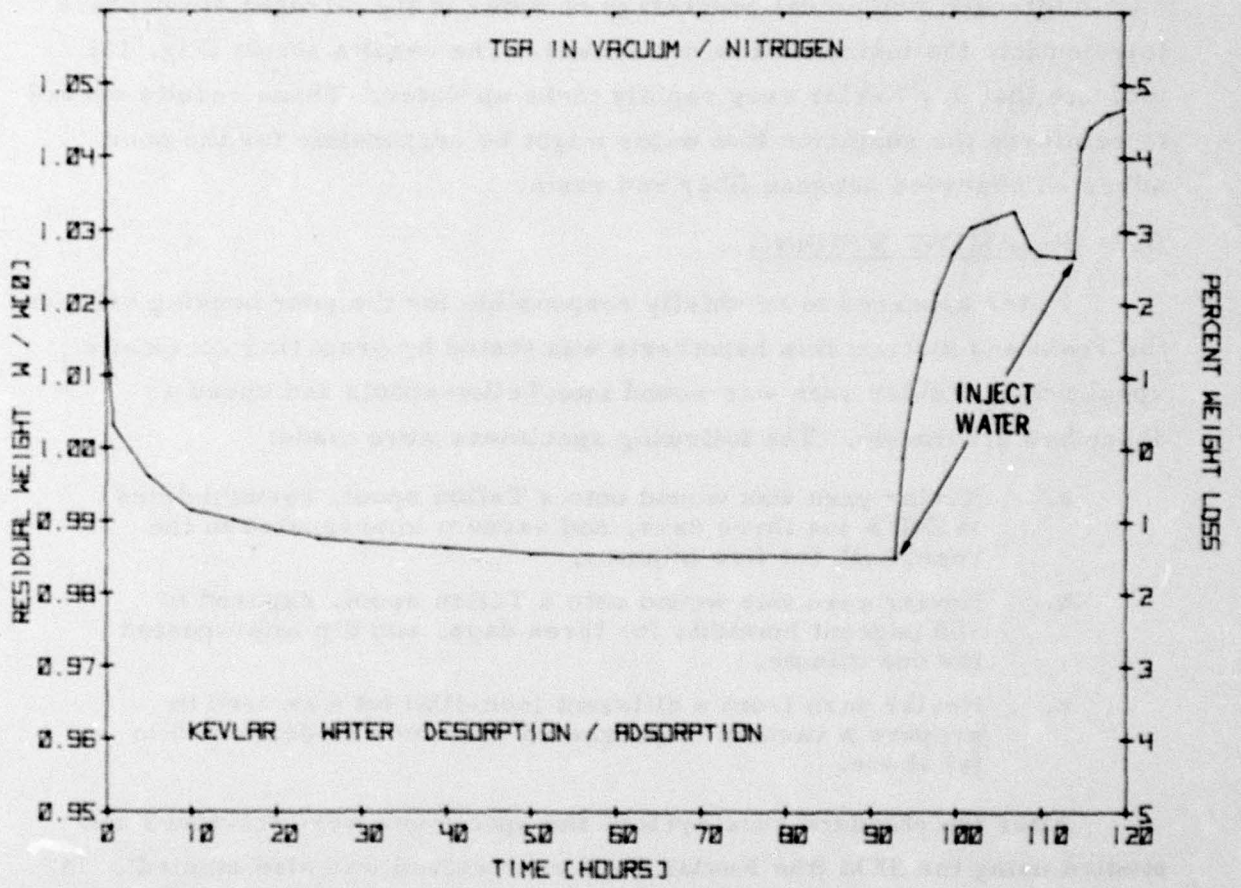
Fig. 13. Water Sorption Characteristics of Kevlar

investigate the rate at which dry Kevlar fiber absorbs or adsorbs water. This instrument utilizes a quartz crystal microbalance to monitor the weight of a specimen, usually as a function of temperature. In this experiment the temperature was held constant, and the weight of Kevlar was monitored with time as the Kevlar was exposed first to vacuum and then to humid nitrogen (the actual percentage of water in the nitrogen atmosphere injected into the instrument is not known). The results shown (Fig. 13) indicate that dry Kevlar very rapidly picks up water. These results served to reinforce the suspicion that water might be responsible for the poor adhesion observed between fiber and resin.

After the standard cure cycles, the specimens were fractured and studied using the SEM (the Kevlar fiber as received was also studied). In every case the interface was found to be indistinguishable from those shown in Figs. 1b, 2, and 11b, which indicates that neither water nor contaminated Kevlar is responsible for the poor fiber-resin adhesion. The possibility that a resin component is responsible should be investigated; there is some indication that MDA leads to poor interaction with the polyaramide fiber.

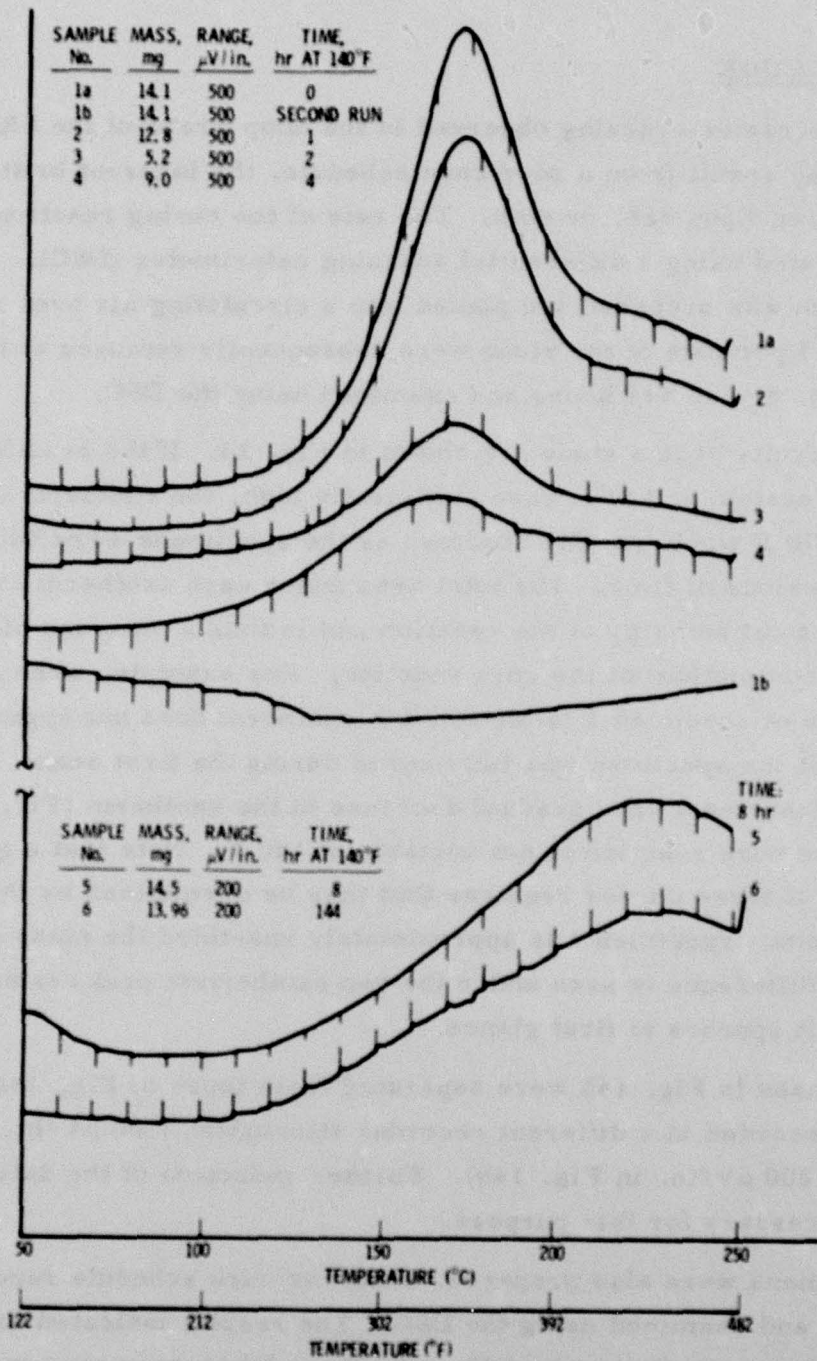
Fig. 14. DSC Studies of MDA-Cured Epon 828

The results of this study are shown in Fig. 14. If the reaction rate of the resin system at 140°F were sufficiently high, the exotherm in the vicinity of 170°F would rapidly diminish as the specimens were held at 140°F for longer periods of time. The total area under each exotherm is proportional to the total enthalpy of the reaction and is thus a measure of the extent (or percent completion) of the cure reaction. For example, when a second scan is made of specimen 1 (scan 1b), the exotherm does not appear, which indicates that the specimen was fully cured during the first scan. The result of measuring a very gradual decrease in the exotherm (Fig. 14) indicates that the cure reaction is not unstable at 140°F. Note that a quantitative comparison of these curves requires that they be normalized by the specimen mass; since specimen 3 is approximately one-third the mass of specimen 1, the total difference in area under the two exothermic peaks is not nearly as great as it appears at first glance.

The scans in Fig. 14b were separated from those of Fig. 14a because they were recorded at a different recorder attenuation (500 μ V/in. in Fig. 14a vs 200 μ V/in. in Fig. 14b). Further reduction of the data was not felt to be necessary for this purpose.

The most alarming result of this study was the fact that the resin system gelled to a weak, brittle solid in three to four days at 70°F. This length of time would ordinarily pose no problem, but the SRM-1 prototype required seven days to wind, and this period will probably not be significantly shortened in the future. The interior of the motor case will thus become quite weak and brittle while the outer portion is still being wound. Additionally, resin flow that normally occurs during the initial phase of the cure cycle does not occur.
