OSWEGO RIVER BASIN

DE RUYTER DAM

ONONDAGA COUNTY  
NEW YORK

PHASE I INSPECTION REPORT  
NATIONAL DAM SAFETY PROGRAM

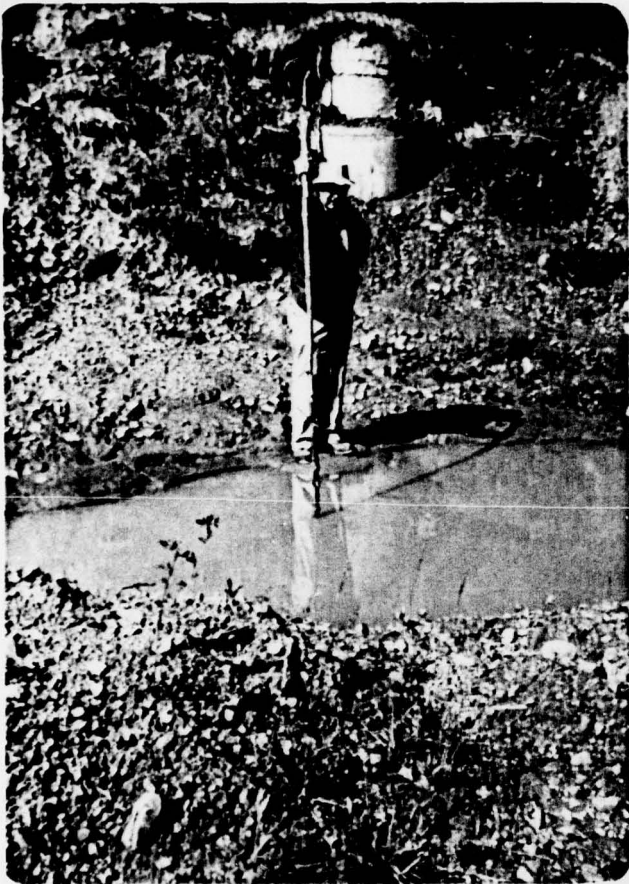
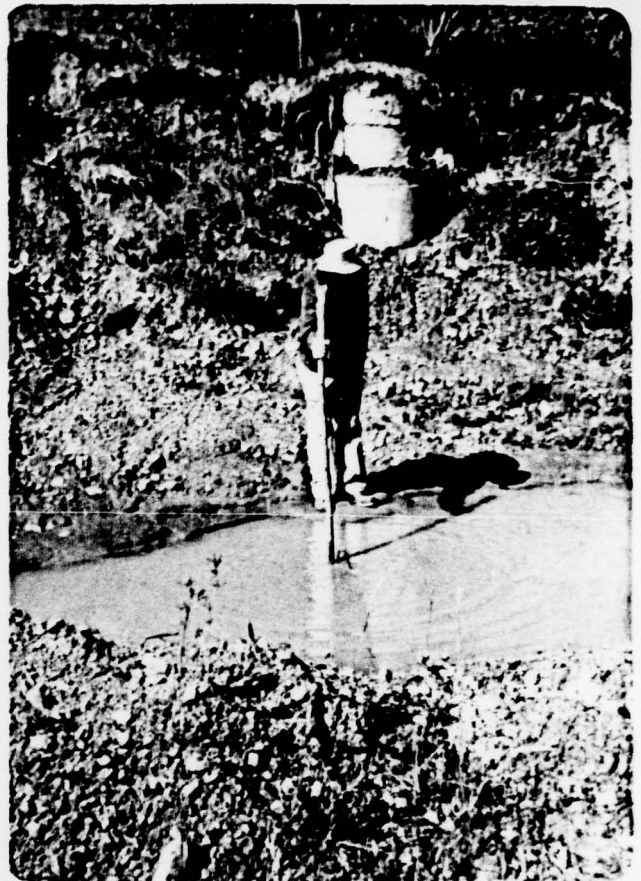
7. Area in deep section of embankment where drainage system was repaired and needs to be regraded.

1. Necessary repairs should be made to the existing underdrain system to utilize the available protection against the seepage conditions which are known to occur. Areas of surfacing seepage should be cleared of heavy vegetation and kept under observation. It should be anticipated that seepage zones persisting after the present underdrain collection system is fully operating could require an extension of the present system to also handle new areas.
