Name of Dam: Whites Dam

Location: Albemarle County, State of Virginia

Inventory Number: VA 00327

**PHASE I INSPECTION REPORT
NATIONAL DAM SAFETY PROGRAM**

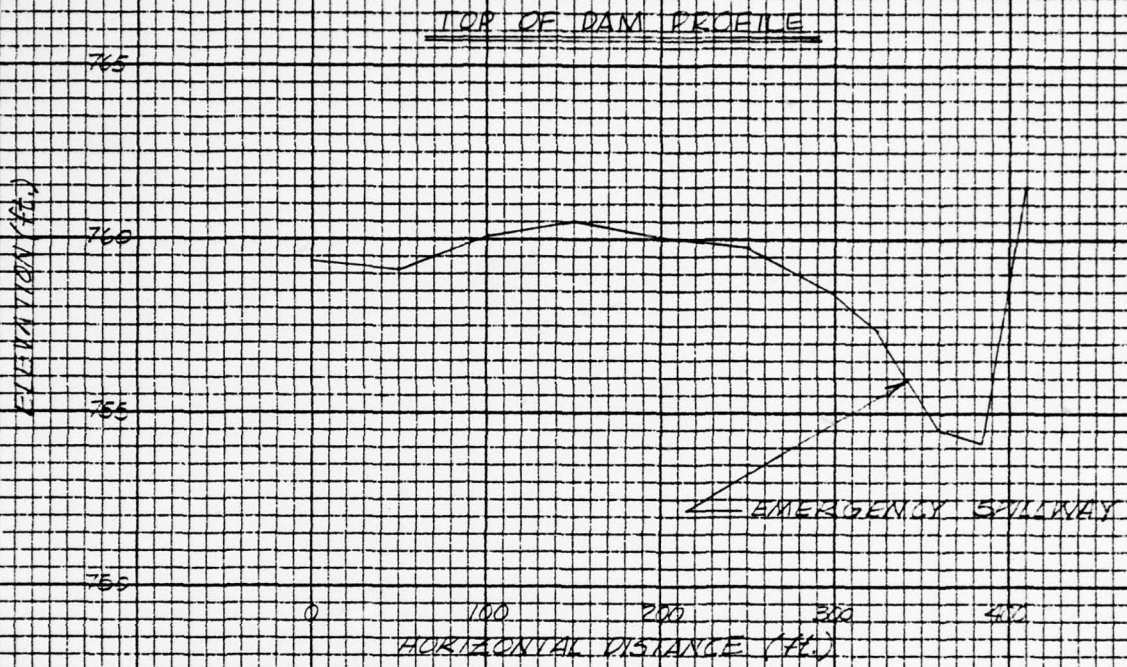
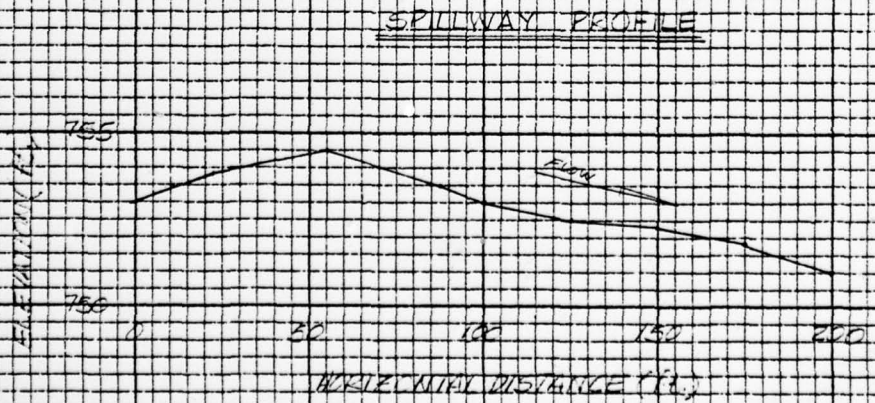
PLATE 3
 WHITES DAM
 TOP OF DAM AND SPILLWAY
 PROFILE
 MICHAEL BAKER, JR., INC.
 SCALE: AS SHOWN

4.1 Procedures: Operation of the dam is automatic. Normal pool (elevation 753.0 feet M.S.L.) is maintained by the vertically standing 15 inch diameter corrugated metal pipe (see Photo 1 and Plate 3). In the event that the reservoir level rises above elevation 754.3 feet M.S.L., water will also flow past the dam through the emergency spillway located outside the right abutment.
