Name of Dam: Mays Dam
Location: Amherst County, State of Virginia
Inventory Number: VA 00909

PHASE I INSPECTION REPORT
NATIONAL DAM SAFETY PROGRAM

SEPTEMBER 1979

Name of Dam: Mays Dam
State: Virginia
County: Amherst
USGS 7.5 Minute Quadrangle: Forks of Buffalo, VA
Stream: Sneads Run
Date of Inspection: 23 May 1979

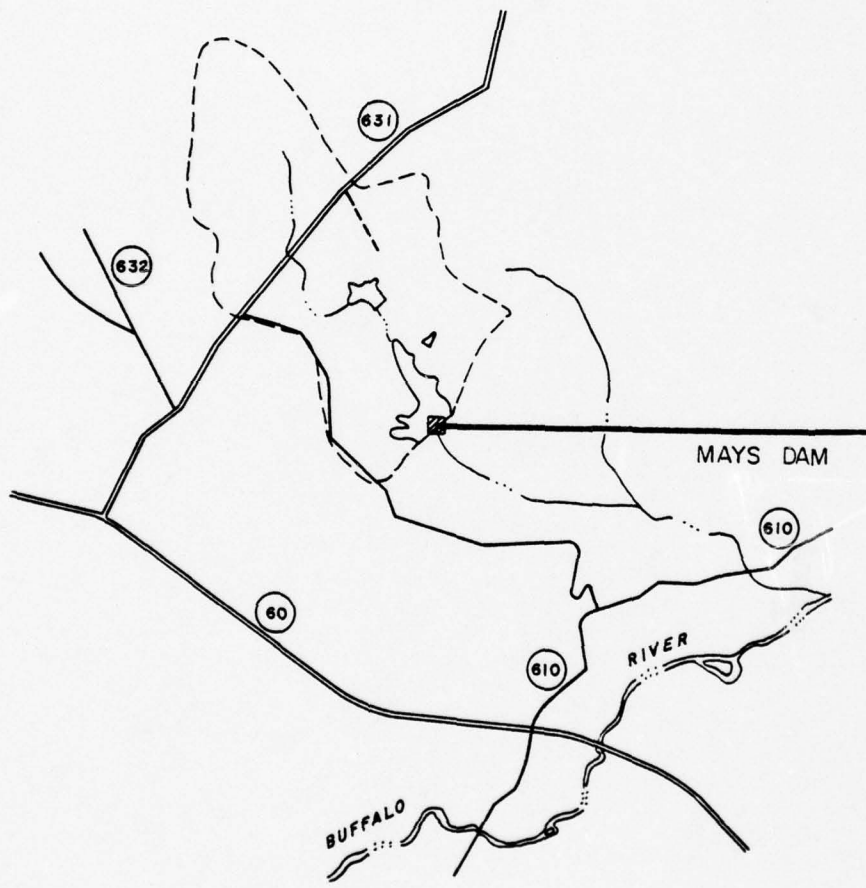
FIELD SKETCH
 MAYS DAM
 Michael Baker, Jr., Inc.
 July 1979
 PLATE I

- 3.1.2 Dam: The embankment was generally found to be in satisfactory condition, with no surface cracks, slumps, or other indications of instability either on the embankment or at the toe. Numerous small erosion gullies have formed in the lower portion of the downstream slope where scattered, nonmeasurable seepage is prevalent (see Plate 1 and Photos 3 and 4). An upper limit of clear seepage on the downstream embankment was very noticeable at approximate elevation 752 feet M.S.L., 8 feet below normal pool. There is good grass cover with some small trees on the downstream slope (see Overall View of Dam). Dumped riprap covers most of the upstream slope except for a section on the left side (see Photo 1 and Plate 1). A road crosses the crest of the dam and the spillway.

- There is a spring with a flow of 1 g.p.m. from the hillside near the left abutment of the dam. The spring does not appear to affect the embankment (see Plate 1). There are some bare and eroded areas on the hillside at the left abutment (see Photo 2).
