Name of Dam: Buffalo River No. 3  
Location: Amherst County, State of Virginia  
Inventory Number: VA 00911

# PHASE I INSPECTION REPORT

## NATIONAL DAM SAFETY PROGRAM

SEPTEMBER 1979

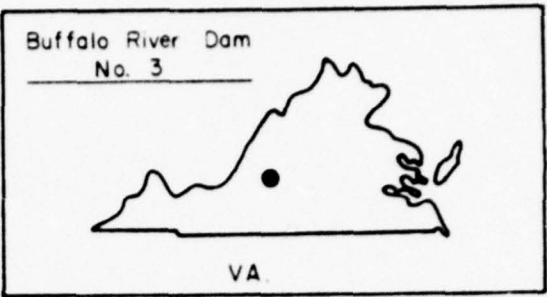
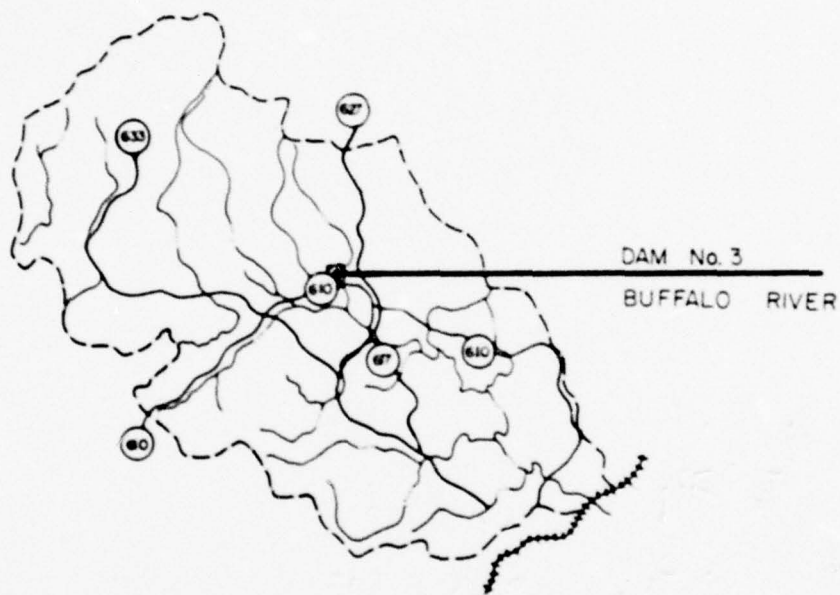
**FIELD SKETCH**  
 BUFFALO RIVER  
 DAM No. 3  
 Michael Baker, Jr., Inc  
 July 1979  
 PLATE I

- 3.1.3 Appurtenant Structures: The principal spillway was in good condition (see Photo 6). Small erosion gullies were observed in the approach channel of the emergency spillway. Several vehicle tracks are located across the emergency spillway and up the right cut slope (see Plate 1 and Photo 7).
