Name of Dam: South River No. 23
Location: Augusta County, State of Virginia
Inventory Number: VA 01508

PHASE I INSPECTION REPORT
NATIONAL DAM SAFETY PROGRAM

PREPARED BY
MICHAEL BAKER, JR., INC.
BEAVER, PENNSYLVANIA 15009

SEPTEMBER 1979 79 11 30 045

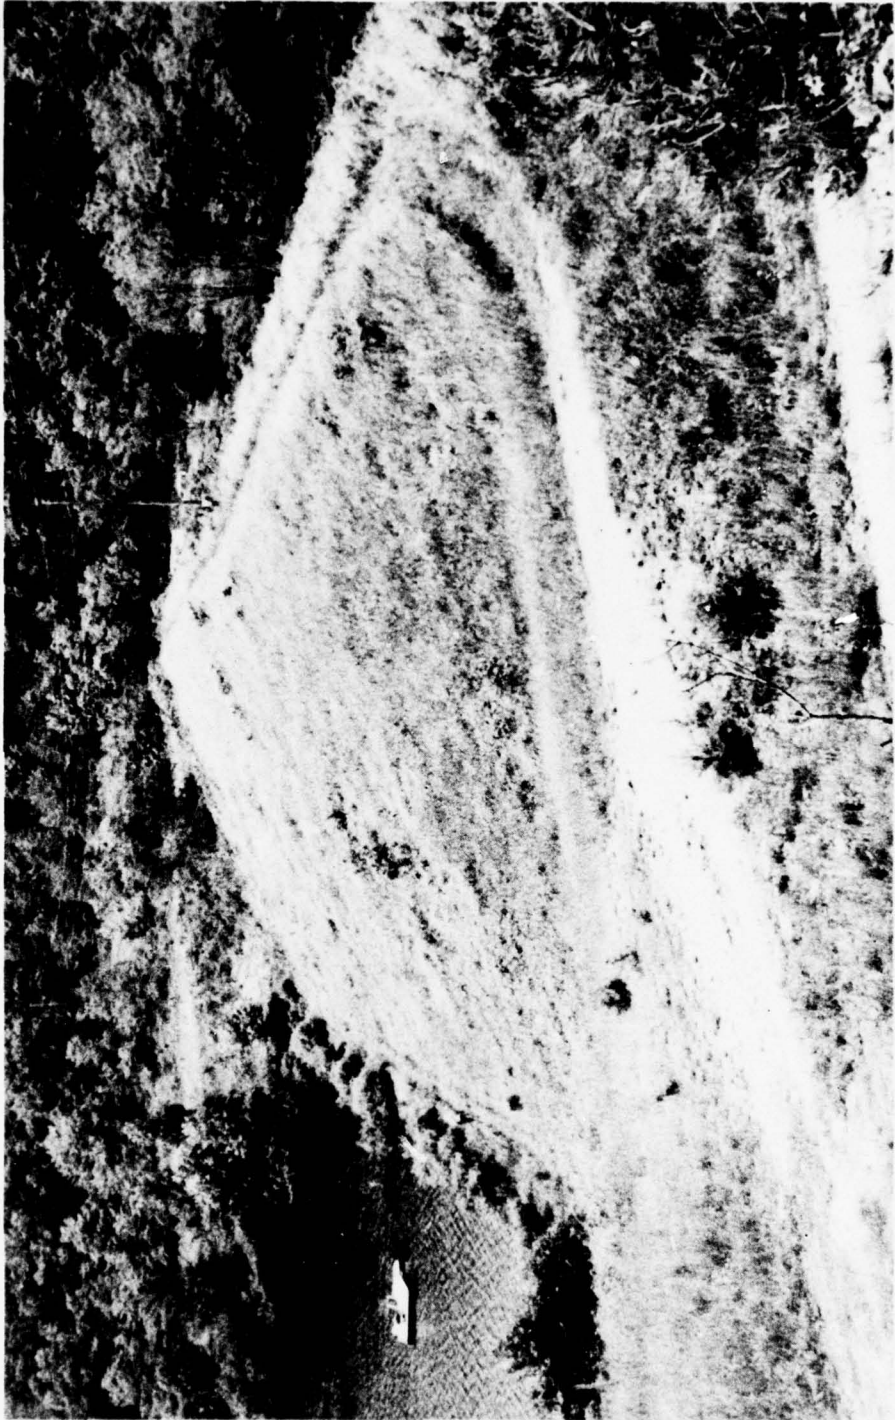
OVERALL VIEW OF DAM

1.2.1 Description of Dam and Appurtenances: South River No. 23 dam is an earthfill embankment approximately 49 feet high¹ and 450 feet long with upstream and downstream slopes of 2.5:1 (horizontal to vertical) and a crest width of 20 feet (see Overall View of Dam and Photo 1). A 10 foot berm is provided on the downstream slope at elevation 1476.0 feet Mean Sea Level (M.S.L.).² Seepage through the dam is collected by a drainage system which exits through an 8 inch diameter corrugated metal pipe at the left³ of the outlet conduit at the toe of the dam (see Plate 1).

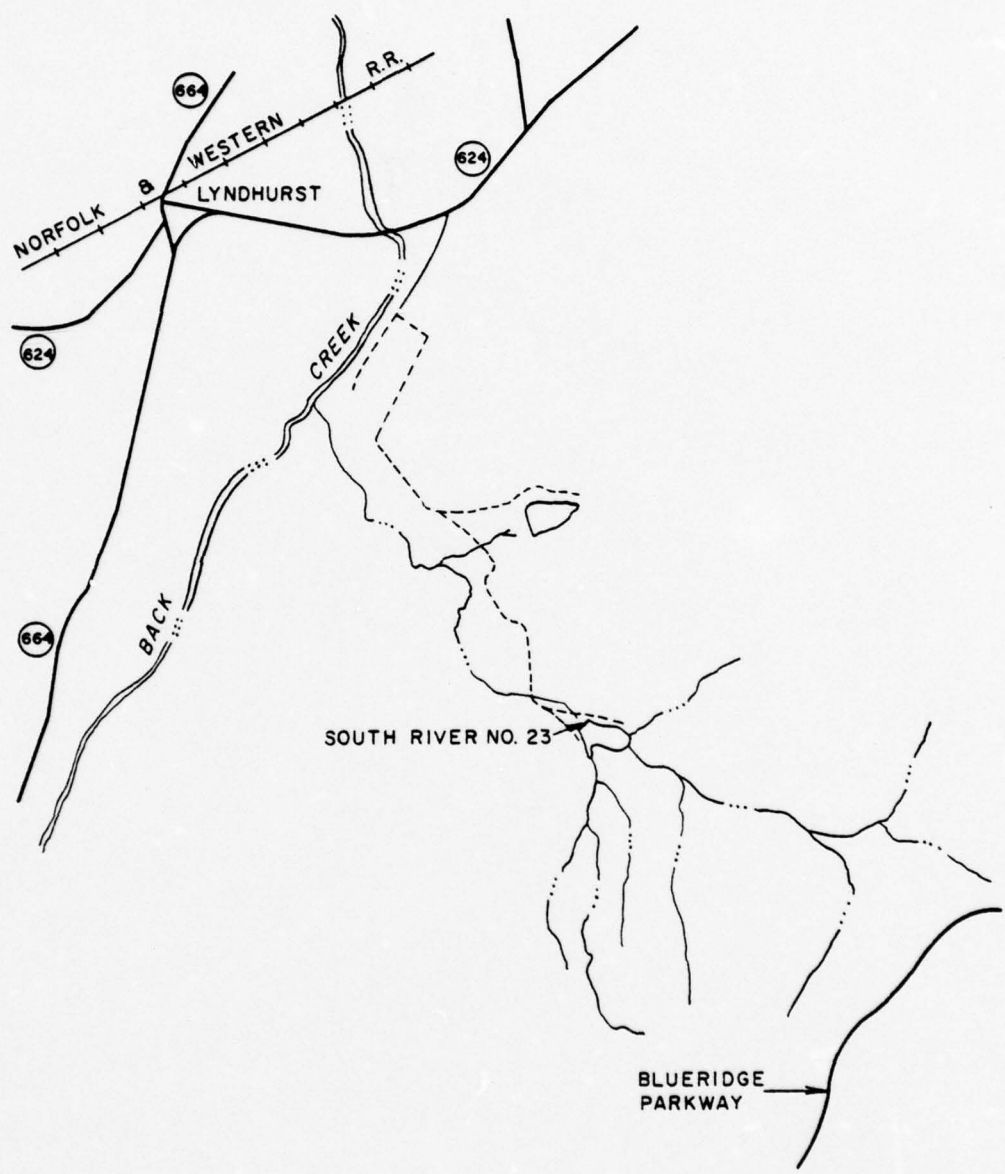
FIELD SKETCH
 SOUTH RIVER #23, VIRGINIA
 PLATE 1

Plate 1 is a Field Sketch of the facility which depicts the conditions observed during the visual inspection. The complete visual inspection check list is included in Appendix III. Following are summaries of the deficiencies noted during the inspection.

3.1.2 Dam: The upstream and downstream embankment slopes are 2.5:1. A few sparsely vegetated areas are located on the upstream embankment slope which are prone to erosion. Small trees have also been allowed to root on the upstream slope at the waterline. Jeeps have traversed numerous parts of the dam as shown on Plate 1. This jeep traffic has caused minor erosion of the ends of the dam bordering the emergency spillways (see Overall View of Dam and Photo 5). Other potential problems are indicated by jeep tracks which cross the upstream slope just above the waterline, the bench on the downstream slope, and all of the abutment slopes. A jeep track is also located on the right side of the downstream embankment slope. Animal burrows were observed in the junction of the upstream embankment slope with the right abutment and the left downstream junction.
