MISCELLANEOUS PAPER SL-79-25

INVESTIGATION OF LIGHTWEIGHT CONCRETE AND MATERIALS, EAST LOS ANGELES COMPREHENSIVE HEALTH CENTER BUILDING

A. D. Buck and T. C. Liu

Structures Laboratory

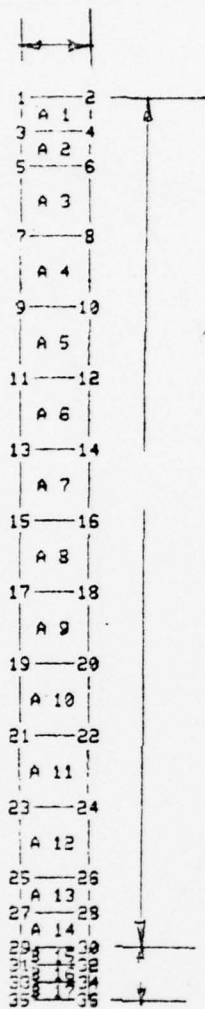
Figure 6. Finite-Element Model.

28. The finite-element model selected for temperature calculation is representative of a unit width of interior section of the lightweight concrete slab. The height of the finite-element model was 12-3/4 in., representing 12 in. of concrete slab and 3/4 in. plywood form. The finite-element model, consisting of 36 nodes and 17 elements, is shown in Figure 6.

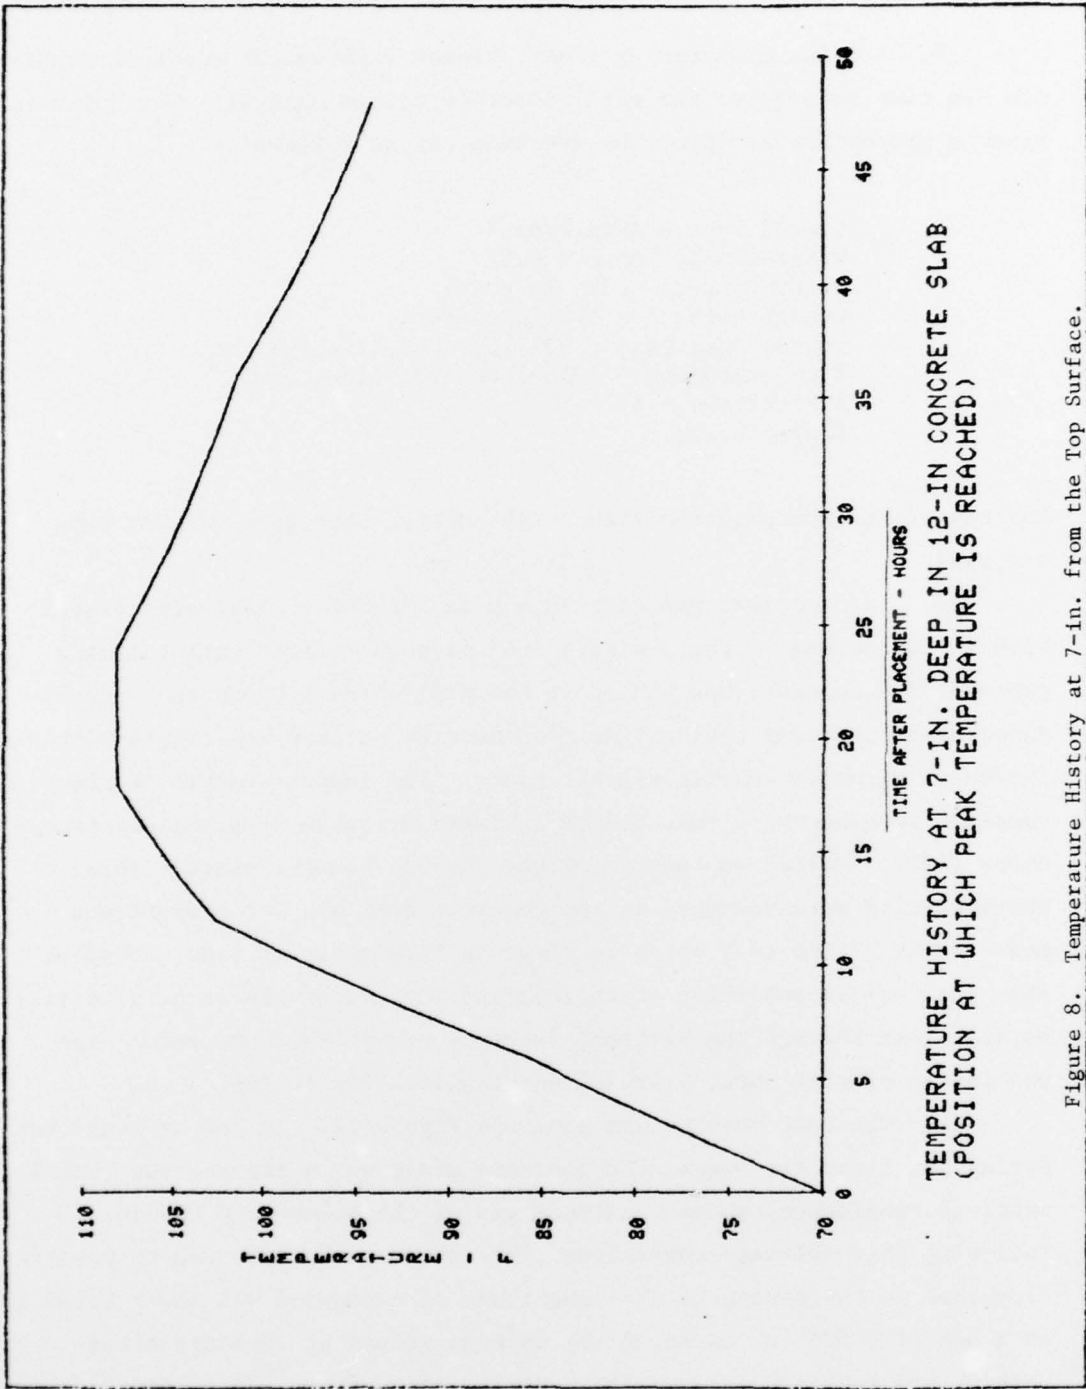
Figure 8. Temperature History at 7-in. from the Top Surface.

31. The calculated temperature distribution in the lightweight concrete slab is shown in Figure 7. It can be seen that peak temperatures of approximately 108°F were attained at about 19 hours after placement. The temperature history at 7 in. from the top surface (position at which peak temperature is reached) is shown in Figure 8. This temperature information was transmitted to Osborne Laboratories, Inc. through County of Los Angeles Facilities Department on 13 September 1978.

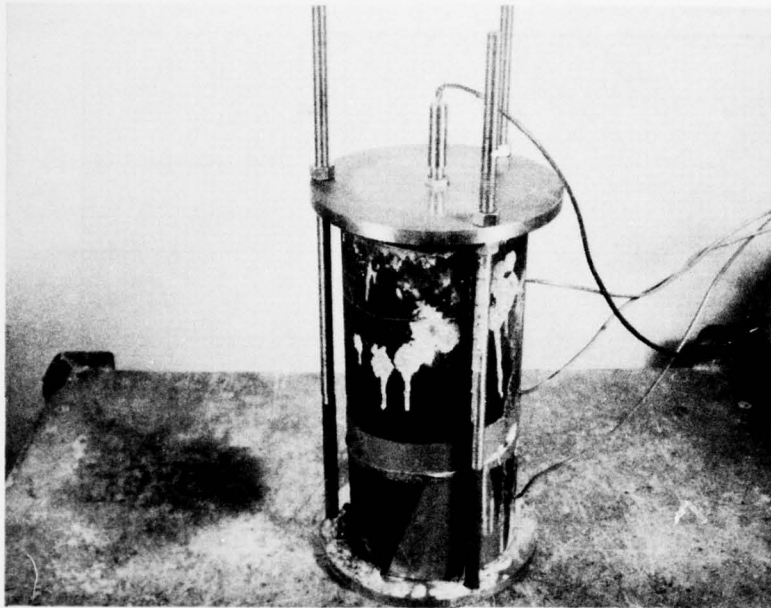
Figure 9. Test Setup for Early Volume Change Study.

33. The specimen was cast in a 6-in. diameter steel pipe fitted with a plywood base. The inside of the pipe was coated with silicone grease. The concrete was placed in the pipe using a scoop and consolidated on a vibrating table. The top concrete surface was capped with a 5-3/4-in. diameter acrylic plastic plate. The length changes of the concrete specimen were measured by a linear variable displacement transducer (LVDT) located on the top of the acrylic plastic plate. Three thermocouples were embedded in the concrete specimen for temperature measurements. The test setup is shown in Figure 9. In order to simulate the thermal condition of an interior portion of the large slab (i.e., no heat loss through the vertical faces is permitted), the steel pipe was insulated with about 8 in. of vermiculite (Figure 10).
