HOT ISOSTATIC PRESSING REJUVENATION OF DISKS

AiResearch Manufacturing Company of Arizona  
111 South 34th Street  
Phoenix, Arizona 85010

July 1979

TECHNICAL REPORT AFML-TR-79-4093

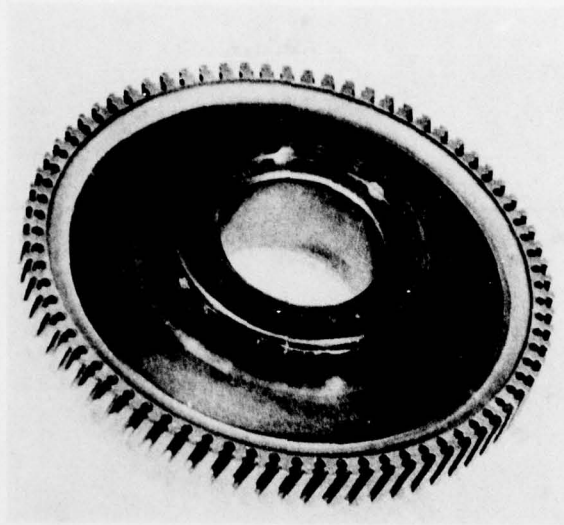
Four TSCP700 high-pressure turbine disks (Part Number 977156) were obtained from commercial airlines. Three of these disks exhibited LCF cracking in the firtrees. The fourth disk (Figure 6) was found to be crack free. Table 3 documents the disk service time and the results of the fluorescent-penetrant and visual inspections which detected the firtree cracks.

Figure 6. TSCP700 High-Pressure Turbine Disk.

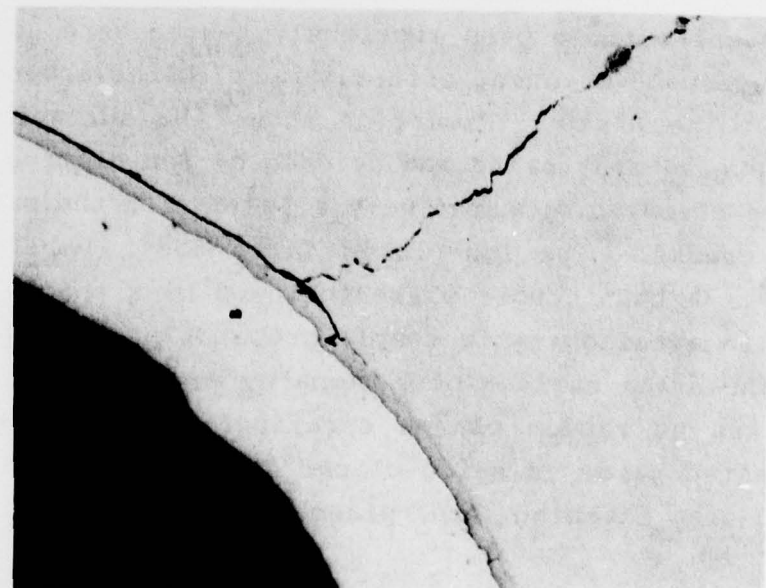
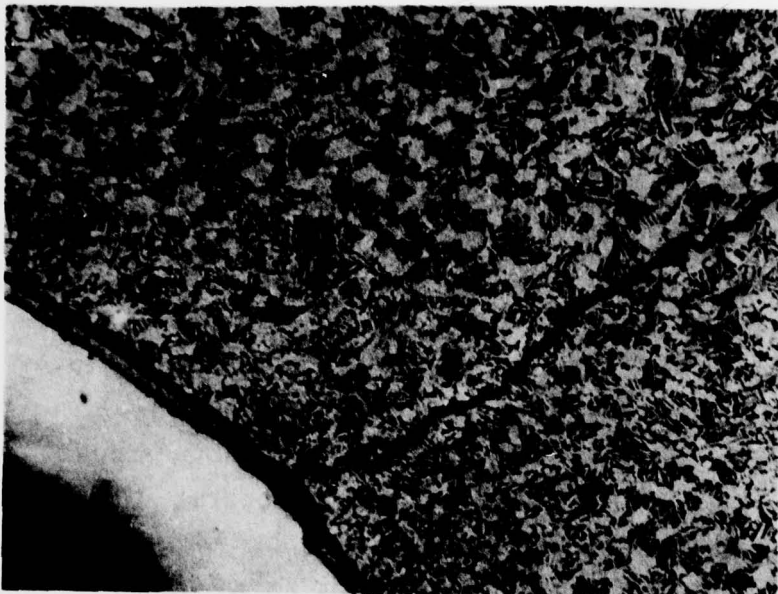
The Ti-6Al-4V and Waspaloy test samples, cleaned and bridged by vacuum plasma spraying at Electro-Plasma, Inc. and by ion plating at Koral Laboratories, were extensively examined by light metallography to determine the effectiveness of the coatings as potential crack seals (bridges). Figure 24 shows a crack in the dovetail of a Ti-6Al-4V compressor disk which has been bridged by ion plating. The titanium layer of plating is not well bonded to the substrate in the region of the crack, but different dovetails coated at the same time appeared to have the titanium layer well bonded to the substrate without the oxide film or gap. Figure 25 shows a comparable cracked dovetail bridged by vacuum plasma spraying pure titanium followed by pure copper. The titanium layer appears oxidized and quite porous compared to the ion-plated bridge. The copper layer also appears cracked and porous and probably would not act as an effective seal.

Figure 24. Dovetail Crack in a TI-6Al-4V Alloy Compressor Disk Test Sample Bridged by Ion Plating with Pure Titanium (A) and Pure Copper (B).

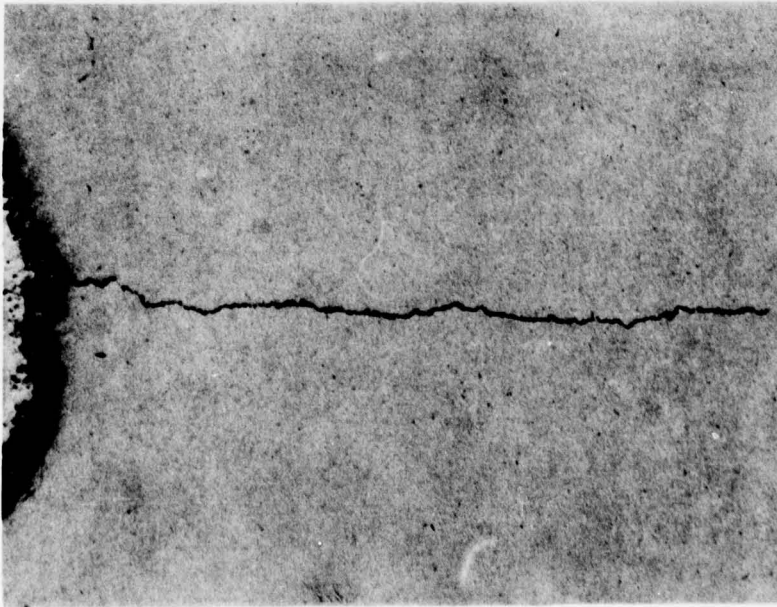
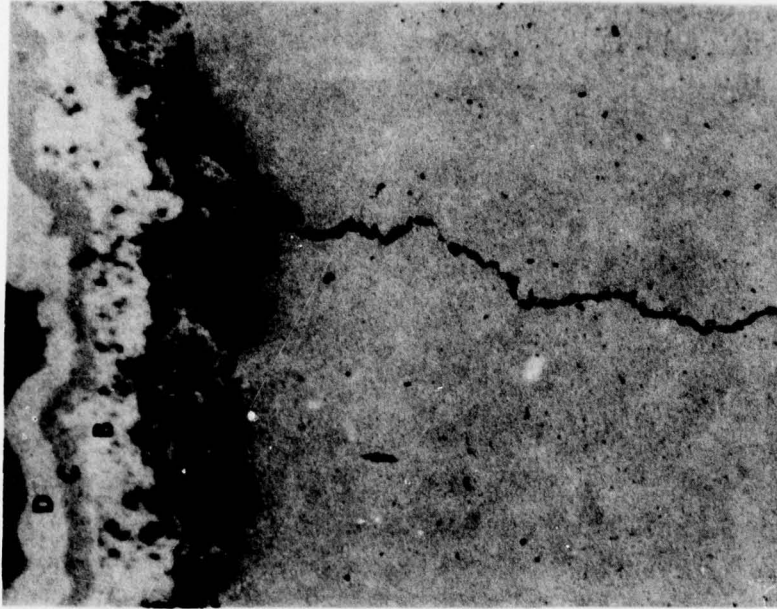
Figure 25. Dovetail Crack in a Ti-6Al-4V Alloy Compressor Disk Test Sample Bridged by Vacuum Plasma Spraying Pure Titanium (A), Pure Copper (B) and Followed by a Layer of Nickel (C) and a Layer of Copper (D) to Aid in Metallographic Sample Preparation.

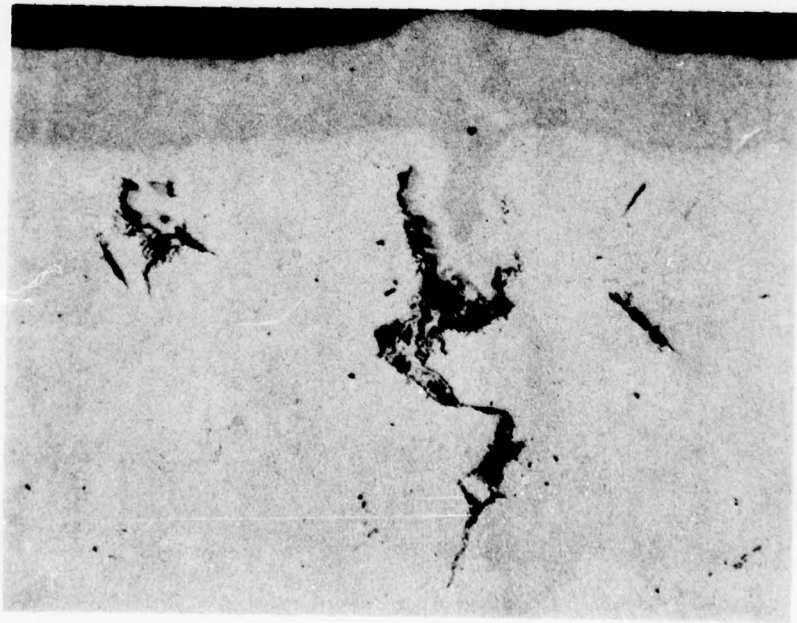
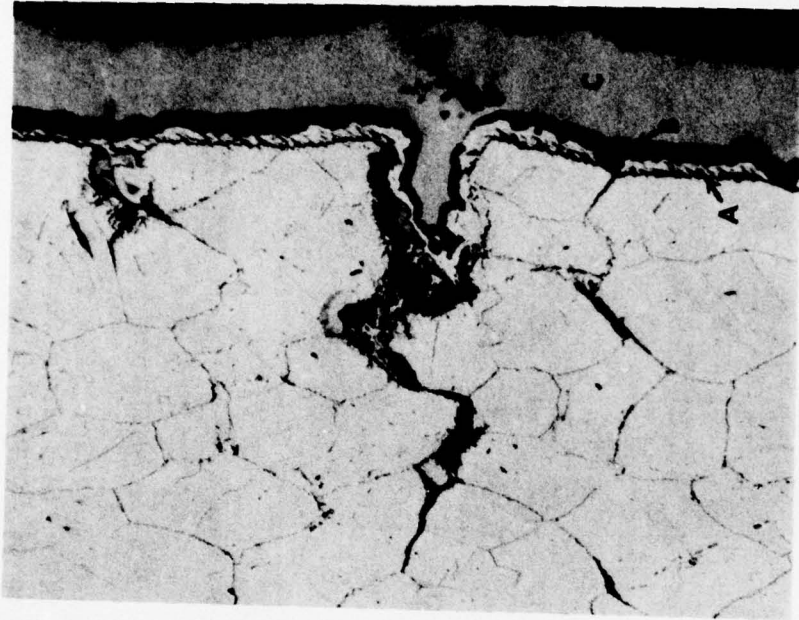
Waspaloy stress-rupture bars previously tested were used as test samples to evaluate bridging effectiveness in the absence of field-cracked turbine disks. Figure 26 shows the surface of a bar cleaned by reverse sputtering and bridged by ion plating with pure nickel. The cleaning appeared very effective on the surface but not in the cracks. The ion-plated layer does, in effect, bridge the crack. A thin copper plate followed by a thick layer of nickel aided in metallographic sample preparation. Figure 27 shows a before-and-after surface of a Waspaloy stress-rupture bar that was subjected to vacuum plasma spraying. The sample was lightly grit-blasted prior to being placed in the vacuum chamber for transferred-arc cleaning and plasma spraying with pure

Figure 26. Cracks in Waspaloy Stress-Rupture Bar Cleaned and Bridged by Ion Plating Techniques. Ion-Plated Pure Nickel (A) followed by a Flash of Copper (B) and Electroless Nickel (C). (B) and (C) Used as Sample Preparation Aids.

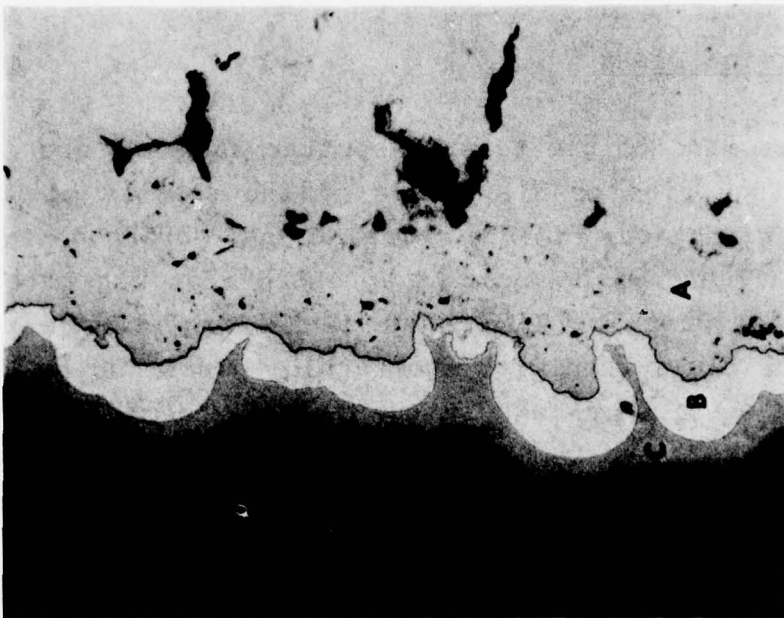
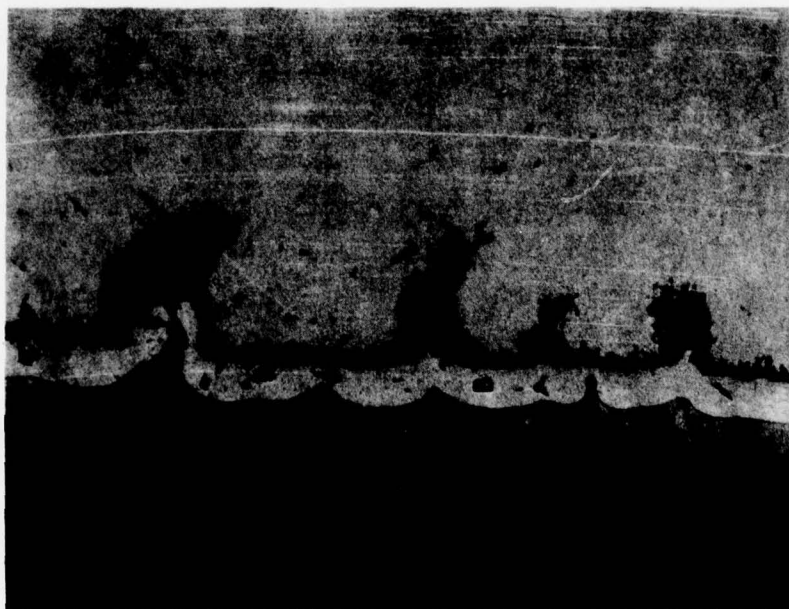
Figure 27. Surface of Waspaloy Stress-Rupture Test Bar Before (Left) and After Grit Blasting, Transferred-Arc Cleaning and Vacuum Plasma Spraying of Nickel A (Right). Copper B and Nickel C are for Metallographic Sample Preparation.

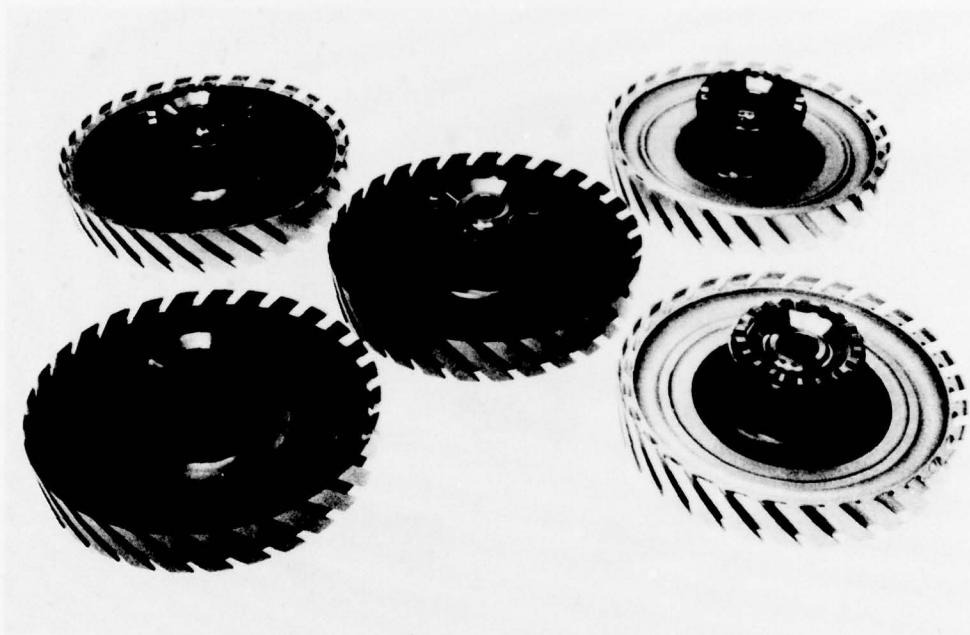
The Ti-6Al-4V alloy compressor disks were ion plated with a 0.001- to 0.002-inch thick layer of pure titanium followed by a 0.001-inch thick layer of copper on the blade attachment dovetails of five field-service compressor disks. Reverse sputtering was employed prior to plating to clean the surfaces. The work was accomplished at Koral Laboratories, St. Paul, Minnesota. Figure 28 shows the five compressor disks after bridging. The light-colored regions encompassing the dovetails and part of the web are the copper plate which was applied over the layer of pure titanium. Additional copper was subsequently electroplated over the flash of copper shown here prior to shipment for HIP.

Figure 28. Five TSCP700 Compressor Disks Which Have Been Reverse-Sputter Cleaned and Ion Plated with Pure Titanium Followed by a Flash of Copper. MAG:  $\sim 0.3X$ .

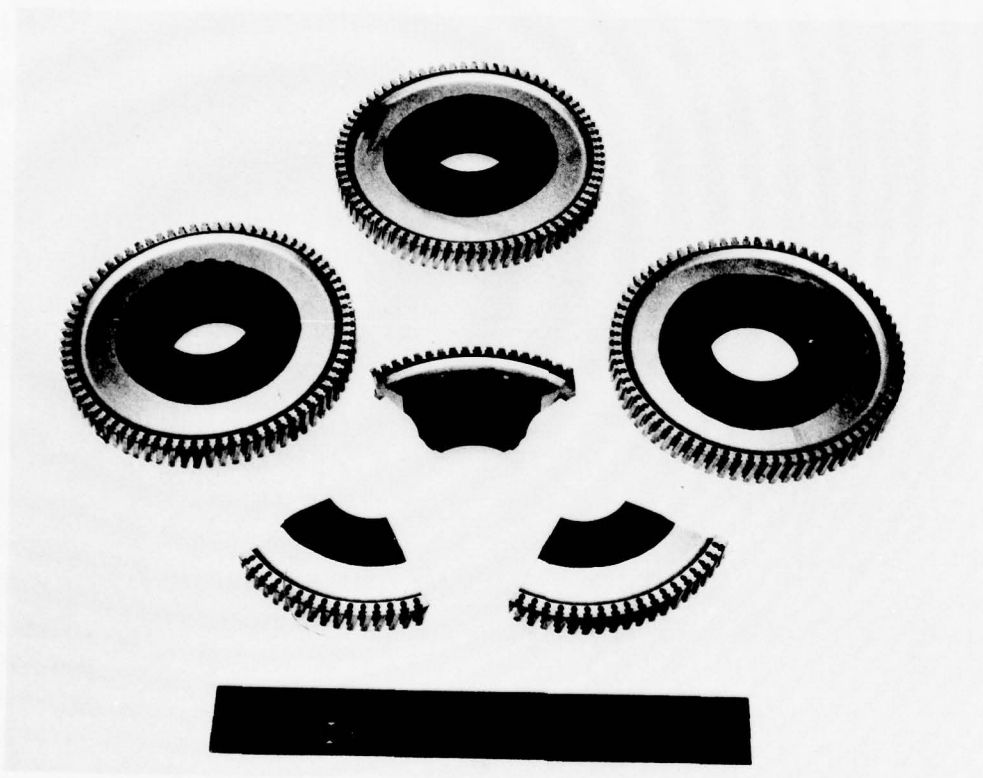
Six Waspaloy turbine disks and disk sections were ion plated with approximately 0.002-inch of pure nickel at Koral Laboratories. The disks and disk sections are shown in Figure 29. Additional nickel (0.003 to 0.005 inch) was electroplated over the ion plate layer to build up the bridge over the fatigue cracks.

Figure 29. Turbine Disks and Disk Sections Ion Plated with Pure Nickel Prior to HIP.

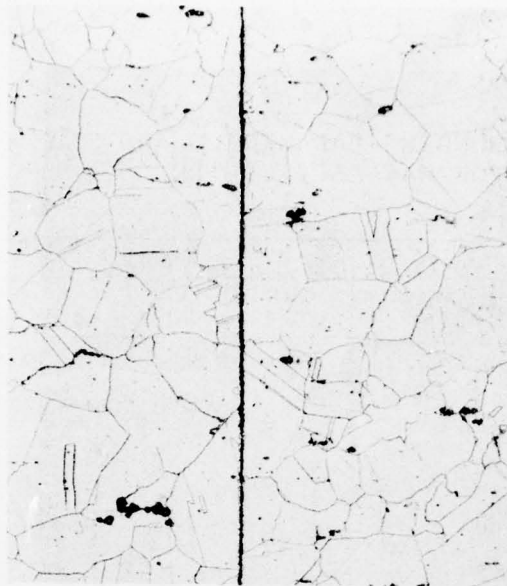
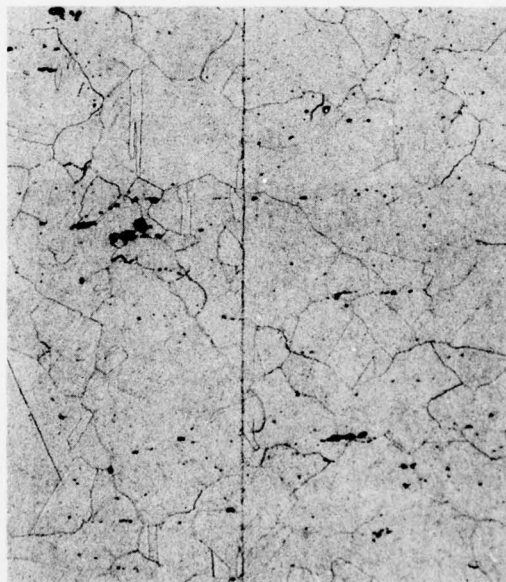
At bonding temperatures above 1800°F, grain growth was observed which contributed to the reduced strength of samples bonded under these conditions. Figure 36 is a photomicrograph showing the increase in grain size exhibited by the 1900°F/4-hours/5-ksi specimens over those bonded at 1800°F. The latter specimens experienced essentially no grain growth.

Figure 36. Photomicrographs Showing Grain Growth Experienced by 1900°F/4-hr/5-ksi Bond Specimen (After Heat Treatment).

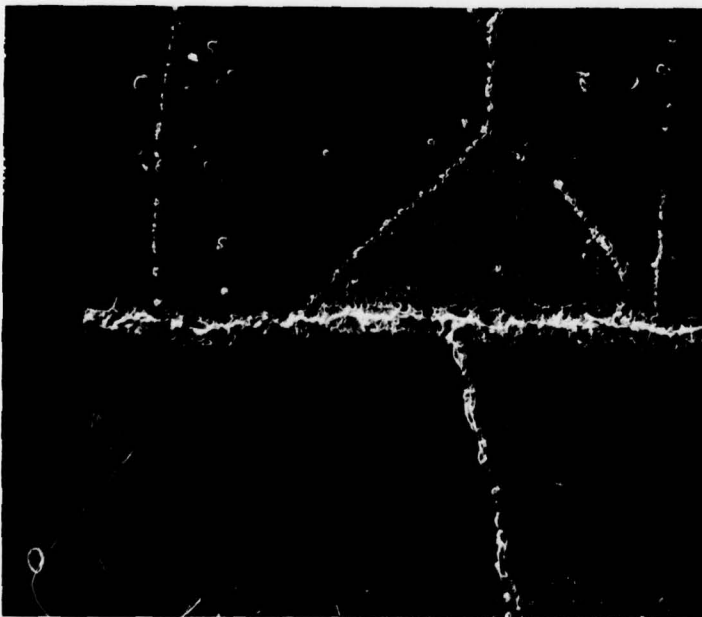
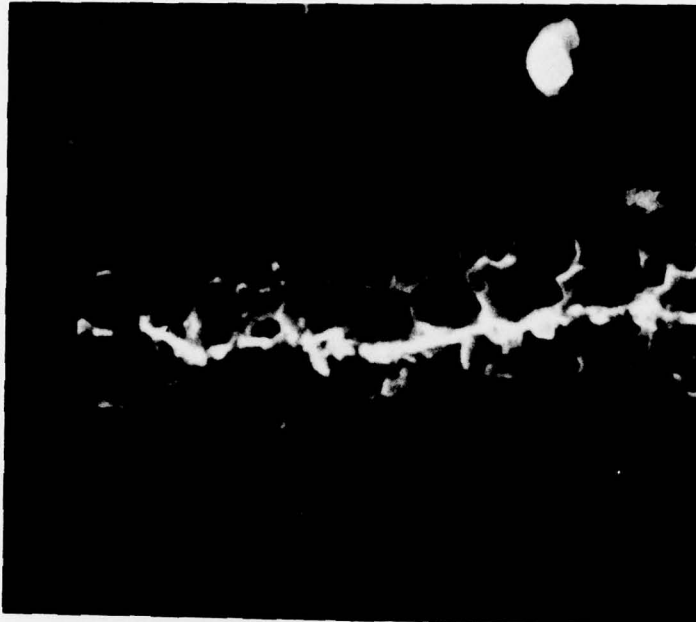
The apparent reason for the observed decrease in ductility of the bonded specimens, versus the baseline unbonded specimens, was the presence of a continuous oxide film at the bond interface (refer to Figure 37). Scanning-Electron-Microscope (SEM) analysis of the film revealed it to be high in aluminum and titanium. Another feature of the bond area was the presence of a narrow band of recrystallized grains denuded of gamma prime. This apparently resulted from the cold work introduced during the grinding and lapping of the bond specimen surfaces prior to joining, and should not occur in cracked and rejuvenated hardware.

The depletion of gamma prime in the grains adjacent to the bond line indicated that aluminum and titanium in this area reacted with available oxygen to form the observed oxide interlayer. Since a high vacuum was maintained during the bond cycle,

Figure 37. SEM Photomicrographs of Typical Bond Joint Showing Aluminum/Titanium Oxide Interlayer. Note Recrystallization Adjacent to Bond.

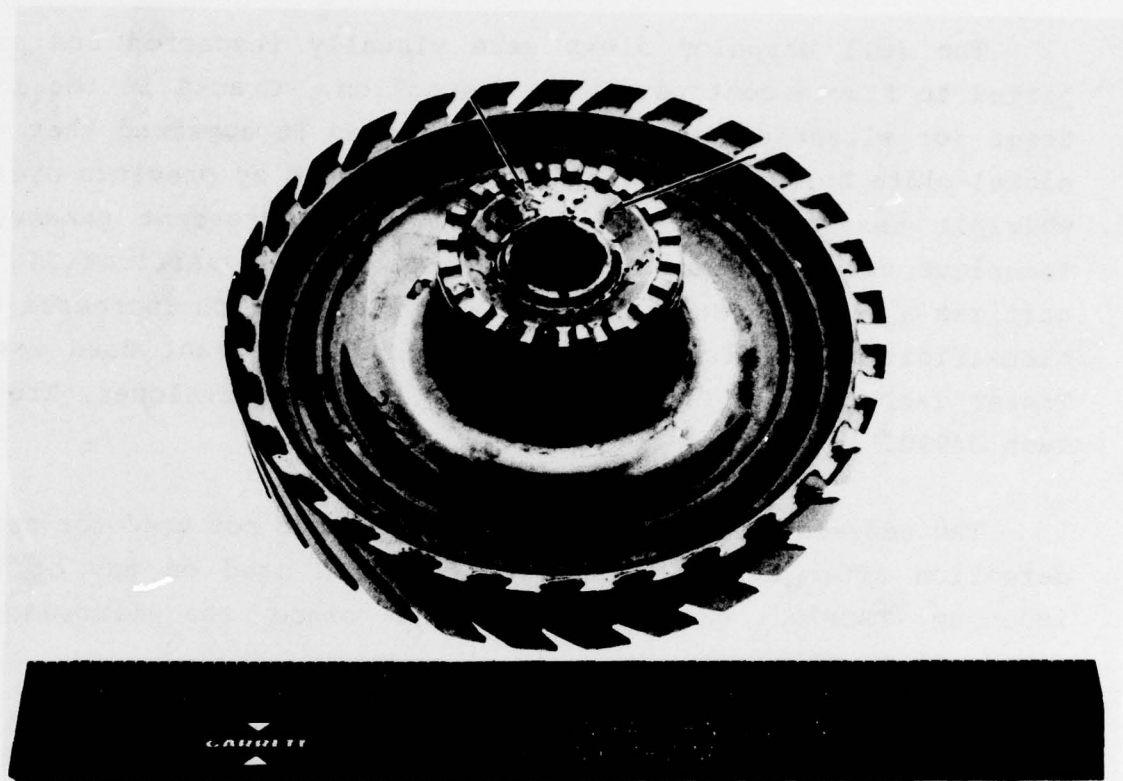
MAG: 1/2X

A pitting-type corrosion was noted in regions that had been electroplated with copper but had not been first ion plated. Figure 39 shows this corrosion in the region of the curvic coupling. The possibility exists that electroplating solution was trapped between the disk surface and the heavy copper plate due to poor adherence, and upon heating, corrosion of the Ti-6Al-4V occurred.

Figure 39. Ti-6Al-4V Alloy Compressor Disk After HIP and Copper Plate Removal. Note Corrosion (arrows).

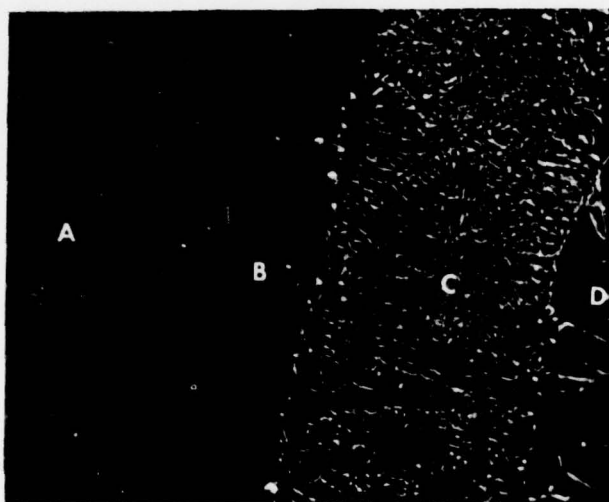
As shown in Figure 40, a dark etching layer existed in the base alloy of disk Serial No. 4829 to a depth of approximately 0.0015 inch. Scanning electron microscope analysis of the layer showed it to contain copper. Electron microprobe analyses were performed at AFML to determine the amount of copper present in the layer. The results are given in Figure 41.

The layer was identified, using TEM thin-film techniques, as stabilized beta with a fine distribution of small alpha and/or  $Ti_2Cu$  precipitates. Copper is a strong beta stabilizer. This beta layer was present on the internal surfaces of the dovetails but changed on the outside diameter of the disk. It appeared to be replaced by a white etching layer, as shown in Figure 42. Figure 43 shows Scanning Electron Microscope (SEM) images of the corner of a dovetail showing this transition from stabilized beta to the unidentified layer. X-ray analysis in the SEM detected a slightly higher copper content in the OD layer than in the beta, but was unable to detect other chemical differences due to the

Analysis Point	Approximate Wt Percent*			
	Cu	V	Al	Ti
A Copper Plate	99.4	0.0	0.3	1.1
B Titanium Plate	62.5	0.5	0.2	33.9
C Beta Phase	13.6	4.2	4.9	73.5
D Ti-6Al-4V Matrix	0.0	1.9	6.1	88.4

Figure 41. Electron Microprobe Chemical Analysis Results of  
Stabilized Beta Phase Layer in Ti-6Al-4V.

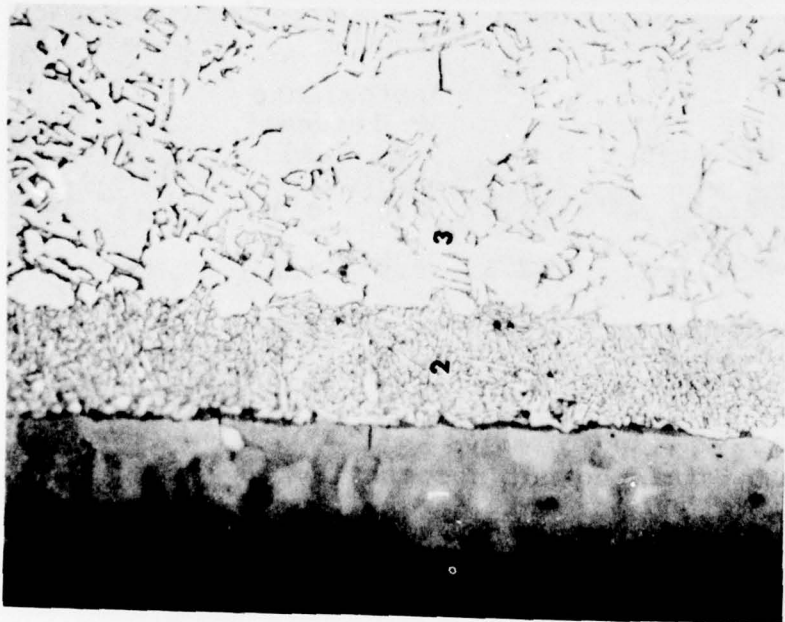
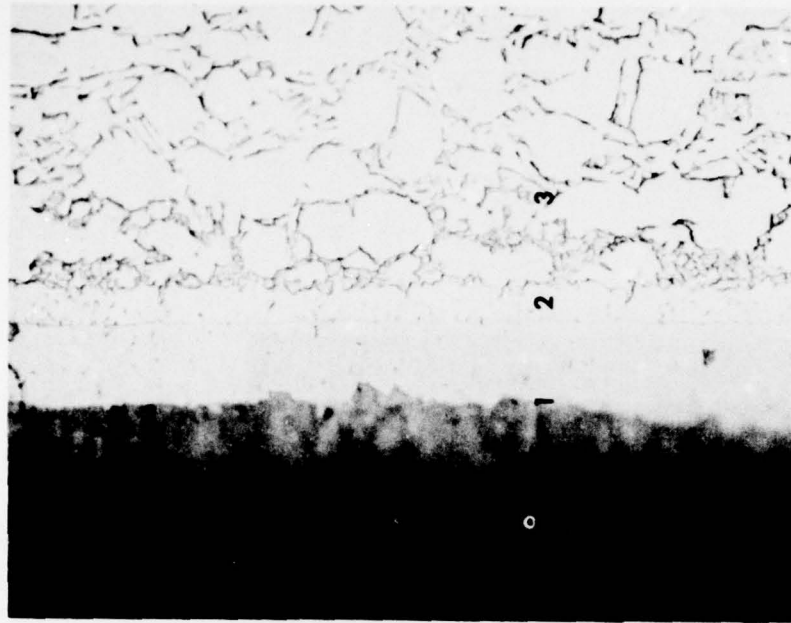
- 1 BRIDGE
- 2 BETA LAYER
- 3 BASE ALLOY Ti-6Al-4V

- 1 BRIDGE
- 2 UNKNOWN LAYER
- 3 BASE ALLOY Ti-6Al-4V

Figure 42. Surfaces of Disk S/N 1706 at the OD and at the Base of the Dovetail.

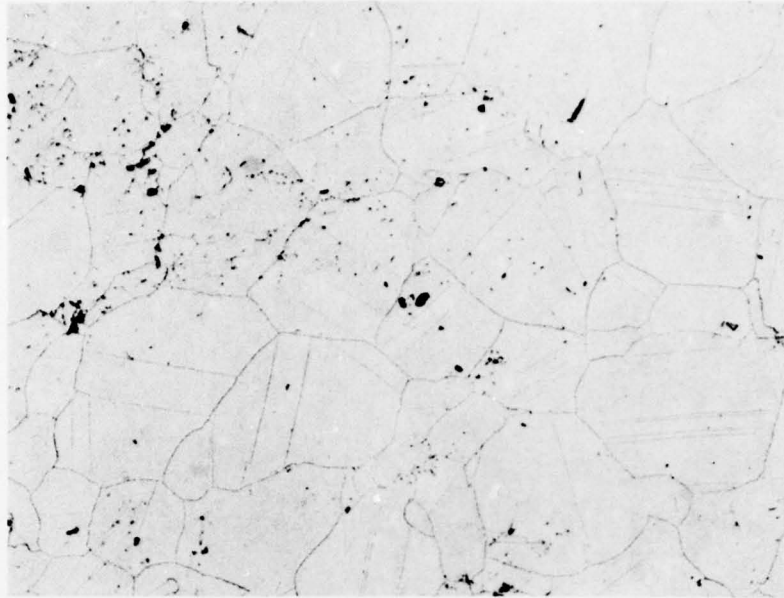
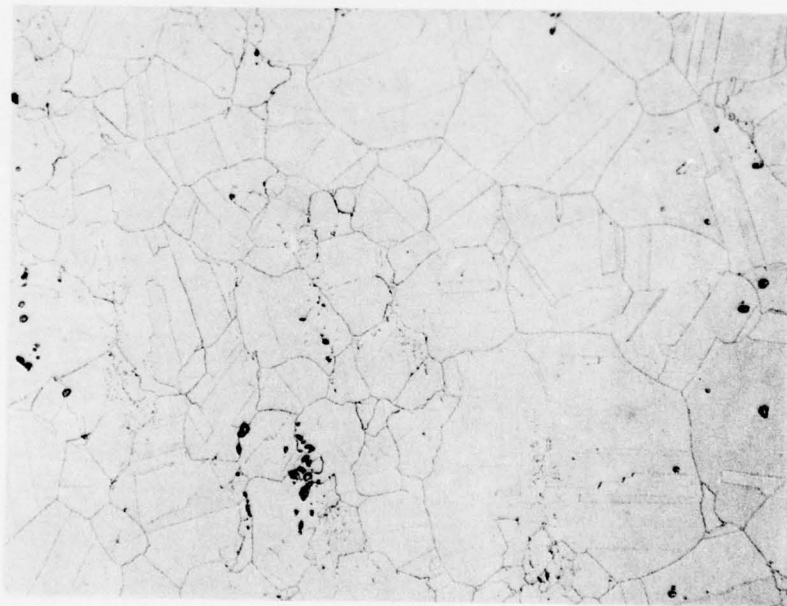
An extensive metallographic examination of the HIPped and heat-treated Waspaloy disks was performed. Figure 48 shows the microstructure comparison of both the pre- and post-HIP of disk Serial No. 1351. The grain size was slightly enlarged by the HIP and subsequent heat treatment but remained in the acceptable range. Figure 49 shows photomicrographs of a

Figure 48. Pre-HIP and Post-HIP Microstructures of Waspaloy  
Disk Serial No. 1351 Etchant: Kallings  
MAG: 100X

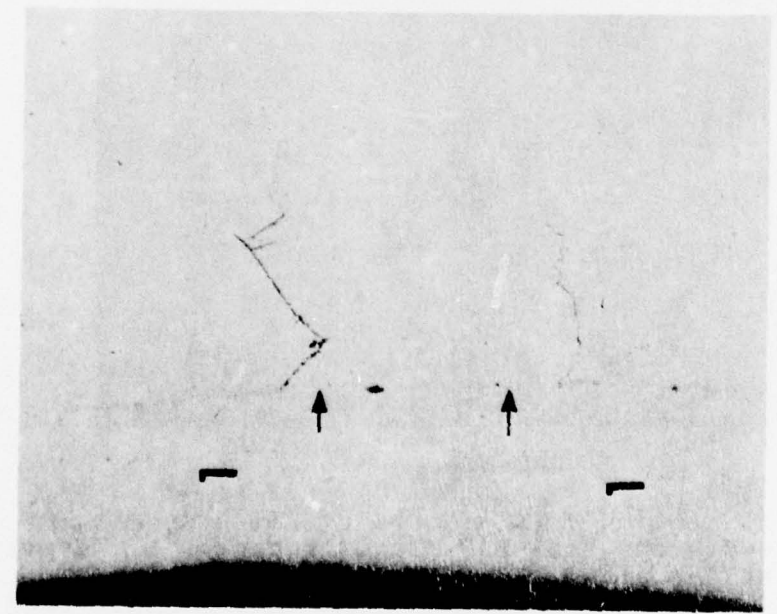
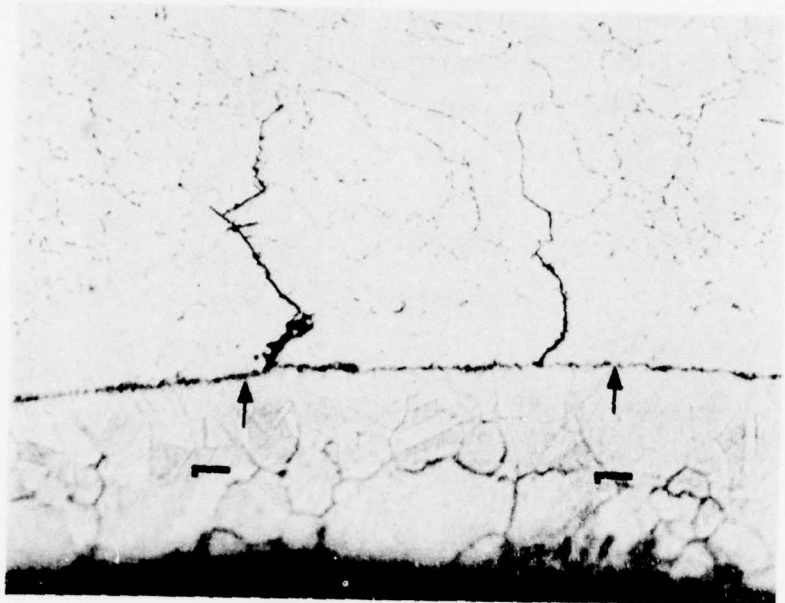
Figure 49. Base of Firtree in Waspaloy Turbine Disk after HIP and Heat Treatment. Cracks are Bridged with Pure Nickel (Layer 1) Bridge to Form a Seal During HIP. Mag.: 400X

section made through the base of a firtree of a field-service disk. This particular blade slot exhibited cracks that were produced in service and were subsequently bridged with nickel prior to HIP. Note the cracks are bridged but HIP did not create a bond. Denuding of the gamma prime below the original disk surface is evident. The aluminum and titanium appear to be diffusing into the pure nickel plate leaving the Waspaloy deficient in the alloying elements.

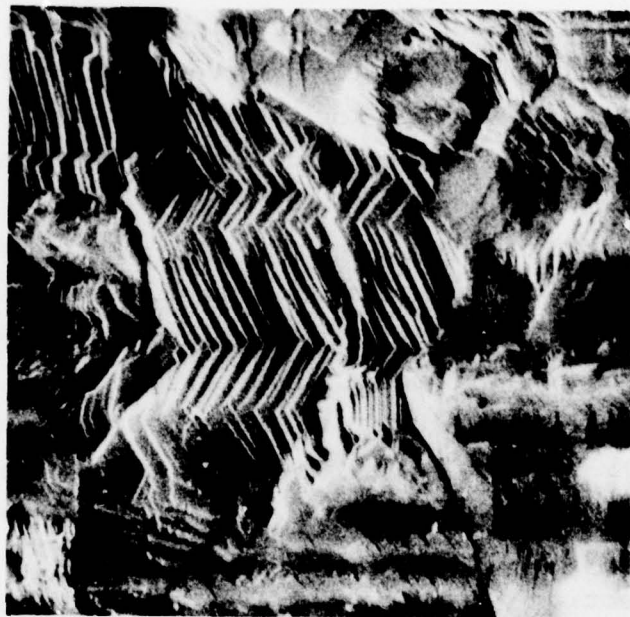
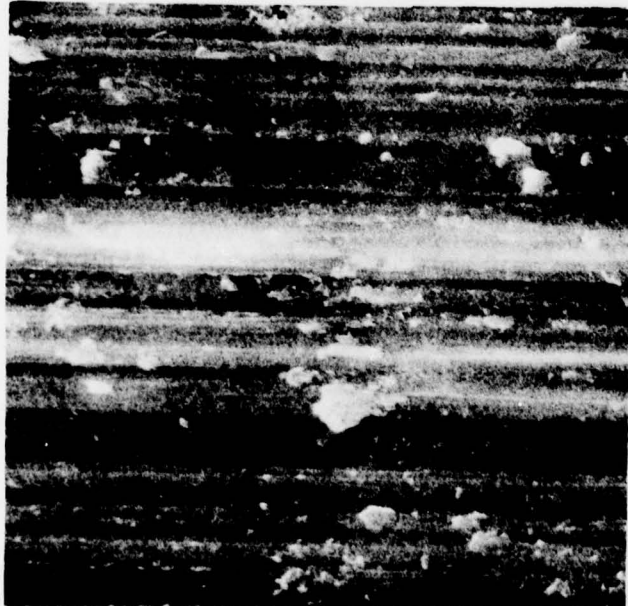
and X-ray residual stress measurements were performed on un-HIPped and HIPped disk samples. SEM analysis of the broached dovetail surface indicated a surface change occurred during HIP. Figure 55 shows before and after photographs indicating that most of the residual broach marks were removed by a thermal etching or thermal faceting. It was not known to what degree this thermally etched surface might affect fatigue crack initiation.

Figure 55. SEM Analysis of Dovetail Surface Before and After HIP.  
Mag.: 5000X

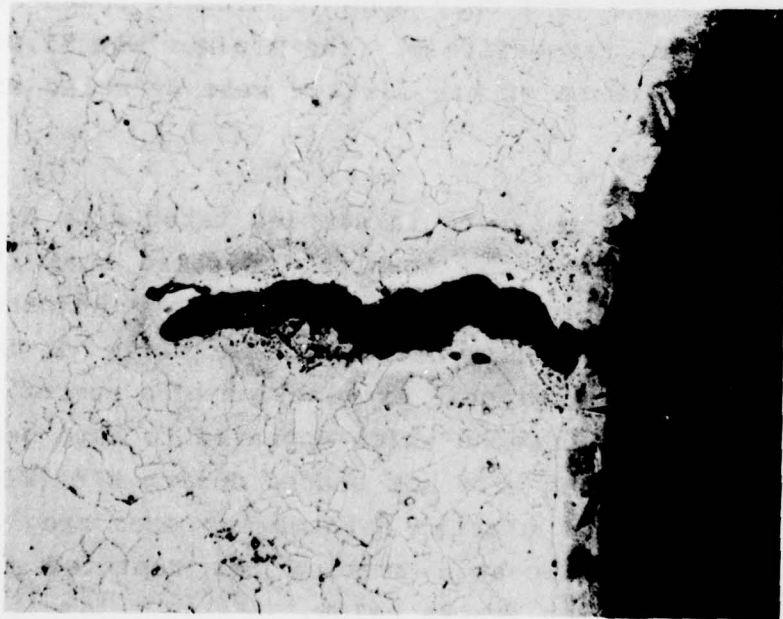
DISK S/N 727

The first bridged disk, Serial No. 2685, which had been spin tested prior to HIP, was cycled in steps of increasing speed to monitor bore growth. After eleven cycles (maximum speed of 53,100 rpm), cracks were detected at the base of the firtrees in locations matching those present prior to bridging, HIP, and heat treatment. Subsequently, field-service disks (Serial Nos. 90309 and 727), which had exhibited cracks prior to bridging and HIP, were spun. These two disks were only spun to maximum speeds of 51,800 rpm and 52,200 rpm, respectively, (the minimum was 52,900 rpm) before cracks at the base of the firtree were detected and the disks were retired.

Tensile properties were measured in samples taken from disk Serial Nos. 90309 and 727, and the results indicated that the strengths of the disks were acceptable according to AiResearch specifications, and exceeded those reported in Table 21 for the post-HIP material. Metallographic examination of a number of cracked firtrees showed large cracks which appeared to have been bridged by the nickel plate but were not bonded during HIP (Figure 56). It appears that the plastic deformation occurring at the firtree base during cyclic-spin testing has ruptured the bridge and exposed the existing cracks below.

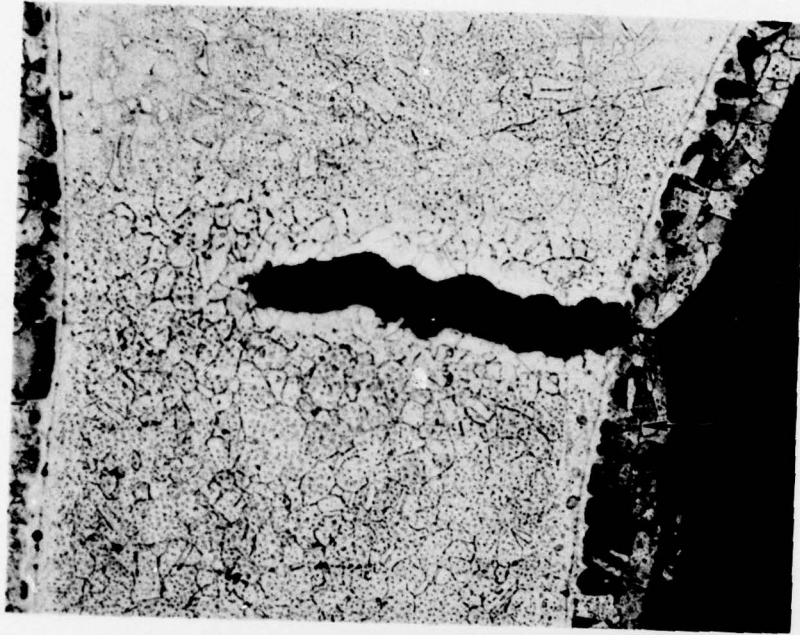
DISK S/N 90309

Figure 56. Cross Section of the Bases of Two Firtrees After Bridging with Nickel, HIP, Heat Treatment, and Spin Testing. Etchant: Modified Kallings. Mag.: 100X. Arrows Indicate Nickel Bridge.

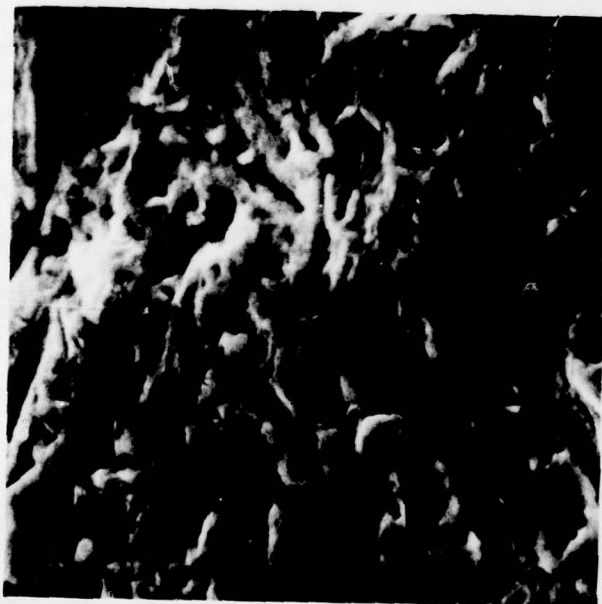
BEFORE HIP

Figure 58 shows the appearance of the surface of Waspaloy in the SEM before and after HIP. The area is just below the base of the firtree and was oxidized in engine service. The HIPped surface shows additional oxidation present but it is not considered detrimental.

Figure 58. Appearance in the SEM, of Waspaloy Before and After HIP.  
Mag.: 5000X
