**EVALUATION OF AIRCRAFT WINDSHIELD MATERIALS  
IN A SIMULATED SUPERSONIC FLIGHT ENVIRONMENT**

J.B. HOFFMAN  
Douglas Aircraft Company  
McDonnell Douglas Corporation  
3855 Lakewood Boulevard  
Long Beach, California 90846

JUNE 1979

TECHNICAL REPORT AFFDL-TR-79-3058

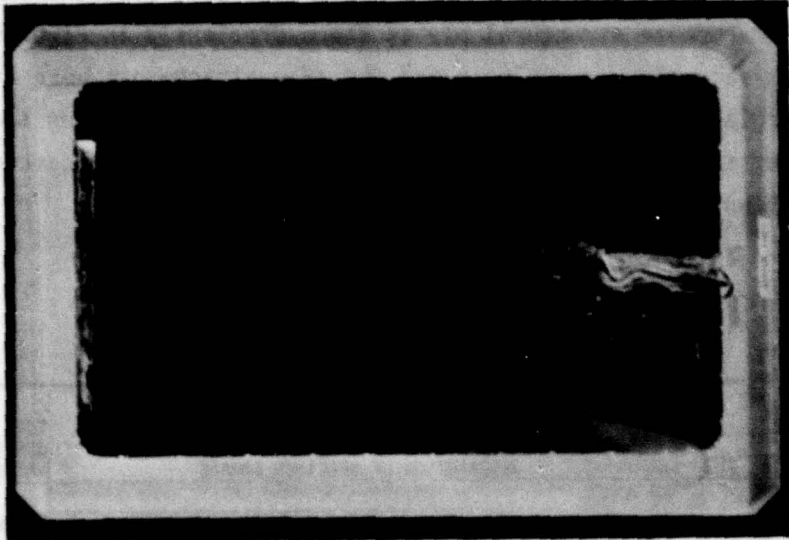
Figure 31. Post-Test Photo of Specimen SK05.

GY01 was tested. SK06 and GY01 were previously subjected to a temperature of 250°F as part of an abrasion test (Reference 9). These three specimens sustained delamination of the face ply from the interlayer during the last seconds of tunnel injection and were considered to have failed. Specimen SK05 survived Mach 2.4 test but failed at Mach 3.0. Specimen SK06 and GY01 failed at Mach 2.6. The delamination of SK06 began in the area of the imbedded thermocouple at Mach 2.6. The delamination of SK05, Figure 31, and GY01, Figure 32, began near the aft edge and spread forward. The direction of air flow in these figures was left to right and aft edge is at the right side of the figure. The polycarbonate along the aft edge of both specimens bubbled and protruded about 0.10-inch. The material expanded until it contacted the forward face of the simulator cover (Figure 13, Page 19).

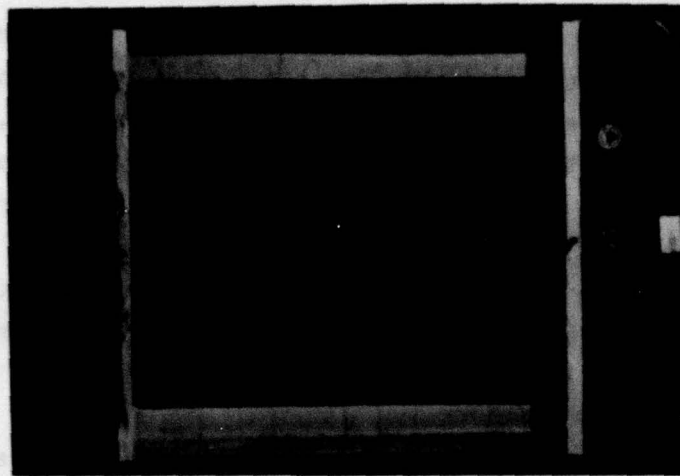
Figure 35. Post-Test Photo of Specimen SWU21.

Specimen SWU21, Figure 35, was tested at Mach 2.4, 2.6 and 3.0. This specimen sustained erosion and discoloration of the groove sealant. The discoloration appeared to be residue from the fiberglass. The sealant remained pliable.

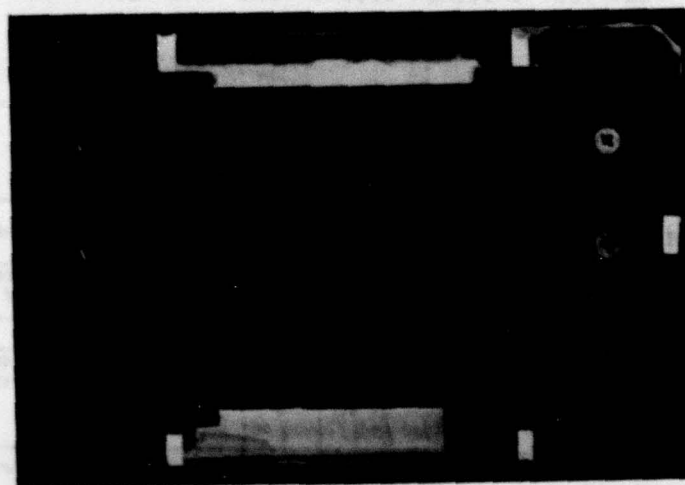
Figure 36. Post-Test Photo of Specimen SWU22.

Specimen SWU22, is shown in Figure 36. This specimen suffered delamination during its second injection at Mach 2.6. The delamination began in the area of the imbedded thermocouple. No erosion occurred under the fiberglass retainer.

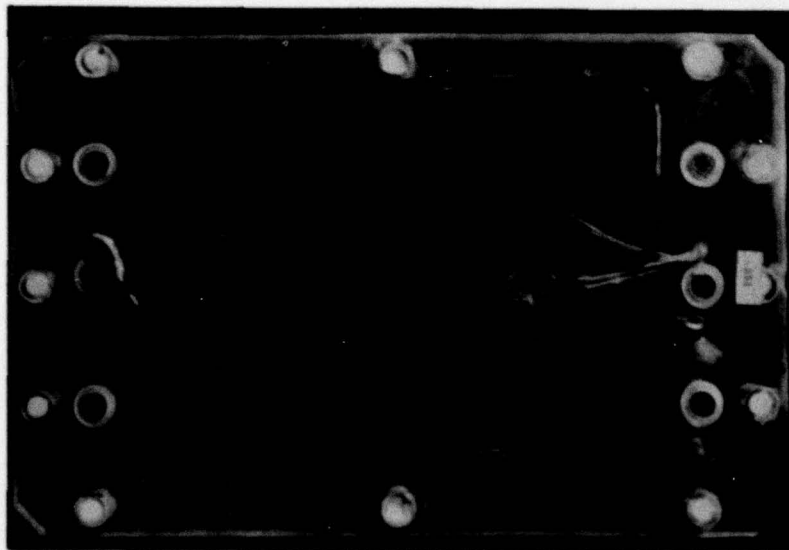
Figure 41. Post-Test Photo of Specimen GY25.

An examination of GY25, Figure 41, revealed slight face ply/interlayer delamination in the area of the imbedded thermocouples after the first injection at Mach 2.4. Severe delamination occurred during the second injection.

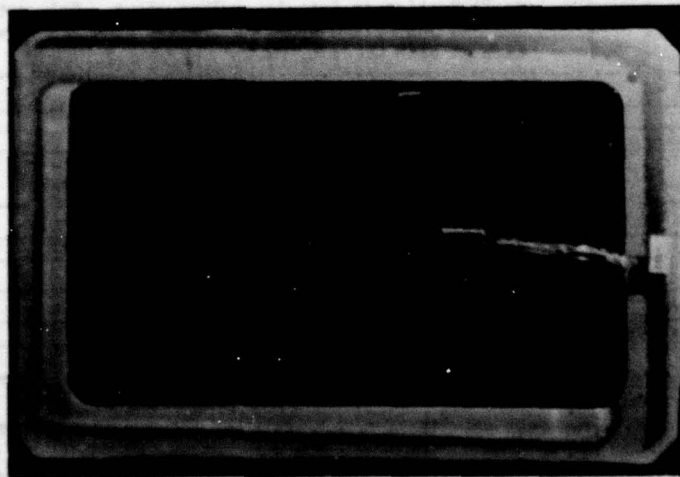
Figure 42. Post-Test Photo of Specimen GY02.

The urethane face ply of GY02, Figure 42, delaminated at the imbedded thermocouple and formed a 1.0-inch diameter bubble in the face ply. It is not clear whether the separation occurred between the face ply and interlayer, or interlayer and polycarbonate. The delamination occurred at the end of the second injection at Mach 2.4. Post-test examination revealed bubbles and deformation of the outer polycarbonate ply along its aft edge. The polycarbonate bubbled and expanded aft about 0.10-inch until it contacted the surface of the simulator cover as evidenced by its flat shape. The intensity of the bubbles gave the polycarbonate a frothy appearance, as shown in Figure 43. Similar bubbling occurred at each corner of the forward edge. Minute bubbles are visible throughout the urethane interlayer.

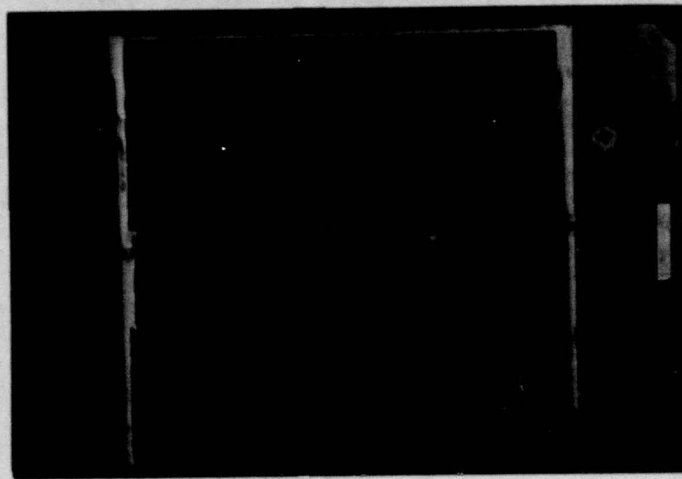
Figure 44. Post-Test Photo of Specimen SK23.

Specimen SK23 is shown in Figure 44. This specimen, tested at Mach 2.6 and 3.0, sustained bubbling and deformation of the polycarbonate structural ply along the aft edge. The flatness of the deformed area indicates that this surface was in direct contact with the simulator cover's aft edge. The adhesive that bonds the aft fiberglass edge members, consisting of two sheets, melted and oozed out from between the two pieces of fiberglass. The sealant in the groove between the edge of the glass and fiberglass edge member was discolored. The discoloration was easily removed and is apparently residue from the fiberglass edge member.

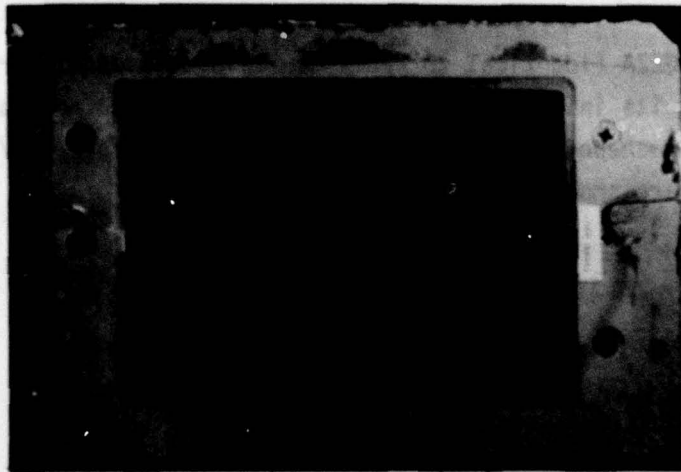
Figure 46. Post-Test Photo of Specimen PPG21.

Specimen PPG21 (Figure 46) displayed interlayer bubbles at the edges after its initial Mach 2.4 injection. The entire surface bubbled at the termination of its second injection. The interlayer, which extends to the edges of this specimen, melted on all four edges, and especially along the forward and aft edges. Specimen PPG21A (identical to PPG21) suffered interlayer bubbling early in its Mach 3.0 injection and was retracted.

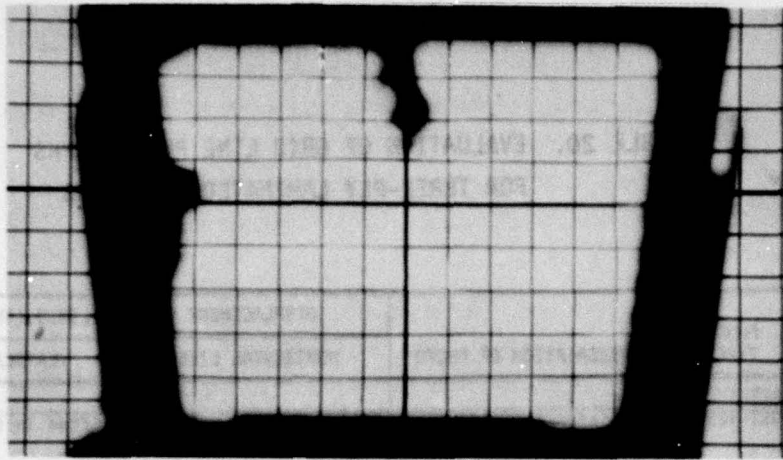
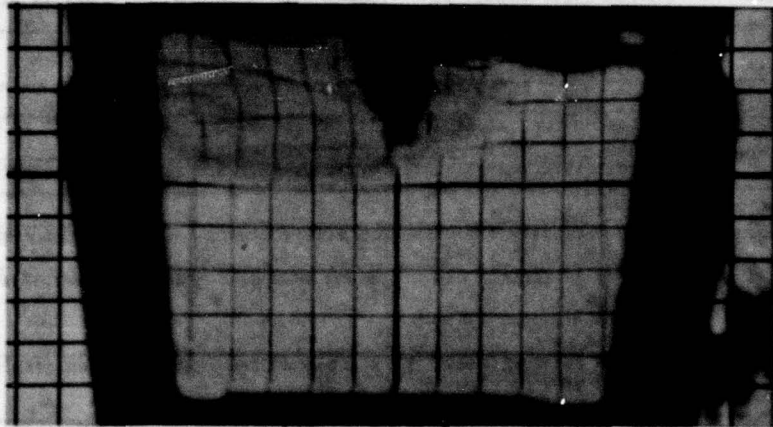
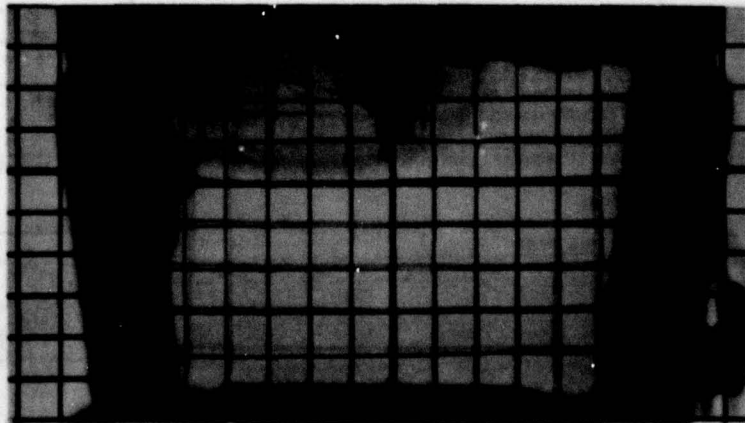
Figure 49. Grid Board Photos for Specimen SK05.

Figure 49 shows grid board photos of Specimen SK05 before and after tunnel testing, and an overlay of the two photos. Similar photos are shown in Figures 50, 51, 52, and 53 for Specimens SK06, SK21, SK22 and SWU21. The delamination suffered by SK05 is evident in Figure 49. Haze is visible in all the pre-test photos and is seen by comparing the specimen surface with the lines beyond the frame of the specimen. The oval shaped hazy spot visible in SK06 (lower, center) was caused by an abrasion test (Reference 9). All specimens suffered distortion at the edges of the specimens. Slight line displacement is seen in the overlays.

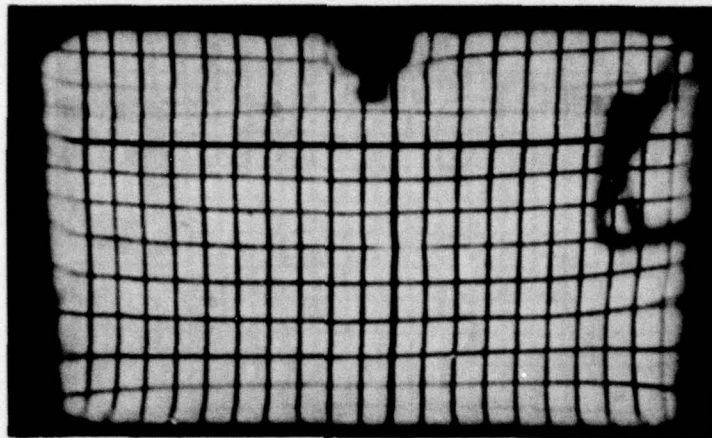
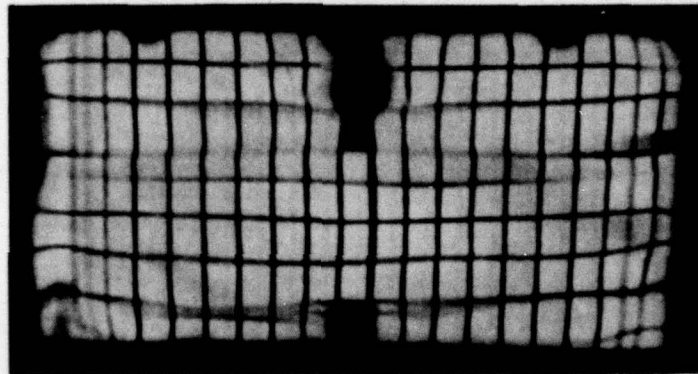
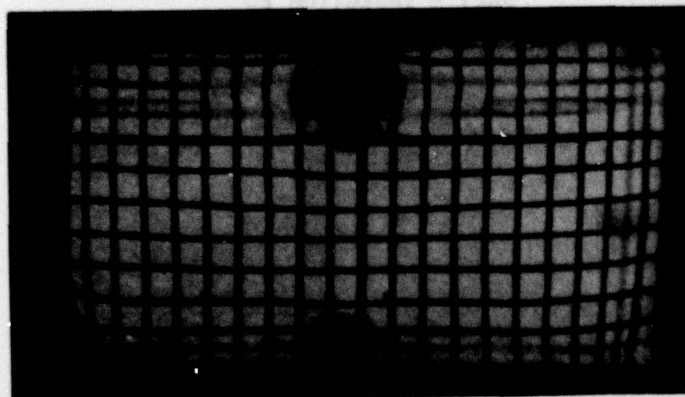
Figure 54. Tunnel Photos for Specimens SK05, SK21 and SHU21 at Mach 2.4 (10-Minute Injection).

The final tunnel photos and overlays for the Mach 2.4 injections are presented in Figures 54 and 55 for Specimens SK05, SK21 and SWU21. These were the last photos taken during the 10-minute injections. Specimen SK21 sustained more distortion than SK05 and SWU21. The cross section of SK21 and SWU21 were identical. Maximum line displacement is about 0.18 inch for the horizontal lines of SK21.

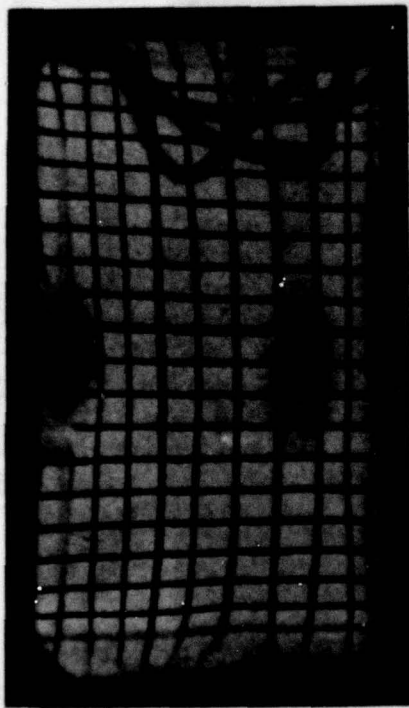
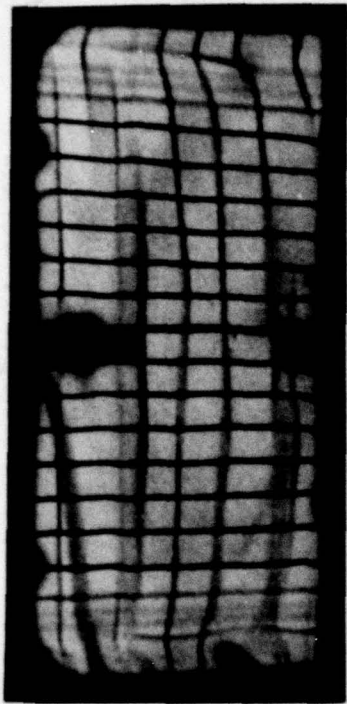
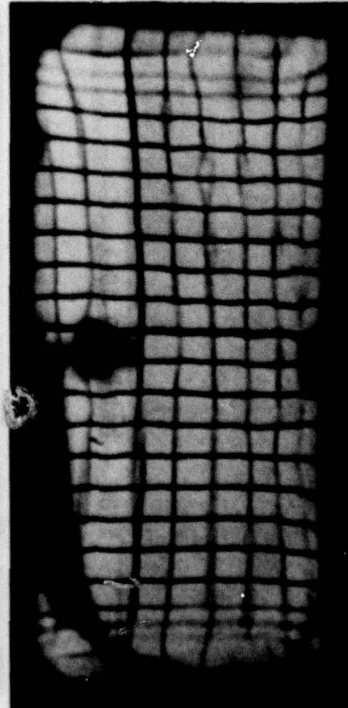
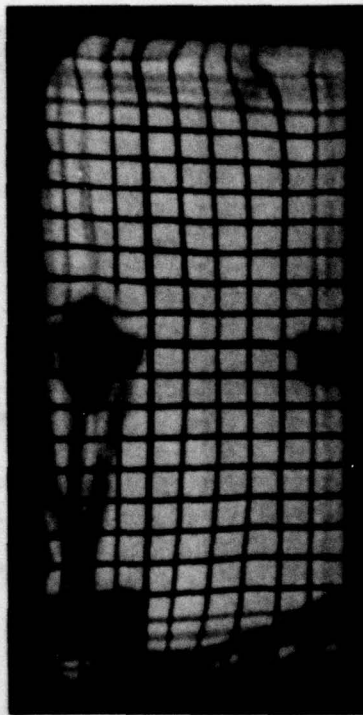
Figure 56. Tunnel Photos for Specimens SK06, SK21, SK22 and SMU21 at Mach 2.6 (10-Minute Injection).

Photos and overlays for the Mach 2.6 injections are exhibited in Figures 56 and 57 for the 10-minute injection of Specimens SK06, SK21, SK22 and SWU21. Specimen SK06 and SWU21 display the clearest line definition. Specimen SK06 shows the largest line displacement, 0.25 inch for its horizontal lines.

The acrylic/silicone/polycarbonate configuration is a viable candidate for aircraft windshields that will operate at the Mach 2.6 level, as evidenced by the clarity of the tunnel photos for Specimen SK06 and SWU21 (Figures 56 and 57). Some distortion did occur along each side. Line displacement was about 0.25 inch maximum for the horizontal lines. Specimen SK21 and SK22 did not fare well. The photos showed irregular lines, distortion and loss of clarity. Specimen SWU22 could not be evaluated because the application of thermal paint prevented light transmission.

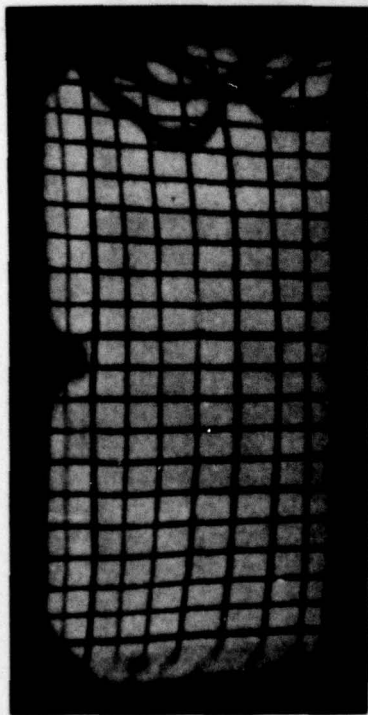
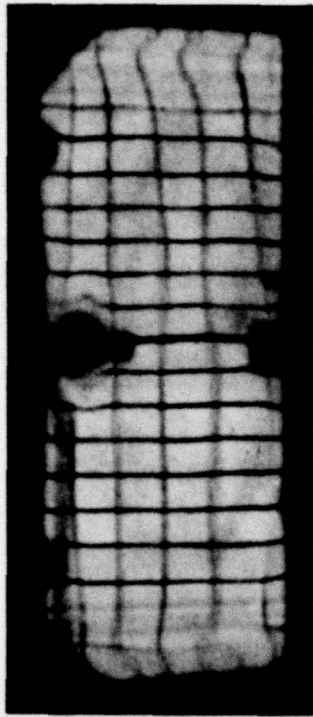
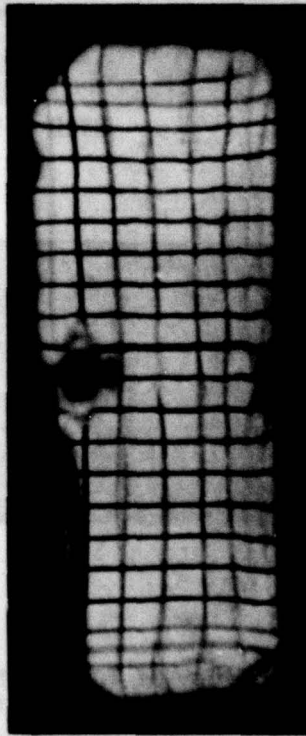
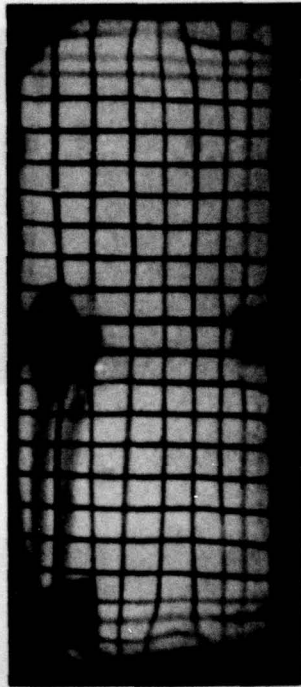
Figure 58. Tunnel Photos for Specimens SK05, SK21, SK22 and SMU21 at Mach 3.0 (3-Minute Injection).

Photos and overlays for the 3-minute injection of Specimen SK05, SK22 and SWU21 at Mach 3.0 are exhibited in Figures 58 and 59. The line quality is better for SK05 and SWU21 than for SK22. Line displacement for SK05 is 0.25-inch maximum for the horizontal lines.

The optical clarity of Specimen SK05 and SWU21 make the acrylic/silicone/polycarbonate configuration a potential candidate for Mach 3.0 aircraft (Figures 58 and 59). Further studies are needed to define the cause of optical degradation experienced by similar specimens, SK21 and SK22. Specimen SWU22 could not be evaluated due to the application of thermal paint.

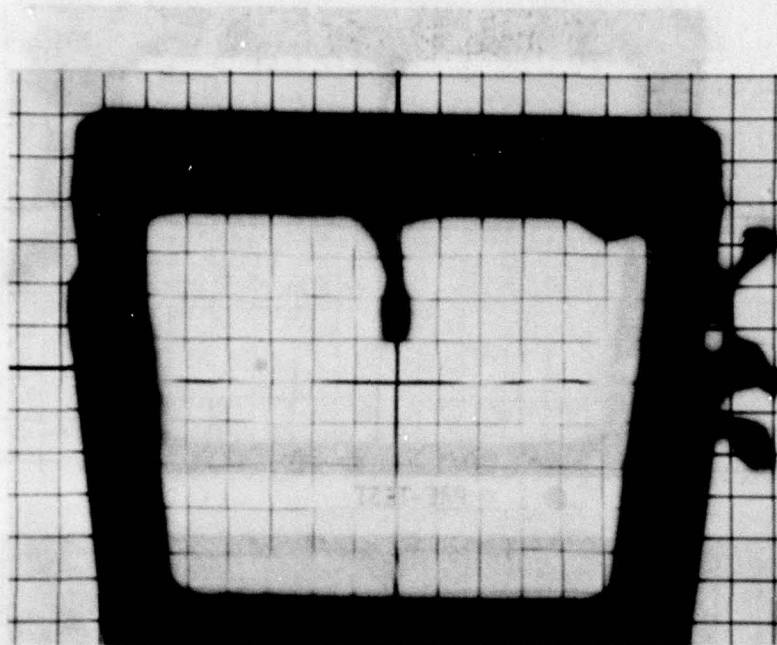
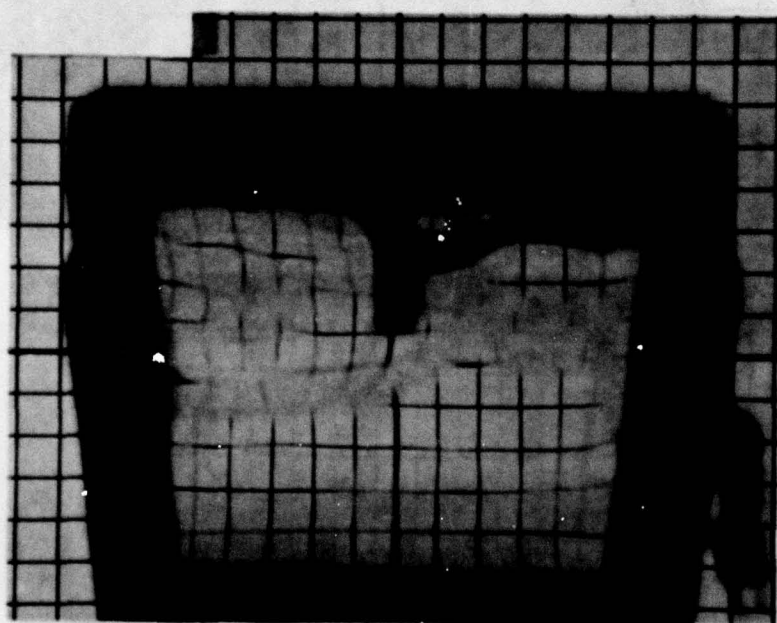
Figure 60. Grid Board Photos for Specimen GY01.

Figures 60 through 64 show grid board photos of the five specimens taken before testing and at the test completion. Overlays of pre-test and post-test photos are also shown for GY02 through GY05. All five specimens show distortion and loss of line clarity at the edges. There is slight line displacement visible in the photo overlays.

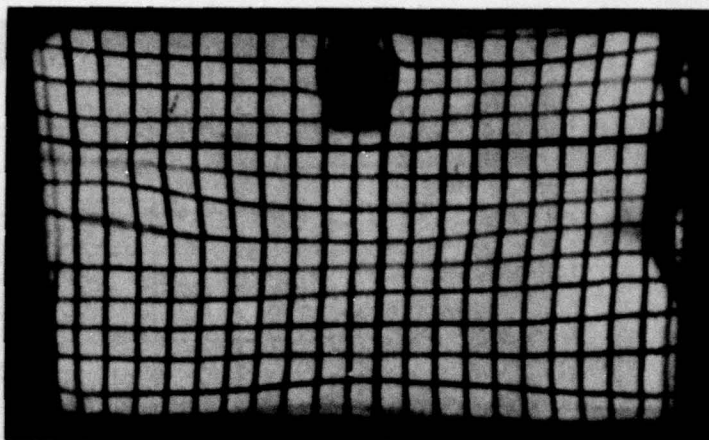
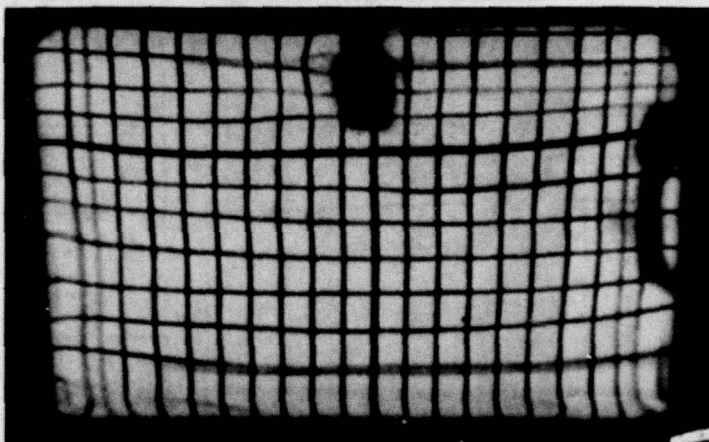
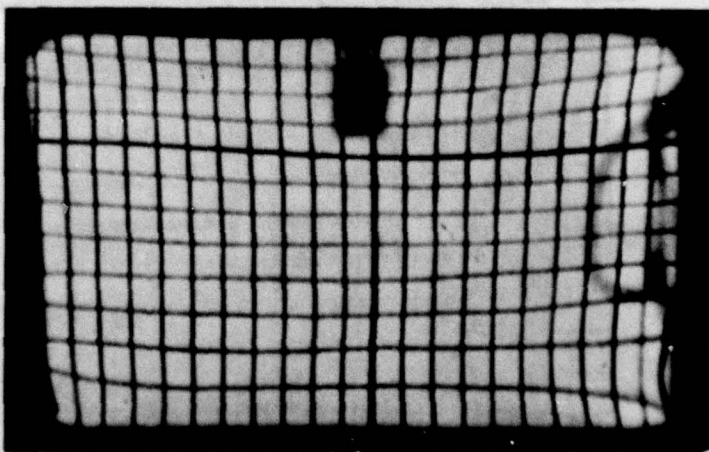
Figure 65. Tunnel Photos for Specimens GY03, GY04 and GY05 at Mach 2.4 (10-Minute Injection).

Figure 65 presents the final tunnel grid line photos for the 10-minute injections of GY03, GY04 and GY05 at Mach 2.4. Figure 66 displays overlays for the same injections. The dark oval spots in the GY03 overlay (Figure 66) is not visible in the final tunnel photo (Figure 65). This area was abraded with salt (Reference 9). The photos indicate consistent distortion for the three specimens. The maximum horizontal line displacement is approximately 0.20 inch for each specimen.

Specimens GY03, GY04 and GY05 withstood the Mach 2.4 environment very well. The lines were clear and dark (Figure 65). GY04 displayed some distortion along the sides. Generally, the horizontal line displacement (Figure 66) did not exceed 0.12 inch.

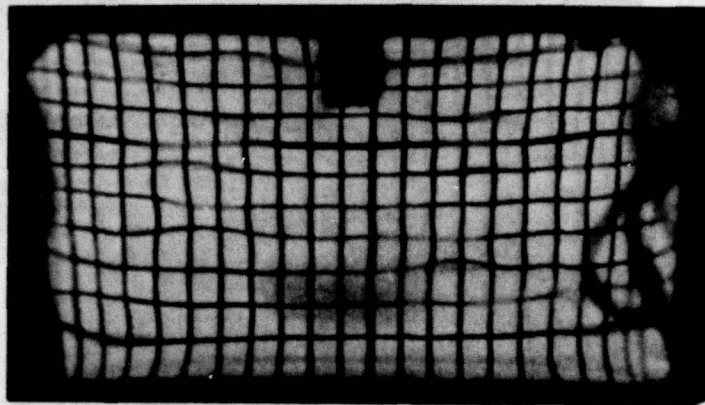
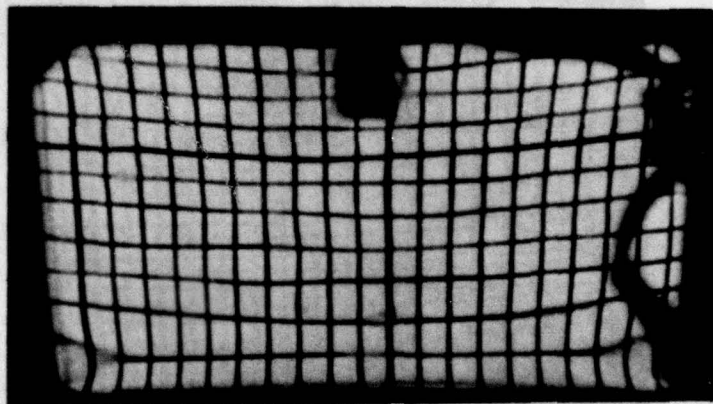
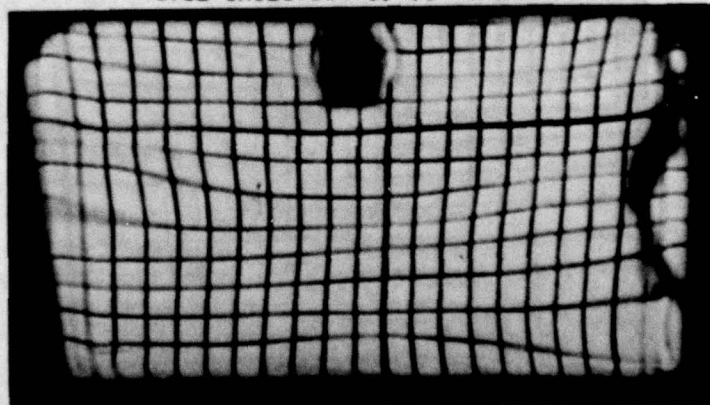
Figure 67. Tunnel Photos for Specimens GY01, GY02 and GY03 at Mach 2.6.

Photos and overlays are presented in Figures 67 and 68 for Specimens GY01, GY02 and GY03 at Mach 2.6. These injections were five minutes for Specimens GY01 and GY02, and 10 minutes for GY03. The oval spots in the photos for GY01 and GY02 resulted from salt abrasion (Reference 9). Specimen GY02 displays the least severe line distortion among the three specimens. Maximum line displacement approaches 0.25 inch for GY03.

Specimens GY01 and GY02 and GY03 are potential windshield candidates for a Mach 2.6 environment. The tunnel photos (Figures 67 and 68) are for 5-minute injections since Specimen GY01 and GY02 delaminated at the termination of their 10-minute injections. GY03 survived. It sustained some distortion and the displacement of the horizontal lines was 0.25 inch maximum.

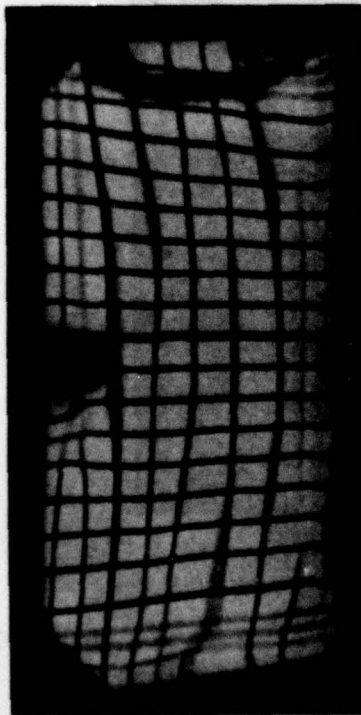
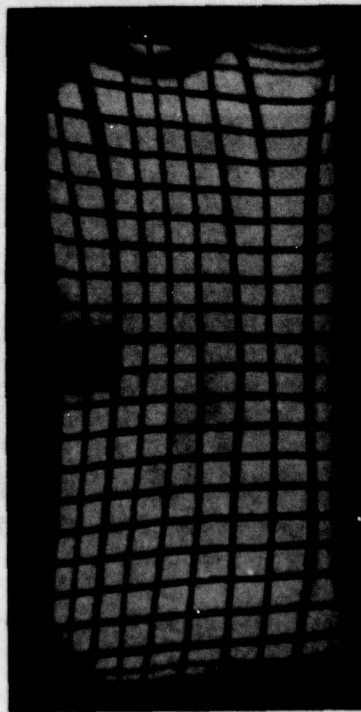
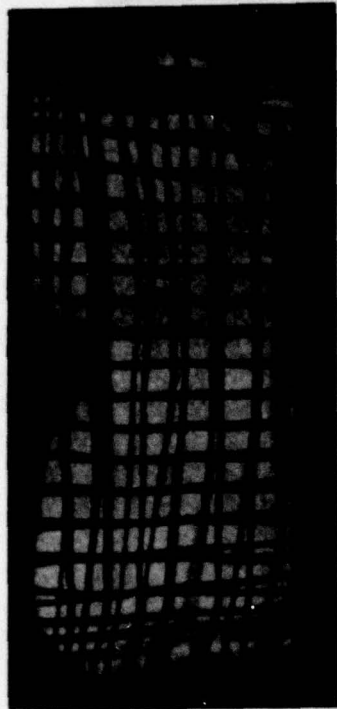
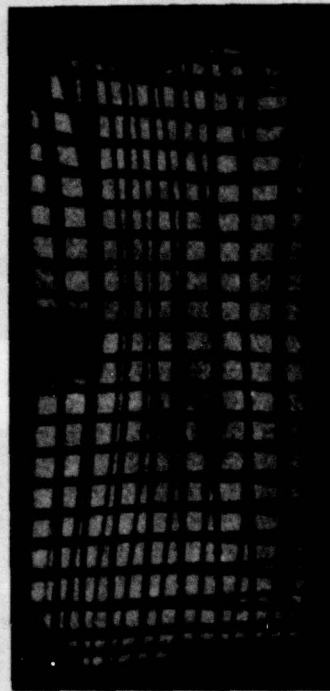
Figure 69. Tunnel Photos for Specimens GY04 and GY05 at Mach 3.0 (3-Minute Injection).

The final tunnel grid line photos and overlays for the 3-minute Mach 3.0 injections are exhibited in Figures 69 and 70 for Specimens GY04 and GY05. The most severe distortion occurred in Specimen GY04. The displacement of the horizontal lines is 0.25 inch for both specimens.

Specimen GY05 displayed acceptable optics at the Mach 3.0 condition (Figures 69 and 70). Specimen GY04 was distorted at the edges but clear in the center. The maximum displacement of the horizontal lines was 0.25 inch for both specimens.

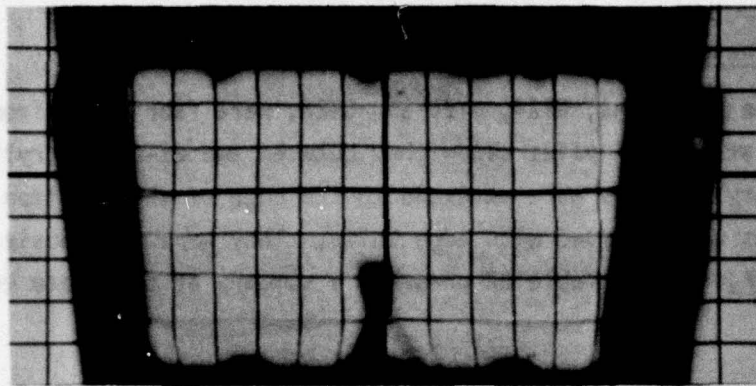
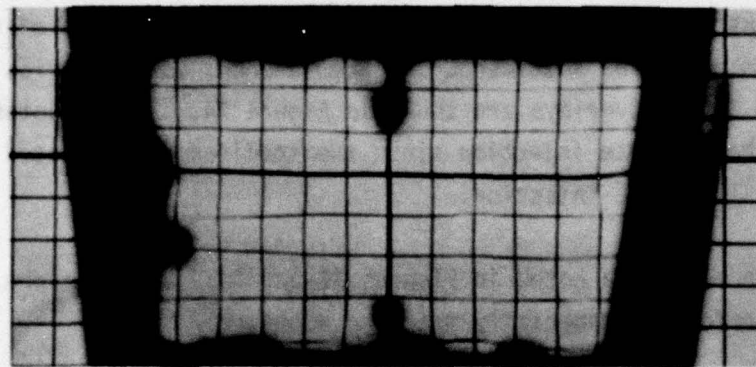
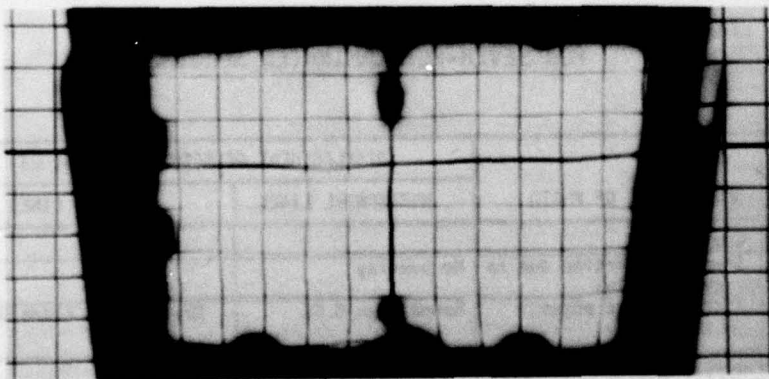
Figure 71. Pre-Test Grid Board Photos for Specimens GY24, GY25 and GY26.

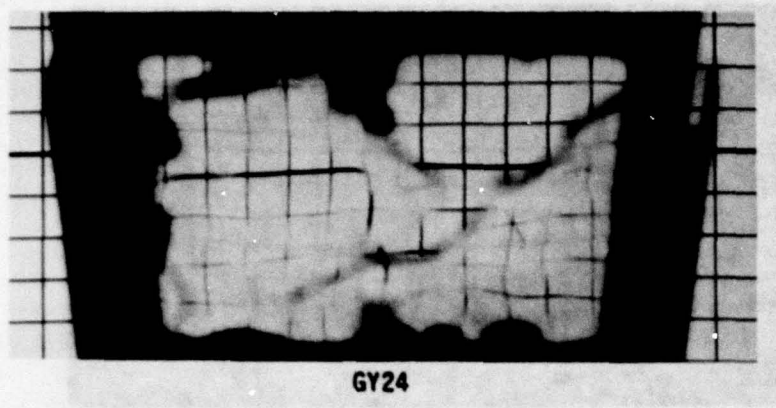
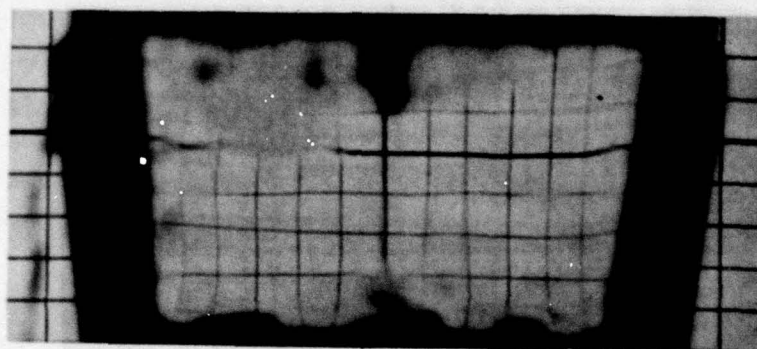
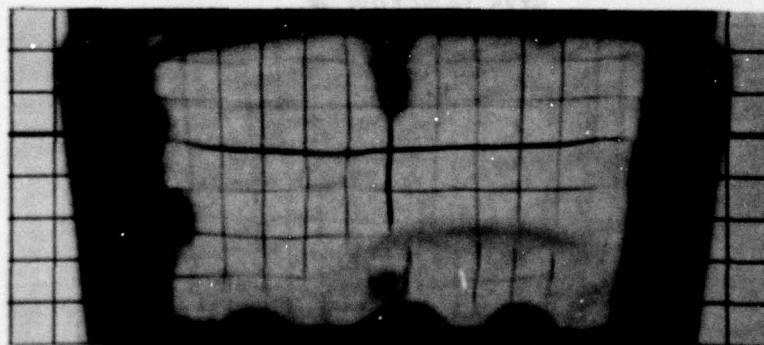
Pre-test and post-test grid board photos are shown in Figures 71 and 72 for Specimens GY24 and GY26. Overlays were not made because of the severity of damage to the specimens. Figure 73 shows tunnel photos for GY24, GY25 and GY26. Overlays are shown in Figure 74. These photos were taken during the 5-minute injection since the specimens delaminated during the subsequent 10-minute injection.

Figure 72. Post-Test Grid Board Photos for Specimens GY24, GY25 and GY26.

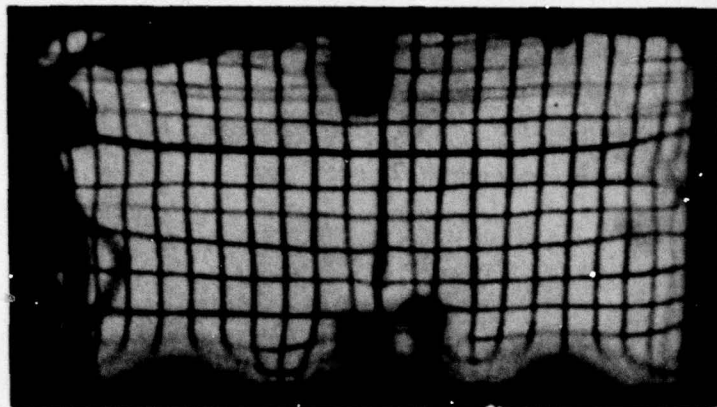
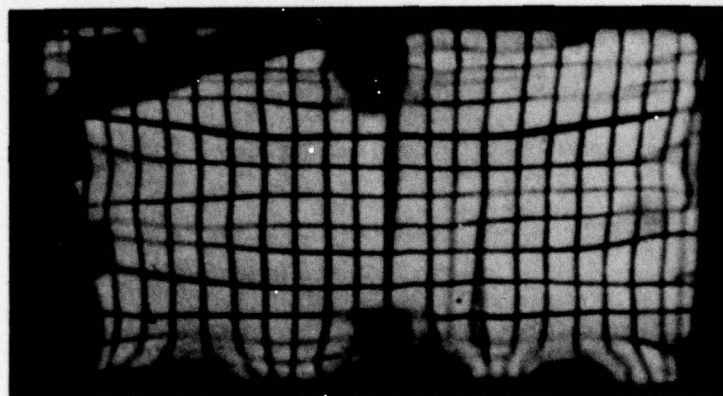
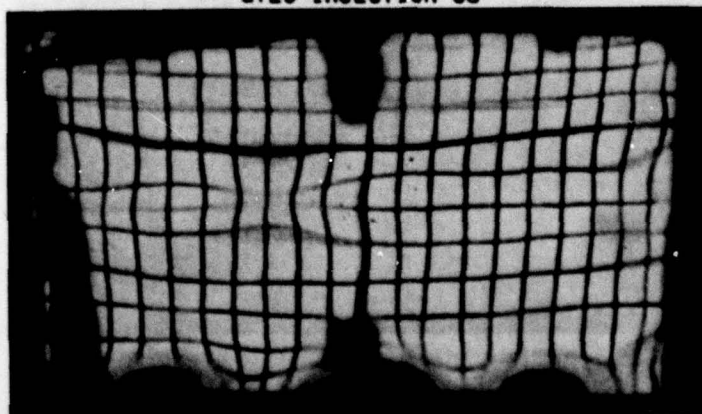
Line displacement, as noted in Figures 73 and 74, is not severe, but the lines are deformed, especially near the edges.

Figure 73. Tunnel Photos for Specimens GY24, GY25 and GY26 at Mach 2.4 (5-Minute Injection).

Specimens GY24, GY25 and GY26 experienced small line displacement after their initial 5-minute injections, but the lines became irregular and distorted (Figures 73 and 74). The distortion along the lower edge of each specimen was due to the projection of the edge bolts into the field of vision at the 60 degree angle of incidence. The distortion would be less severe if these fasteners were removed. These three specimens failed by delamination of the exterior ply during this subsequent 10-minute injection. These specimens sustained comparatively large increases in haze.

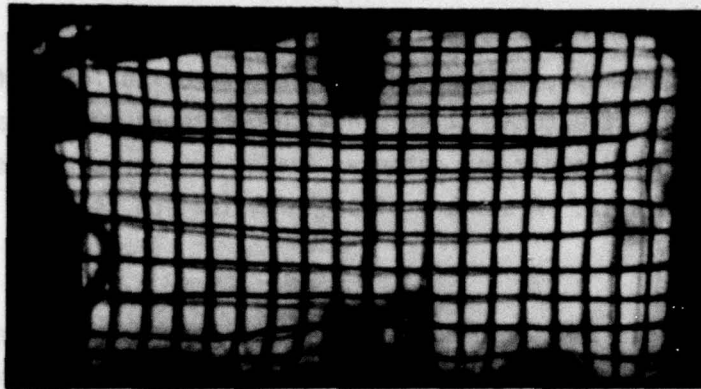
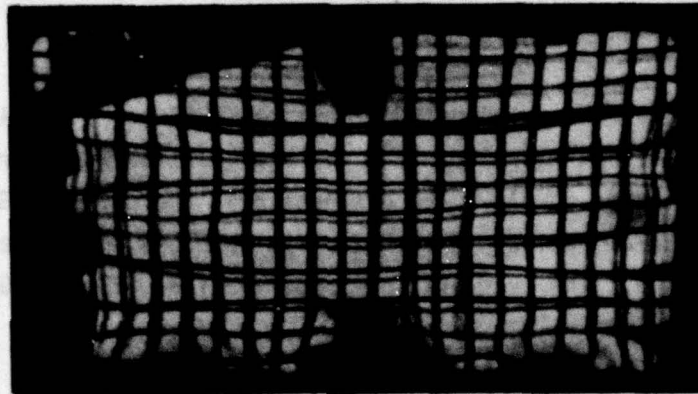
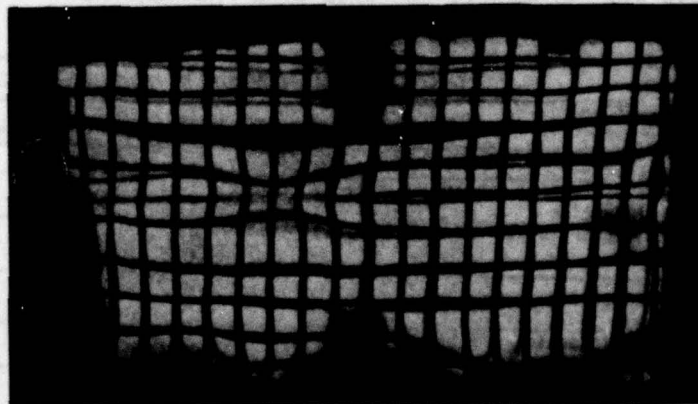
Figure 74. Overlays of Tunnel Photos for Specimens GY24, GY25 and GY26 at Mach 2.4 (5-Minute Injection).

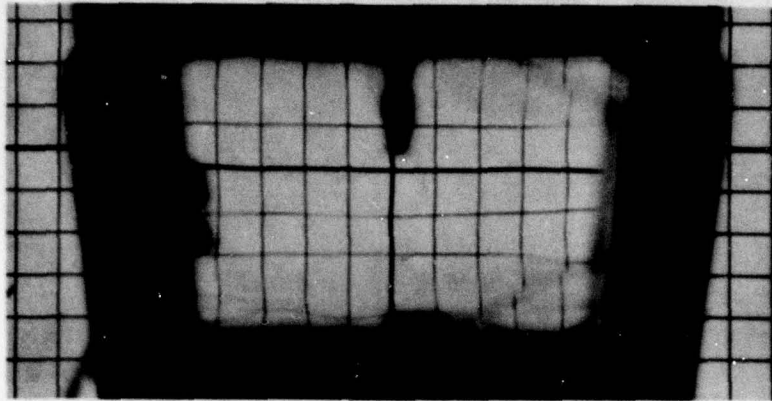
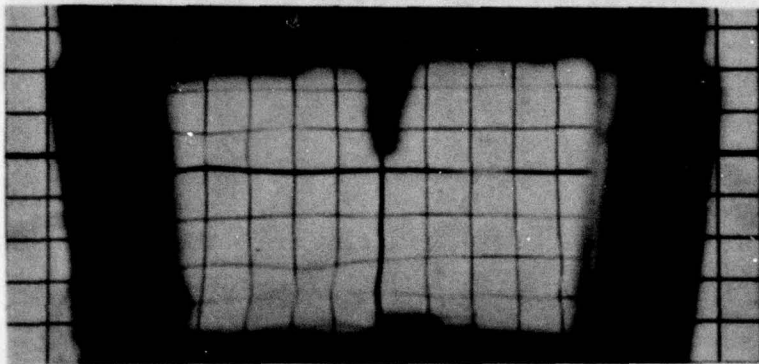
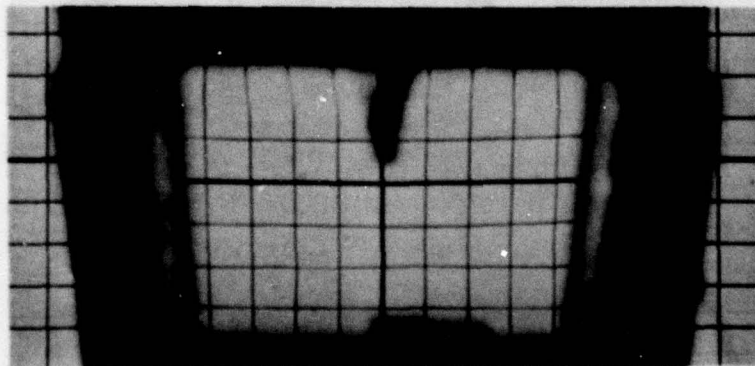
Pre-test and post-test grid board photos are shown in Figures 75 and 76 for Specimen GY21, GY22 and GY23. These specimens exhibit hazy spots and indistinct lines on the pre-test photos. Specimen GY23 shows a definite loss of line clarity in its post-test photo.

Figure 75. Pre-Test Grid Board Photos for Specimens GY21, GY22 and GY23.

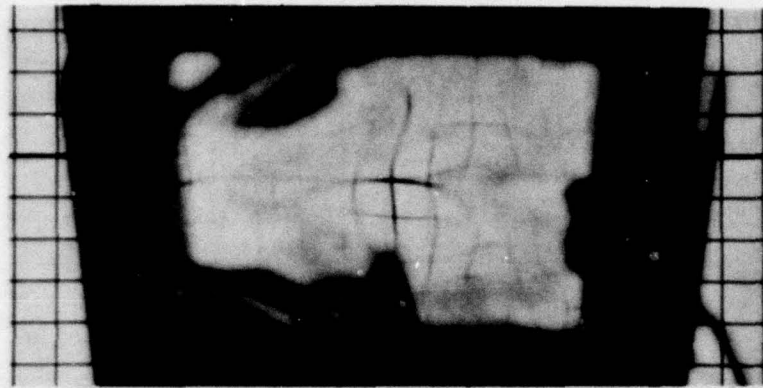
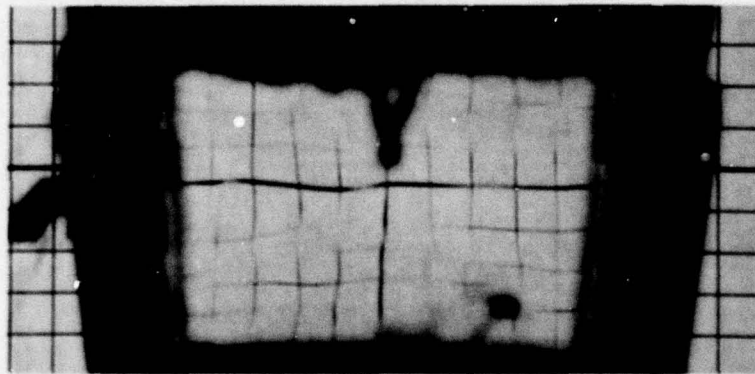
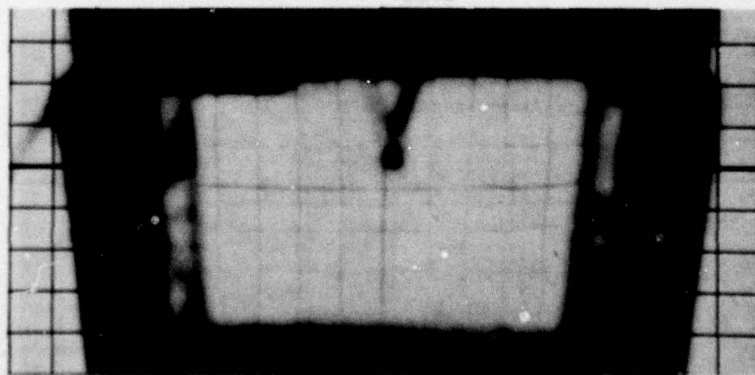
Figure 76. Post-Test Grid Board Photos for Specimens GY21, GY22 and GY23.

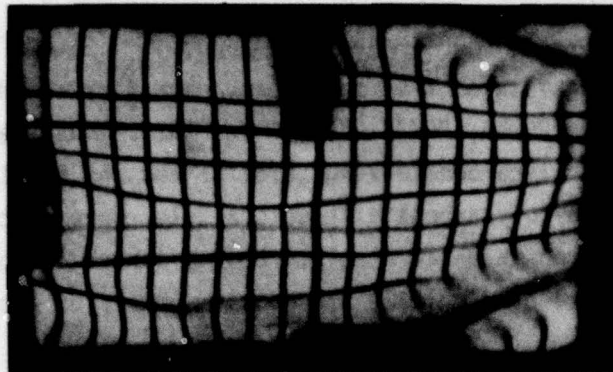
Figure 77 shows a tunnel photo for Specimen GY21 at Mach 2.4, GY22 at Mach 2.6 and GY23 at Mach 3.0. The photo of GY21 shows severe distortion due to cracks in the face ply. The distortion in the photo of GY22 is due to face ply delamination. The photo of GY23 shows poor line intensity and line distortion. The overlays for Specimen GY21, GY22 and GY23 were not clear.

GY21, MACH 2.4, INJECTION 25 (5 MINUTES)

Specimen GY21 experienced severe delamination (Figures 86 and 77) which was precipitated by cracks in the face ply that occurred during fabrication.

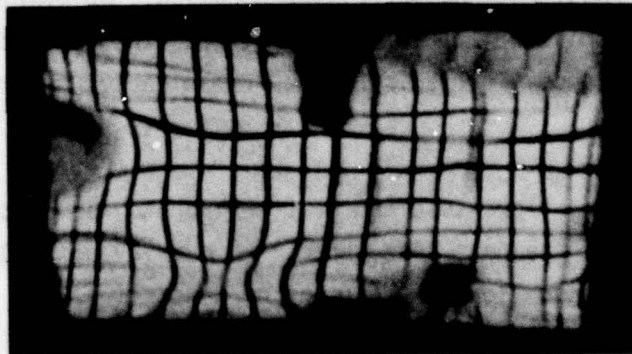
GY22, MACH 2.6, INJECTION 64 (10 MINUTES)

The poor optics for Specimen GY22 was caused by face ply delamination (Figure 77). The delamination was precipitated by a rupture in the rabbeted section of the face ply. This configuration would require a redesigned edge to be considered as a potential Mach 2.6 windshields.

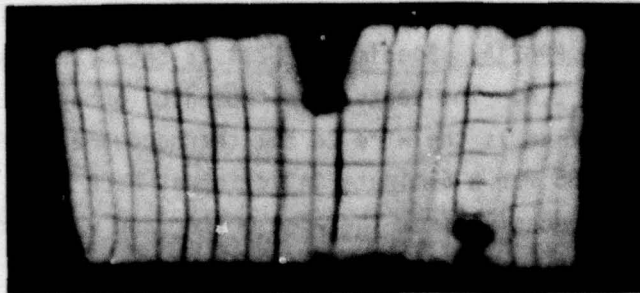
GY23, MACH 3.0, INJECTION 84 (3 MINUTES)

Specimen GY23 became very cloudy and vision through this configuration was severely degraded. The face ply material became rough.

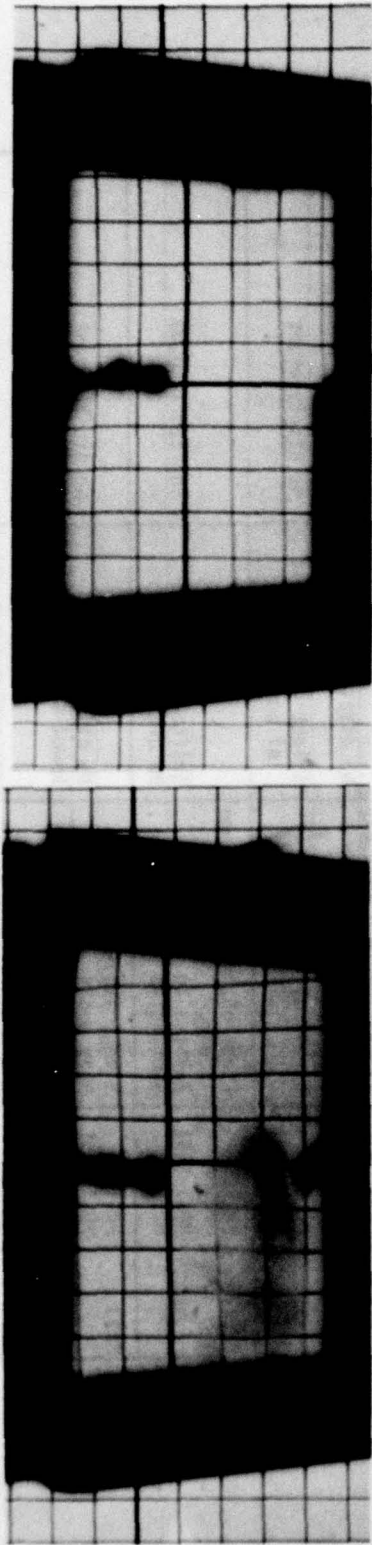
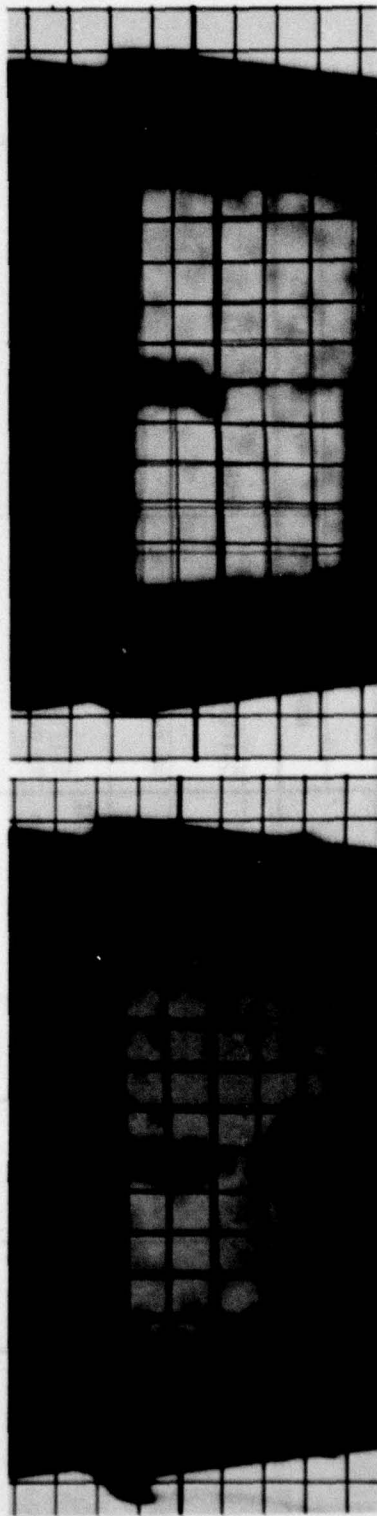
Figure 78, 79, 80 and 81 show pre-test grid board photos and overlay photos for Specimens PPG21, PPG21A, PPG22 and PPG22A. The spots in the overlay photos resulted from interlayer bubbling. An overlay photo of PPG22 is not shown since it did not experience line displacement or distortion. The spot visible in Figure 78 was caused by a defect in the interlayer.

Figure 78. Grid Board Photos for Specimen PG21. Figure 79. Grid Board Photos for Specimen PG21A.

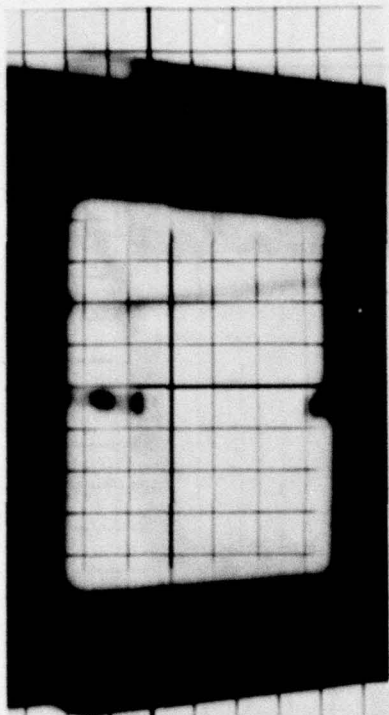
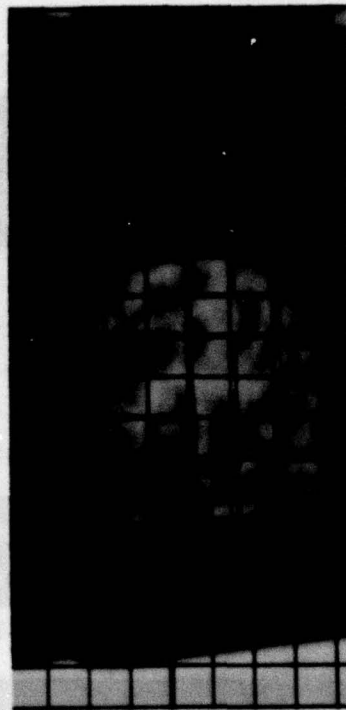
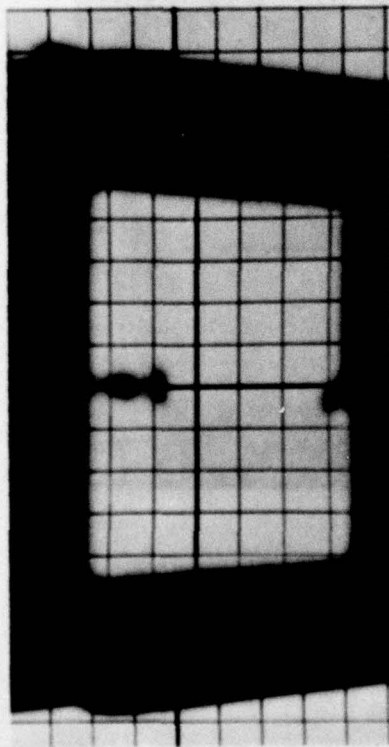
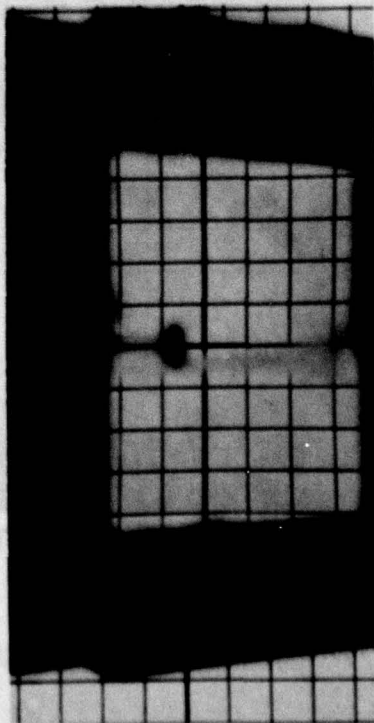
Figure 81. Grid Board Photos for Specimen PPG22A.

Figure 80. Grid Board Photos for Specimen PPG22.

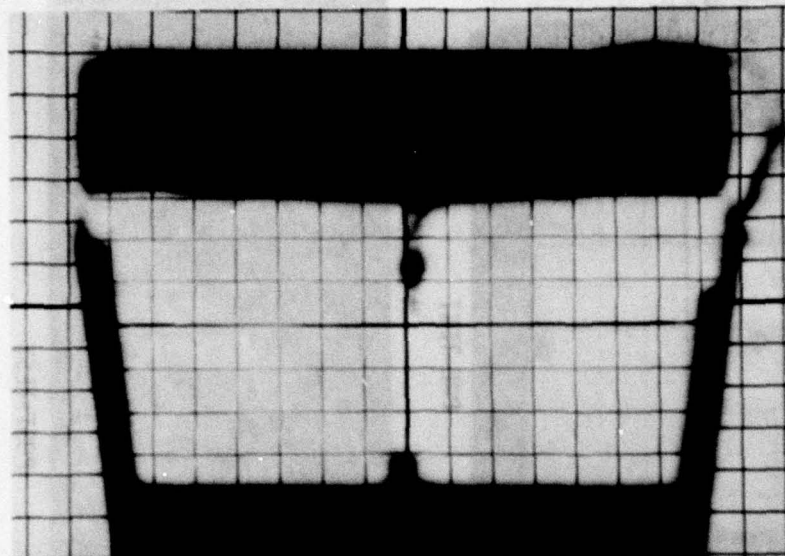
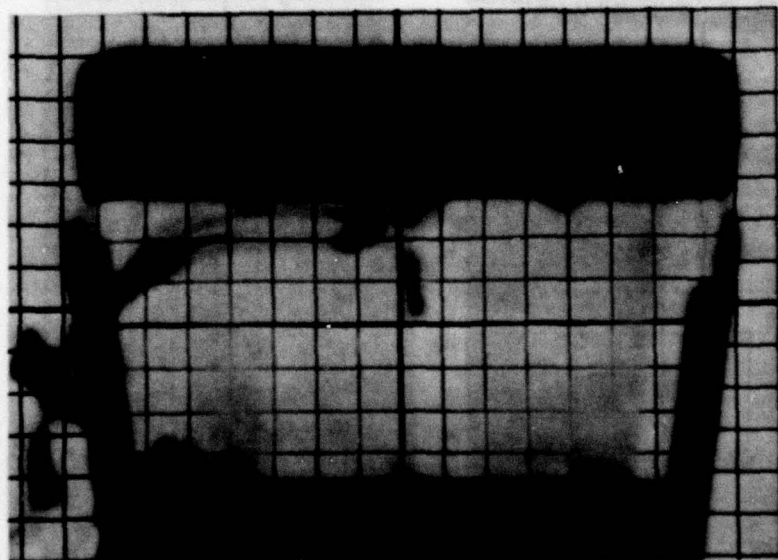
Figure 82 shows a pre-test and post-test photo for Specimen SK23. Haze is visible in the post-test photo. No overlay of SK23 is shown since it did not experience line displacement or distortion.

Figure 82. Grid Board Photos for Specimen SK23.
