**EVALUATION OF AIRCRAFT WINDSHIELD MATERIALS  
IN A SIMULATED SUPERSONIC FLIGHT ENVIRONMENT**

J.B. HOFFMAN  
Douglas Aircraft Company  
McDonnell Douglas Corporation  
3855 Lakewood Boulevard  
Long Beach, California 90846

JUNE 1979

TECHNICAL REPORT AFFDL-TR-79-3058

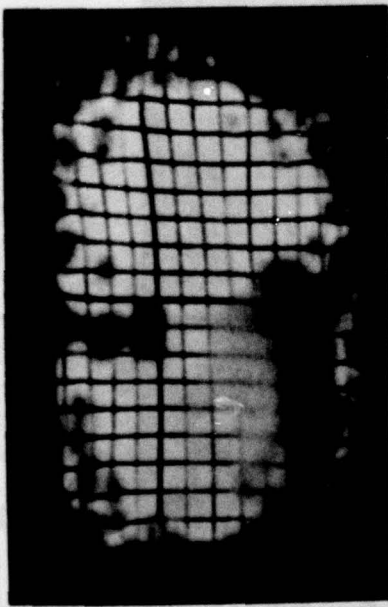
Figure 83 shows Specimen PPG21 at the completion of a 10-minute injection at Mach 2.4. Interlayer bubbling is visible at the perimeter. Loss of light transmission caused by interlayer bubbles prevented tunnel photos for Specimen PPG21A. Specimen PPG22A is shown in Figure 84 after 2.5 minutes at Mach 2.6. The spots were caused by bubbles in the interlayer. The curved line is the wire to the thermocouple. Specimen PPG22 is shown in Figure 85 for a 5-minute injection at Mach 2.4. The vertical line was caused by adhesive from the edge member and was removed with cleaning. PPG22 experienced slight line displacement.

Figure 83. Tunnel Photo for Specimen PPG21 at Mach 2.4 (Injection 24, 10 Minutes).

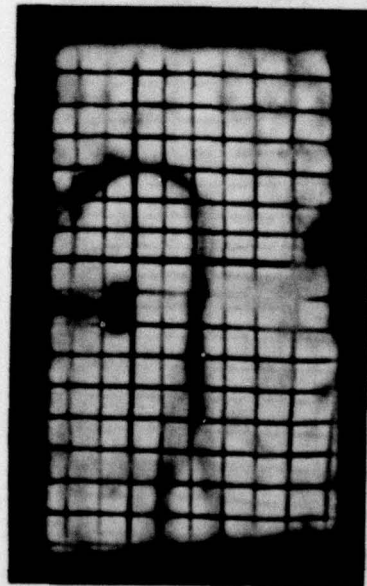
Figure 84. Tunnel Photo for Specimen PPG22A at Mach 2.6 (Injection 66, 2.5 Minutes).

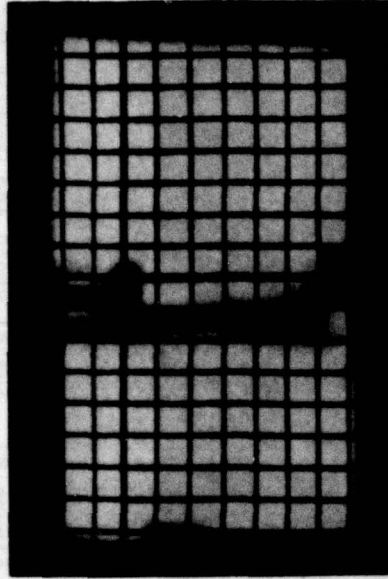
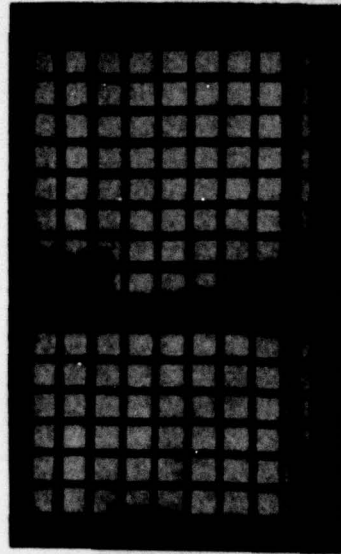
Figure 85. Tunnel Photo and Overlay for Specimen PPG22 at Mach 2.4 Injection 35 (5 minutes)

Specimen PPG22 displayed the least distortion and line displacement of the 13 tested specimens (Figure 85). It was tested for only five minutes, however, since bubbles began to form in the interlayer. Specimen PPG21 was injected for five and ten minute exposures and was damaged by severe interlayer bubbling (Figure 83). Permanent distortion occurred as indicated by movement of the lines in the overlay photo (Figure 78). A heat resistant interlayer would be required to make these configurations acceptable for use at Mach 2.4. The pre-test light transmission reading for Specimen PPG21, 50 percent, makes it unacceptable for use as an aircraft windshield. PPG22 was better with a reading of 78 percent. These readings were the lowest of all specimens.

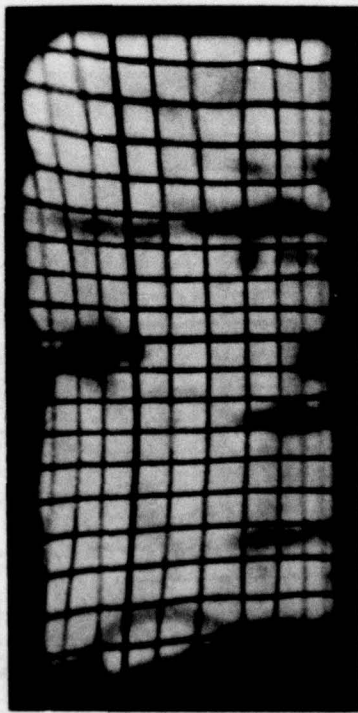
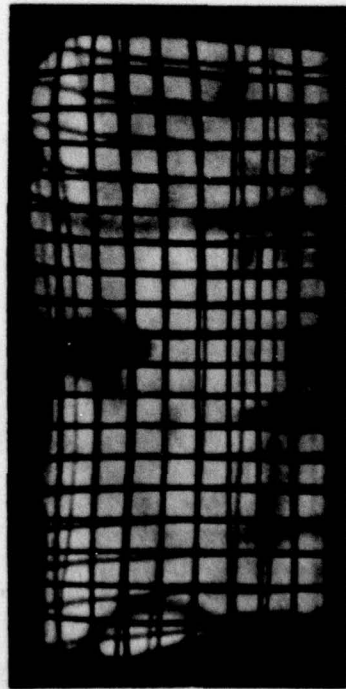
Specimen SK23 is shown in Figure 86 at Mach 2.6 and Figure 87 at Mach 3.0. The spots in Figure 86 were caused by adhesive from the edge member. SK23 displays less line distortion at Mach 2.6 than at Mach 3.0. The haze visible in Figure 87 is also present in Figure 82.

Figure 86. Tunnel Photo and Overlay for Specimens SK23 at Mach 2.6 (Injection 56, 10 Minutes).

Specimen SK23 sustained severe rotation of the vertical lines at the upper corners (Figure 86). The spots in the photo were caused by

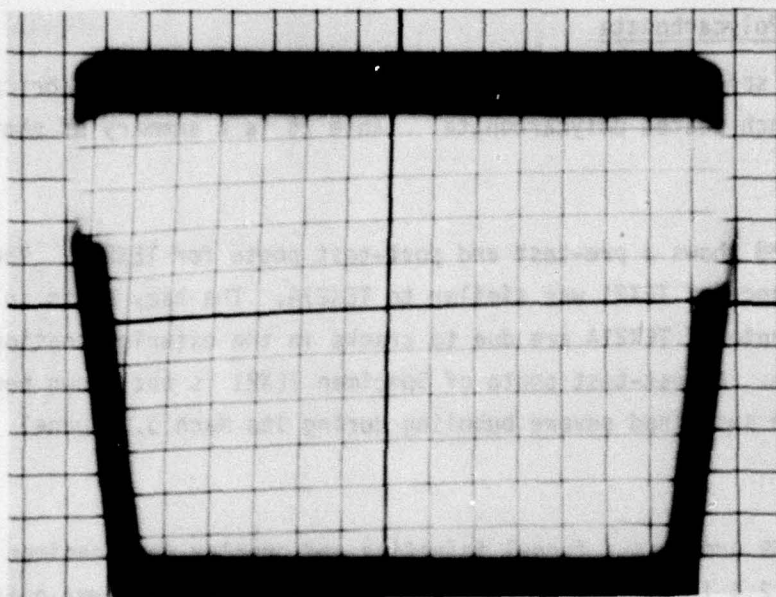
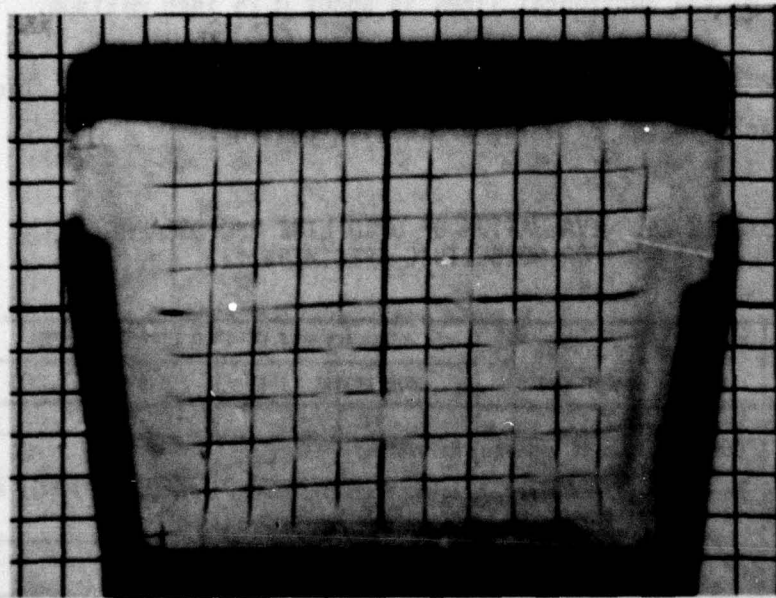
Figure 88 shows a pre-test and post-test photo for TEX21A. The pre-test appearance of TEX21 was similar to TEX21A. The hazy spots in the post-test photo of TEX21A are due to cracks in the exterior coating on the specimen. A post-test photo of Specimen TEX21 is not shown because the specimen sustained severe bubbling during its Mach 3.0 tunnel injection.

Figure 88. Grid Board Photos for Specimen TEX21A.

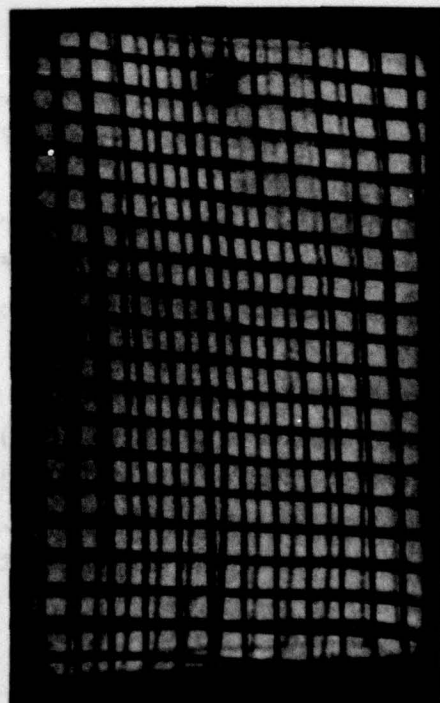
Figure 89 presents a tunnel injection and overlay for Specimen TEX21 at the Mach 2.4 injection. Haze is obvious in the right lower quadrant. Displacement of the horizontal lines is about 0.25 inch maximum.

Figure 89. Tunnel Photo and Overlay for Specimen TEX21 at Mach 2.4 (Injection 28, 10 Minutes).

Specimen TEX21 survived a 10-minute injection in good shape. The lines were clear and dark except for a spot of haze (Figure 89). The displacement of the horizontal lines approaches 0.25 inch.

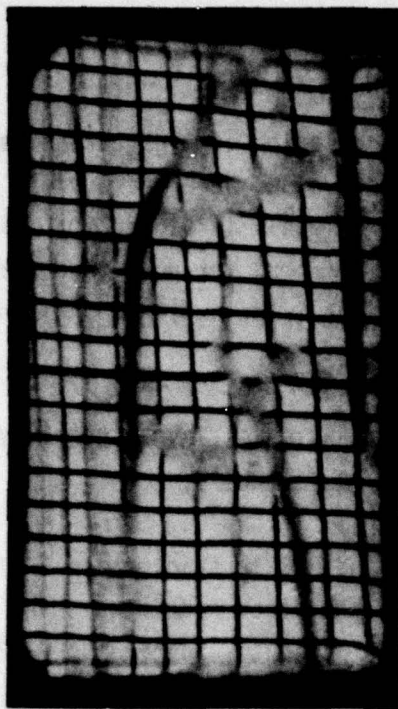
Figure 90 is a tunnel photo of Specimen TEX21A at Mach 2.6. The lines are cracks in the exterior protective coating.

Figure 90. Tunnel Photo for Specimen TEX21A at Mach 2.6 (Injection 65, 5 Minutes).

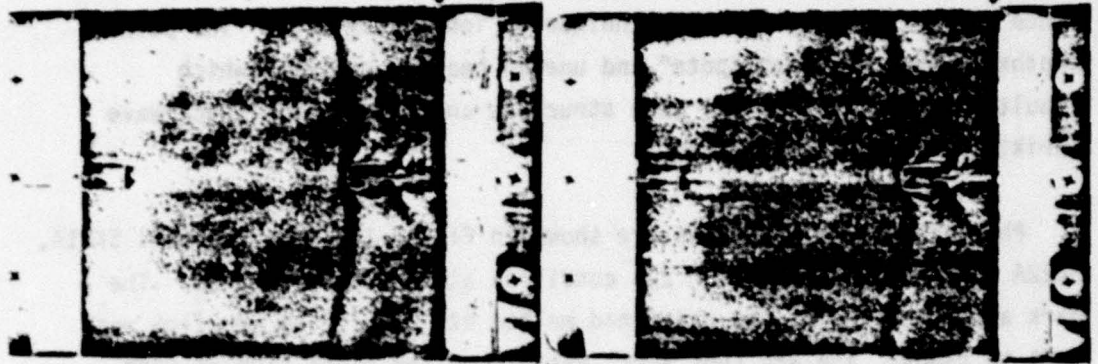
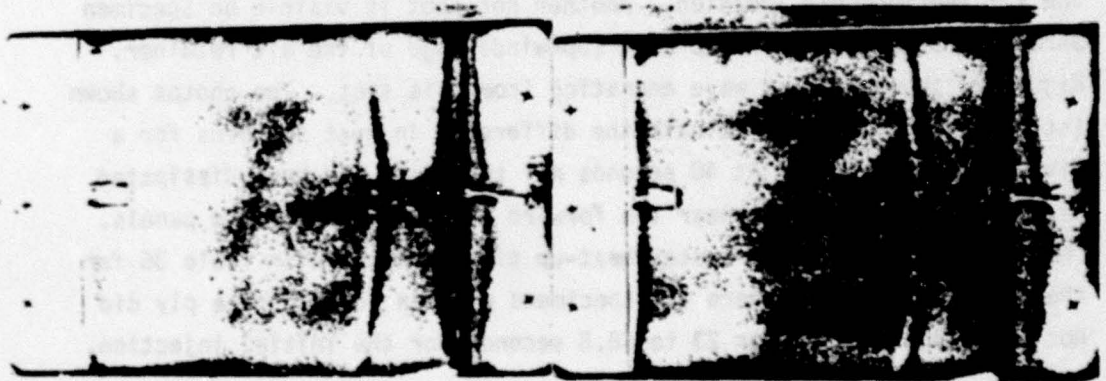
Phase-change paint photos are shown in Figure 105 for Specimens SK21A, SK22A and SWU22 for the Mach 2.4 condition at 25 and 30 seconds. The dark areas show where the paint had melted at 300°F. The air flow was left to right. The arc (hot spot) visible on the right side of each photo was caused by the interference shock visible in the shadowgraph photos shown previously in Figure 30. The shock impacted the panels at the aft thermocouple location. Another hot spot is visible on Specimen SK22A and SWU22 along the forward (up-wind) edge of the aft retainer. Figure 30 shows a shock wave emanating from this spot. The photos shown (at 25 and 30 seconds) indicate the difference in heat patterns for a five second interval. At 40 seconds all the paint had been dissipated except for slight traces near the forward (up-wind) end of the panels. These results indicate a faster heat-up time than shown in Table 36 for the thermocouple data where the specimens with an acrylic face ply did not reach 300 degrees for 23 to 58.8 seconds for the initial injection.

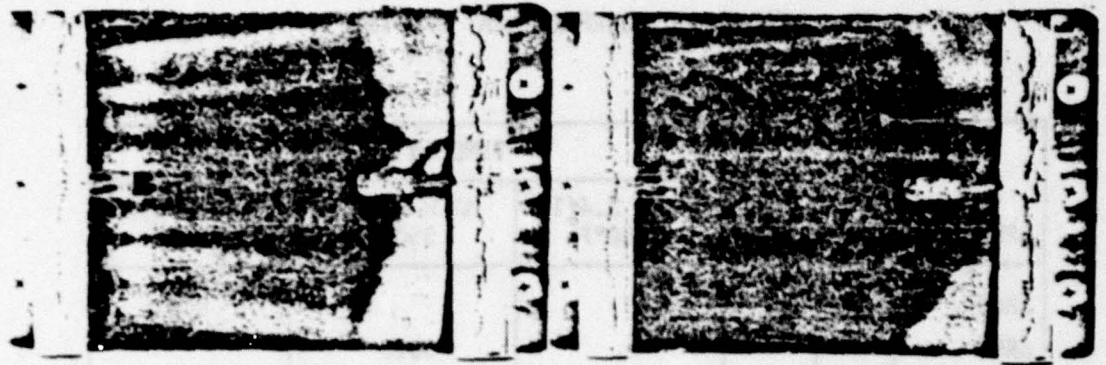
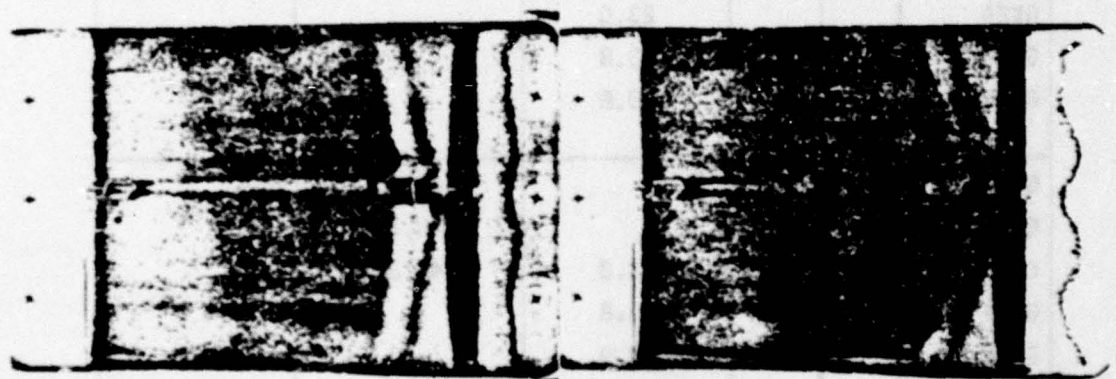
Figure 106. Thermal Paint Injections at Mach 2.6.

Figure 106 shows specimens SK21A and SK22A for the Mach 2.6 condition at 35 and 40 seconds. These specimens had been coated with a paint that would melt at 350°F. Shock wave patterns are visible, as well as a hot spot along the retainer on Specimen SK22A. The paint was completely gone after 45 seconds of exposure. The dark area in the center of the specimens indicates a high temperature area. Table 36 shows a faster heat-up time for the acrylic material than for the urethane material, indicating that urethane dissipates heat quicker than acrylic.
