Forest
Products
Laboratory

Research
Paper,
FPL 342
1979

**Structural Sandwich Performance
After 31 Years of Service.**

Structural Sandwich Performance After 31 Years of Service

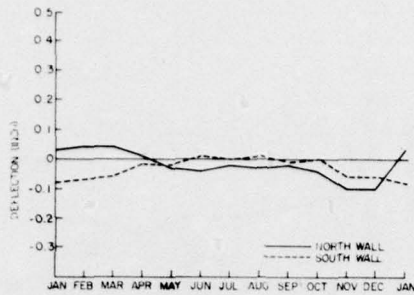
Figure 21.—Seasonal bowing of aluminum-faced panels (15-year average).

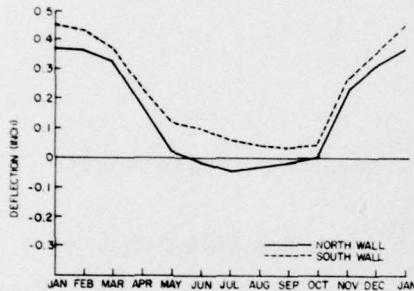
Plywood-faced panels with polyurethane foam/paper cores.—North and south panels bowed in similar patterns and reached a maximum at about 4/10 of an inch in January (fig. 19). Both panels were at a minimum during the warmer months, with the north panel essentially flat and the south panel below 1/10 of an inch.

Figure 19.—Seasonal bowing of plywood-faced panels with urethane cores (9N3, 9S3) (3-year average).

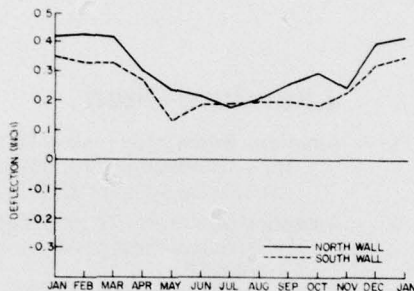
Figure 22.—Seasonal bowing of particleboard-faced panels (2N2, 2S2) (4-year average).

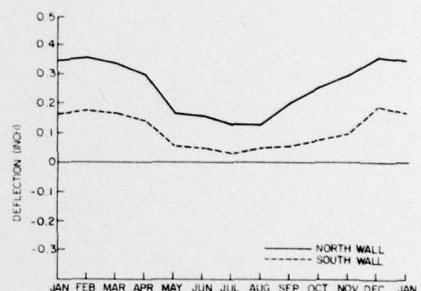
Medium-density hardboard-faced panels.—North and south panels bowed outward throughout the year in similar patterns (fig. 25). Bowing was minimal in the summer, reaching a maximum of about 4/10 inch in the north panel and 2/10 inch in the south panel during the winter.

Figure 25.—Seasonal bowing of medium-density hardboard-faced panels (4-year average).

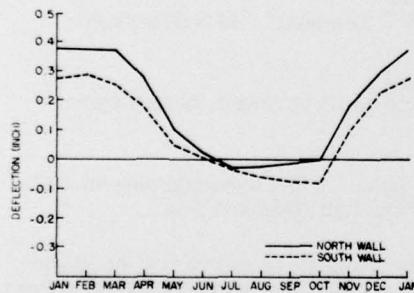
Figure 20.—Seasonal bowing of plywood-faced panels with styrofoam cores (10N3, 10S3) (3-year average).

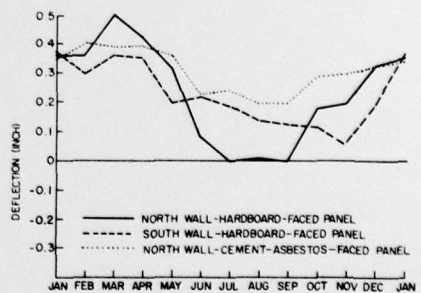
High-density hardboard-faced panels.—North panels were flat in July and August and bowed out greatly to a maximum of 1/2 inch in March (fig. 26). South panels bowed out continuously

Cement asbestos-faced panel.—The one panel on the north wall had a continuous outward bow from 2/10 inch in summer to 4/10 inch in winter (fig. 26).

Figure 26.—Seasonal bowing of high-density hardboard- and cement-asbestos-faced panels (15-year average).

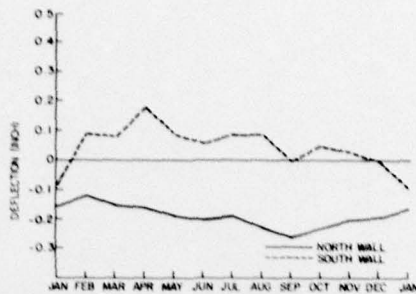
Panels with unbalanced facings.—The inside facing of these panels was 1/4 inch birch plywood and the outside panel was aluminum-faced hardboard (fig. 27). North and south panels varied greatly in the pattern of bowing. The north panel bowed inwardly all year

Figure 27.—Seasonal bowing of panels with plywood outside, aluminum-faced hardboard inside (4-year average).

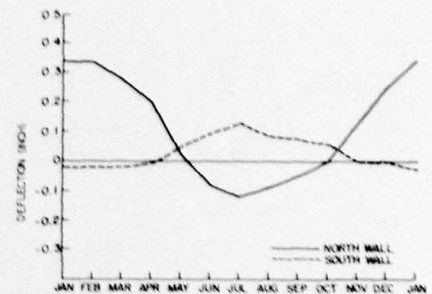
Roof panels.—The pattern of bowing of the plywood roof panels is a reverse image of that for aluminum roof panels (fig. 28). In January, plywood panels reached a maximum outward bow of 3/10 inch while aluminum panels bowed inward slightly. In July, plywood panels bowed inward to 1/10 inch, while aluminum panels bowed outward the same.

Figure 28.—Seasonal bowing of roof panels (15-year average).
