FRACTOGRAPHIC ANALYSIS OF OPTICAL FIBERS

J.J. Mecholsky, S.W. Freiman and S.M. Morey  
Naval Research Laboratory  
Washington, D.C. 20375

November 1977

Interim Technical Report 1

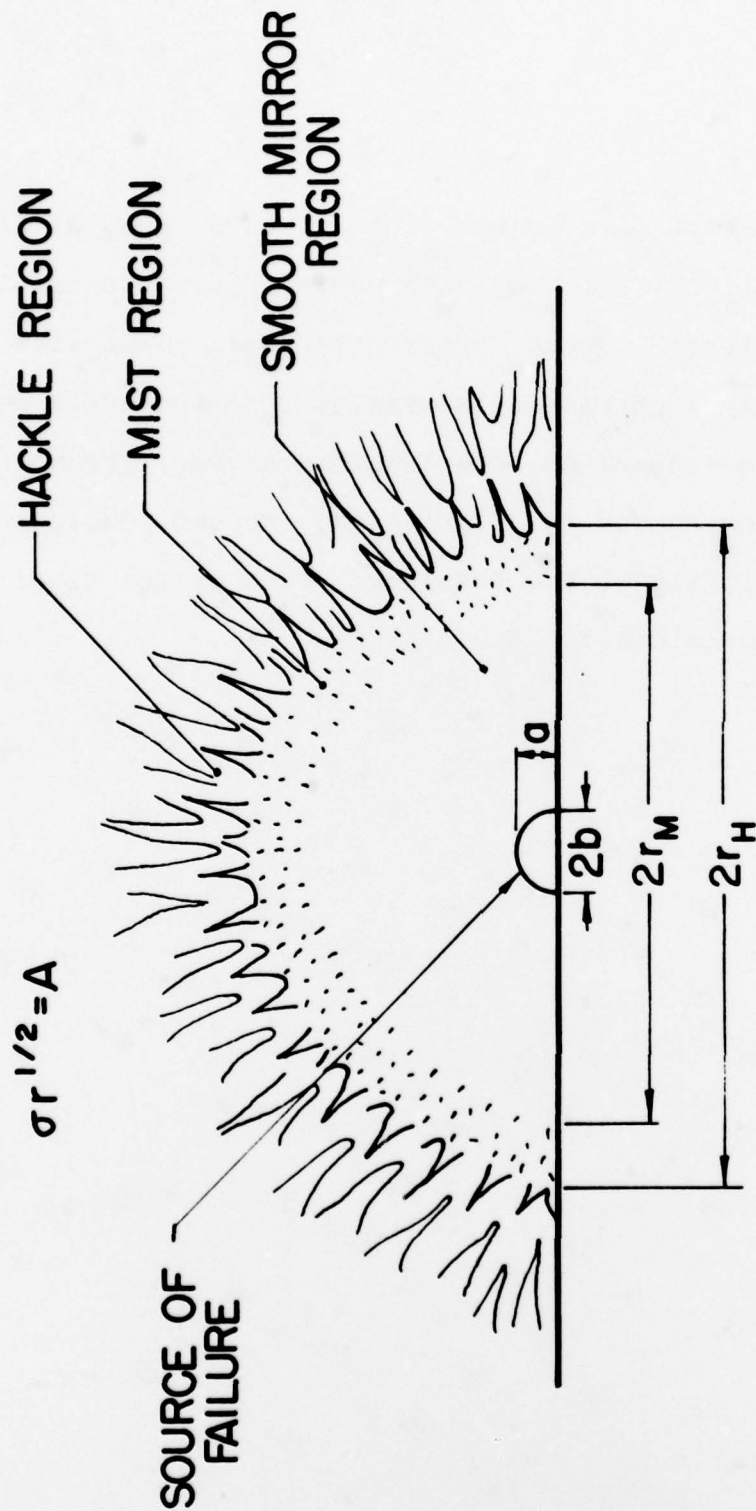
Four definitive regions surrounding fracture initiating flaws<sup>1,2,3</sup> in silicate and non-silicate glasses have been observed (Fig. 1). The mirror (a flat smooth region) is bounded by the onset of mist (a region of small radial ridges) which is bounded in turn by hackle (a region of larger radial ridges) which is bounded by macroscopic crack branching. It has been extensively demonstrated that the products of the strength,  $\sigma$ , and the square root of the distance from the origin to the onset of: mist (i.e., the mirror radius,  $R_m$ ), the onset of hackle ( $R_H$ ) and of crack branching ( $R_B$ ) give three constant values for silicate glasses:

**Fig. 1. Schematic of fracture origin showing idealized semi-elliptical surface flaw and surrounding fracture features known as mirror, mist, and hackle. Crack branching is beyond the hackle.**

SHAPE AND GENERAL APPEARANCE OF FRACTURE MIRROR SURFACES WITH FLAW.
