OHIO RIVER BASIN
CHERRY RUN, INDIANA COUNTY
PENNSYLVANIA
CHERRY RUN DAM

PHASE I INSPECTION REPORT
NATIONAL DAM INSPECTION PROGRAM.

Source LGAI CONSULTANTS, INC.
570 BEATTY ROAD
MONROEVILLE, PENNSYLVANIA 15146

11 AUGUST 1979

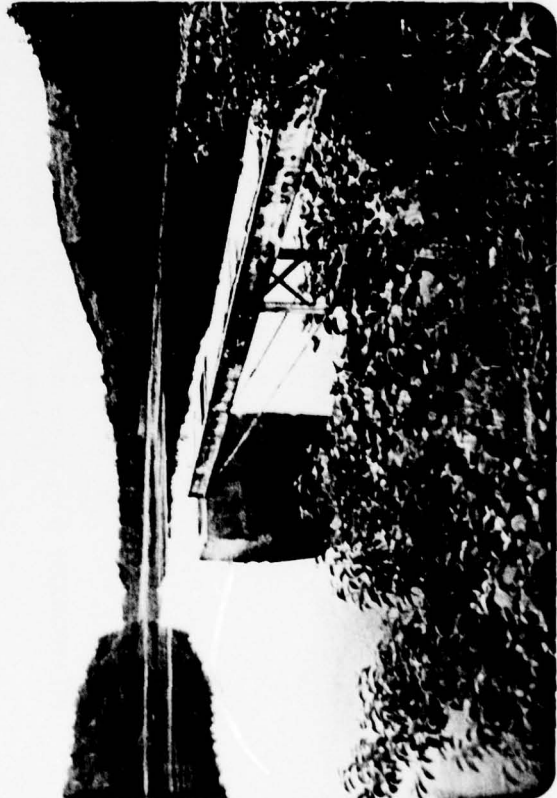
2. Outlet Works. The outlet works at Cherry Run Dam is in poor condition. The access bridge to the control riser is hazardous with missing and/or deteriorated planking (see Photograph 3). The control tower is open (see Photograph 4) and all control mechanisms are missing. Probing with the level rod indicated the control riser may be surrounded by substantial amounts of sediment.

PHOTOGRAPH 3 View of the reservoir behind Cherry Run Dam as seen from the embankment crest. The structure in the center of the view is what remains of the control tower. Note the deteriorated condition of the access footbridge.

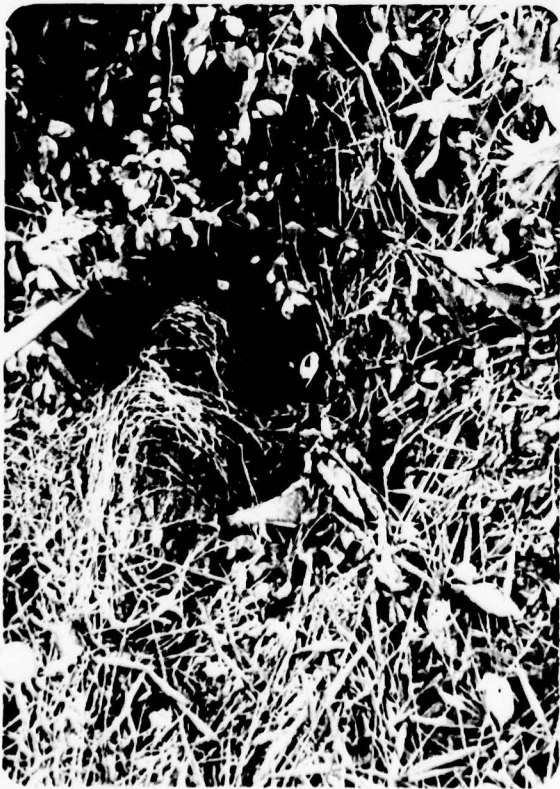
The discharge end of the cast iron blowoff line was found to be partially obstructed and not connected to the terra-cotta pipe extension (Photograph 5) which terminates in the stream about 120 feet from the downstream toe (see Photograph 6). The pump house structure was observed to be dilapidated and the apparent subject of extensive vandalism.

PHOTOGRAPH 5 View of the discharge end of the 24-inch diameter C.I.P. blowoff located to the left of the spillway about 75 feet downstream of the embankment.
