GLEN BROOK NO. 4 DAM

Number
CNDI NO. PA-00650
DER NO. 19-8

PHASE I INSPECTION REPORT.

Berger Associates, Inc.
Harrisburg, Pennsylvania

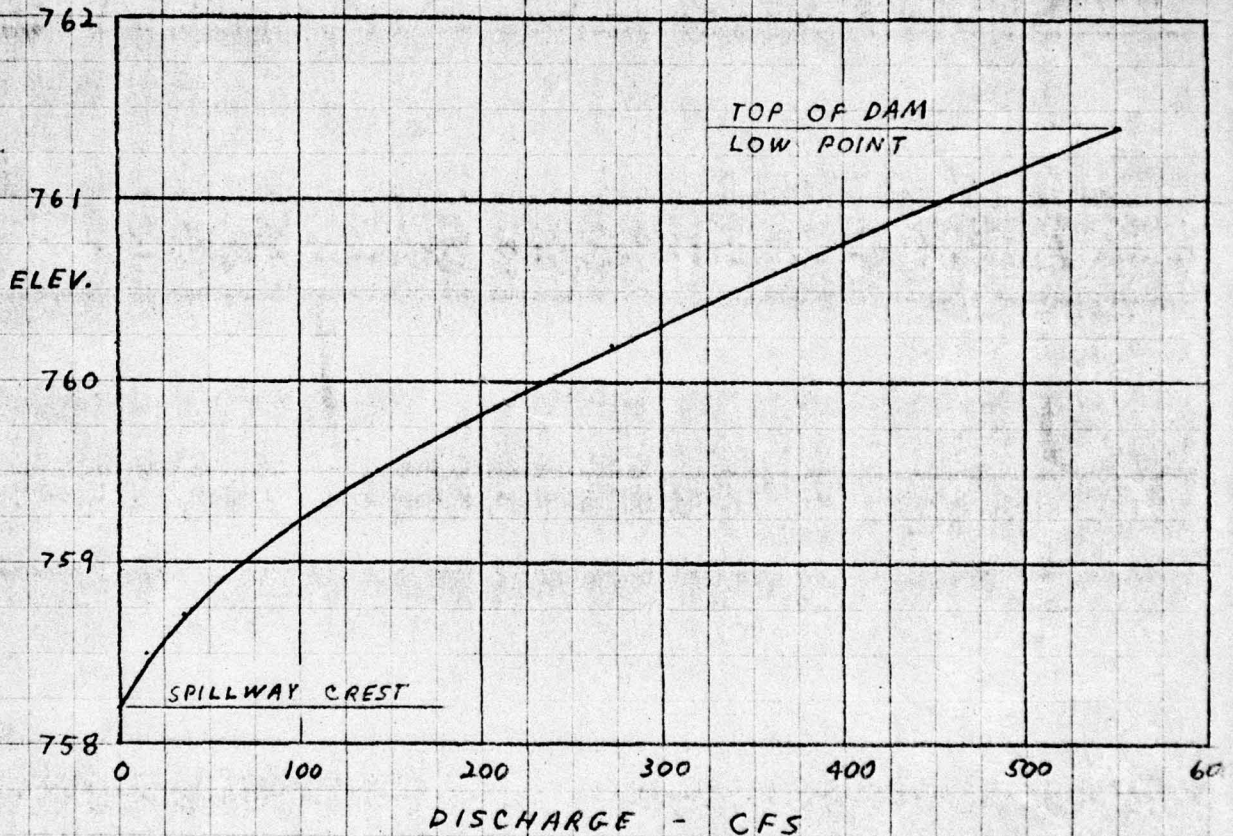
SPILLWAY RATING CURVE

PERSONNEL OF THE KEYSTONE WATER COMPANY REPORTED THAT THE MAXIMUM KNOWN FLOOD AT GLEN BROOK #4 DAM OCCURRED IN JUNE 1972 WHEN THE WATER LEVEL IN THE RESERVOIR REACHED A STAGE OF 48' ON THE STAFF GAGE. THIS WOULD BE ABOUT 1' OVER THE SPILLWAY.
