BIG BASS LAKE DAM

NDI ID NO. PA-00368  
DER ID NO. 35-126

PHASE I INSPECTION REPORT  
NATIONAL DAM INSPECTION PROGRAM

JULY 1979

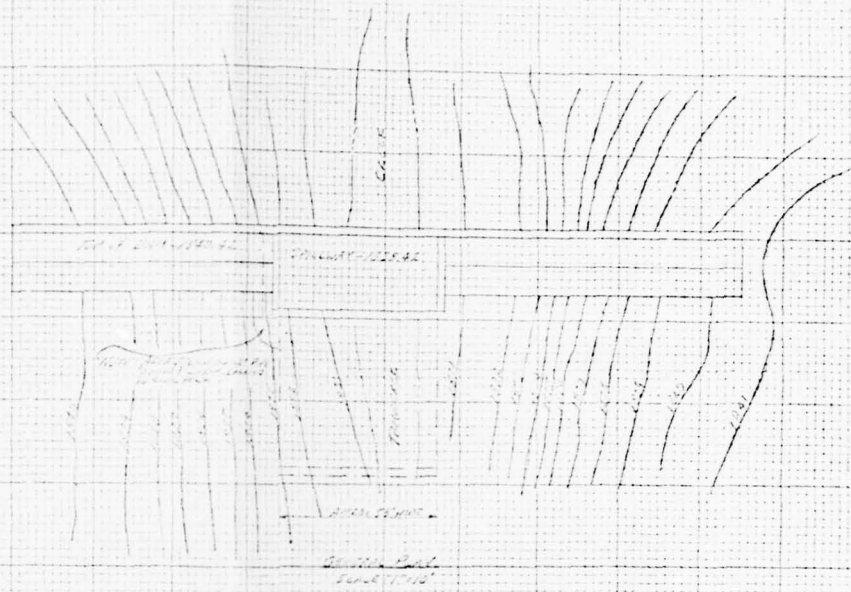
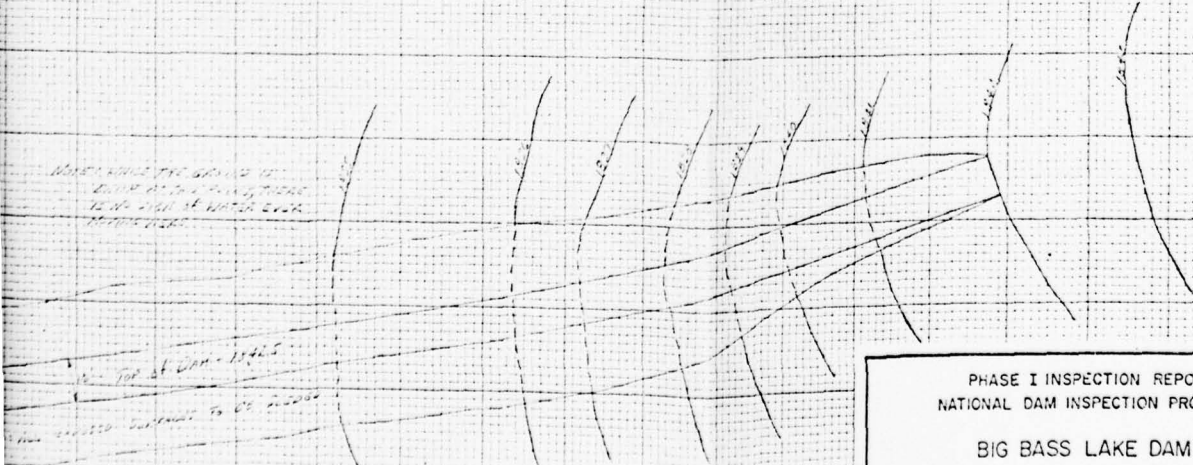
PHASE I INSPECTION REPORT  
 NATIONAL DAM INSPECTION PROGRAM  
 BIG BASS LAKE DAM  
 BIG BASS LAKE, INC.  
 PLAN, PROFILE, SECTIONS  
 SHEET 1 OF 2  
 JULY 1979 PLATE 3A

b. Design and Construction Data. No stability analysis was performed for the embankment. A stability analysis was performed for the main spillway weir during the design of the dam. The computations are in the PennDER files. The results are shown on Plates 3A and 3B. On this plate Case 1 indicates reservoir empty, Case 2 indicates reservoir full-no uplift, and Case 3 indicates reservoir full-uplift. The uplift was computed using 50 percent of the head and no tailwater. The analysis was for the weir as designed, the crest was constructed 1 foot above the design elevation. The toe pressure was not addressed in the analysis.
