BRIAR CREEK DAM

NDI ID No. PA-00651
DER ID No. 19-77
SCS ID No. PA-497

PHASE I INSPECTION REPORT

NATIONAL DAM INSPECTION PROGRAM

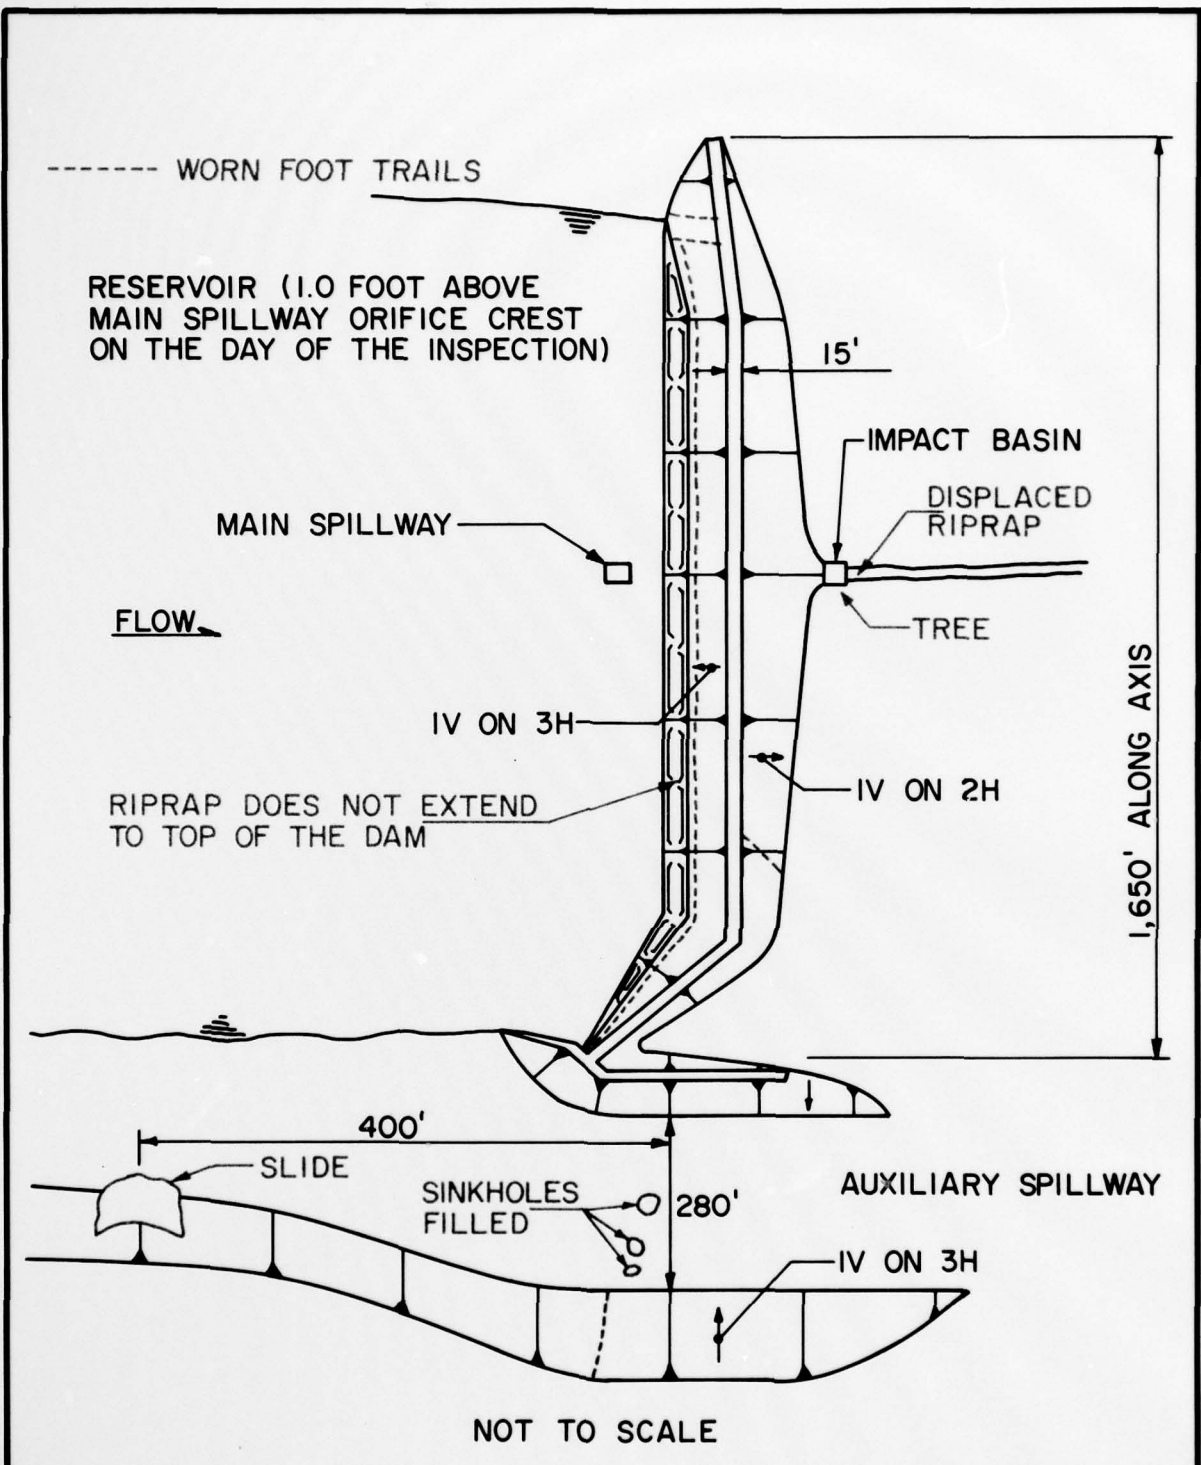
a. General. The overall appearance of the dam is good, with a few deficiencies as noted herein. The locations of deficiencies are shown in Appendix B on Plate B-1. Survey data acquired during this inspection is presented in Appendix B. Datum for the survey was assumed at the design elevation of the platform on top of the riser pipe, El. 607.72. As the riser is founded on soil, settlement may have occurred, which would result in surveyed elevations being higher than the actual. On the day of the inspection, the pool was 1.0 foot above the spillway orifice crest.

PHASE I INSPECTION REPORT
 NATIONAL DAM INSPECTION PROGRAM
 BRIAR CREEK DAM
 PENNSYLVANIA FISH COMMISSION
 RESULTS OF VISUAL INSPECTION
 MAY 1979
