6 National Dam Inspection Program. Number  
Musser Forests Dam (NDIVPA-287,  
DER IDV 32-65), Ohio River Basin, McKee  
Run, Indiana County, Pennsylvania.

PHASE I ~~REPORT~~ Inspection Report,  
NATIONAL DAM INSPECTION PROGRAM

NAME OF DAM: Musser Forests Dam  
STATE LOCATED: Pennsylvania  
COUNTY LOCATED: Indiana  
STREAM: McKee Run  
SIZE CLASSIFICATION: Small  
HAZARD CLASSIFICATION: High  
DATE OF INSPECTION: May 23 and 25, 1979

MUSSER FORESTS DAM  
NDI I.D. NO. PA-287  
MAY 23, 1979

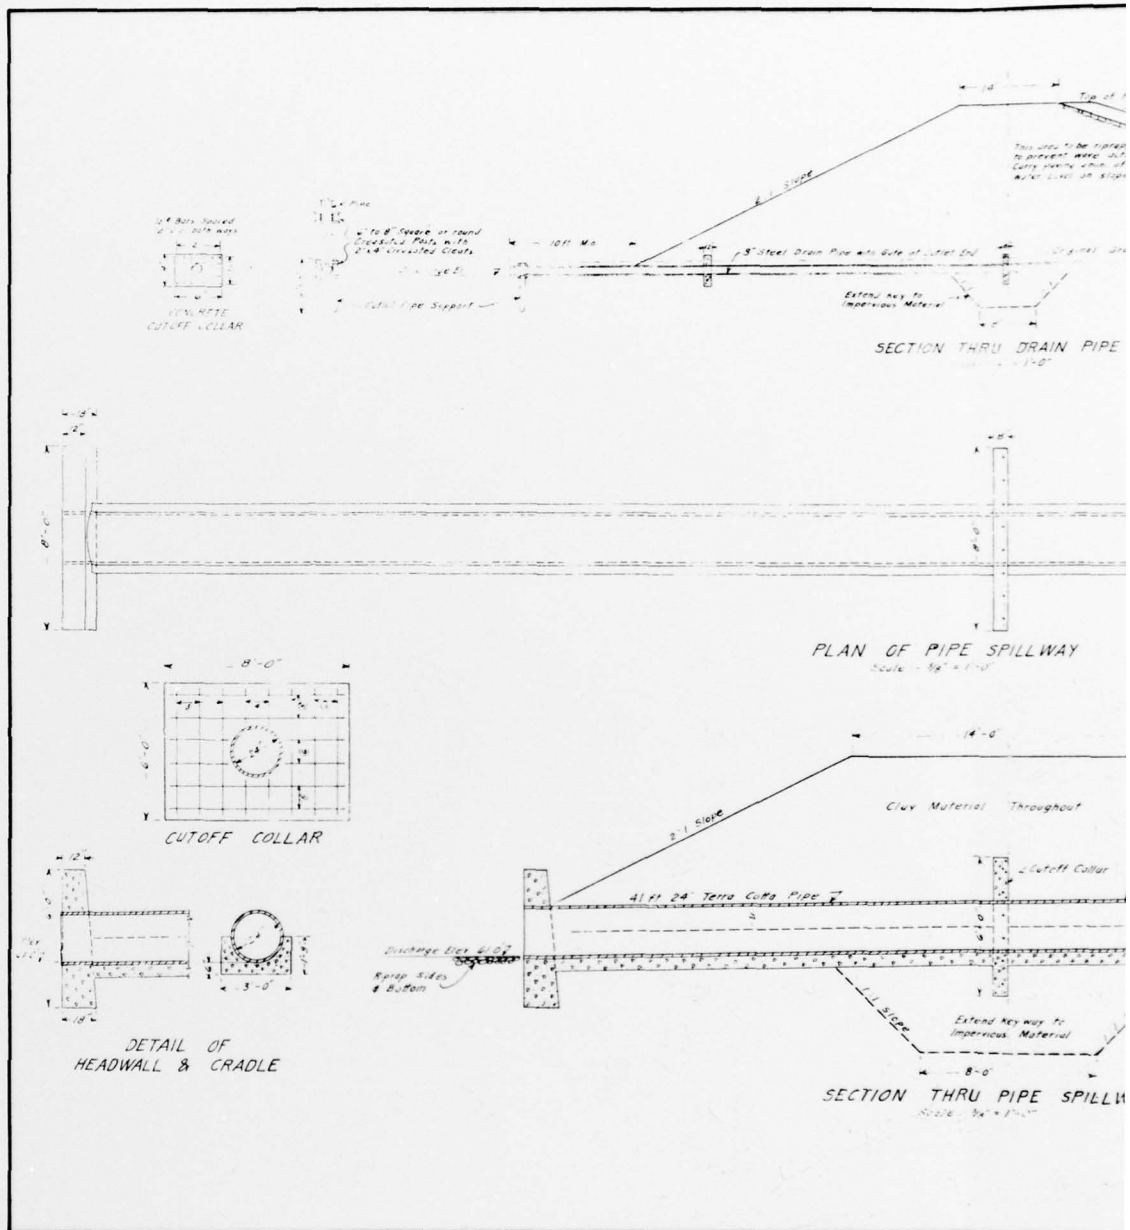
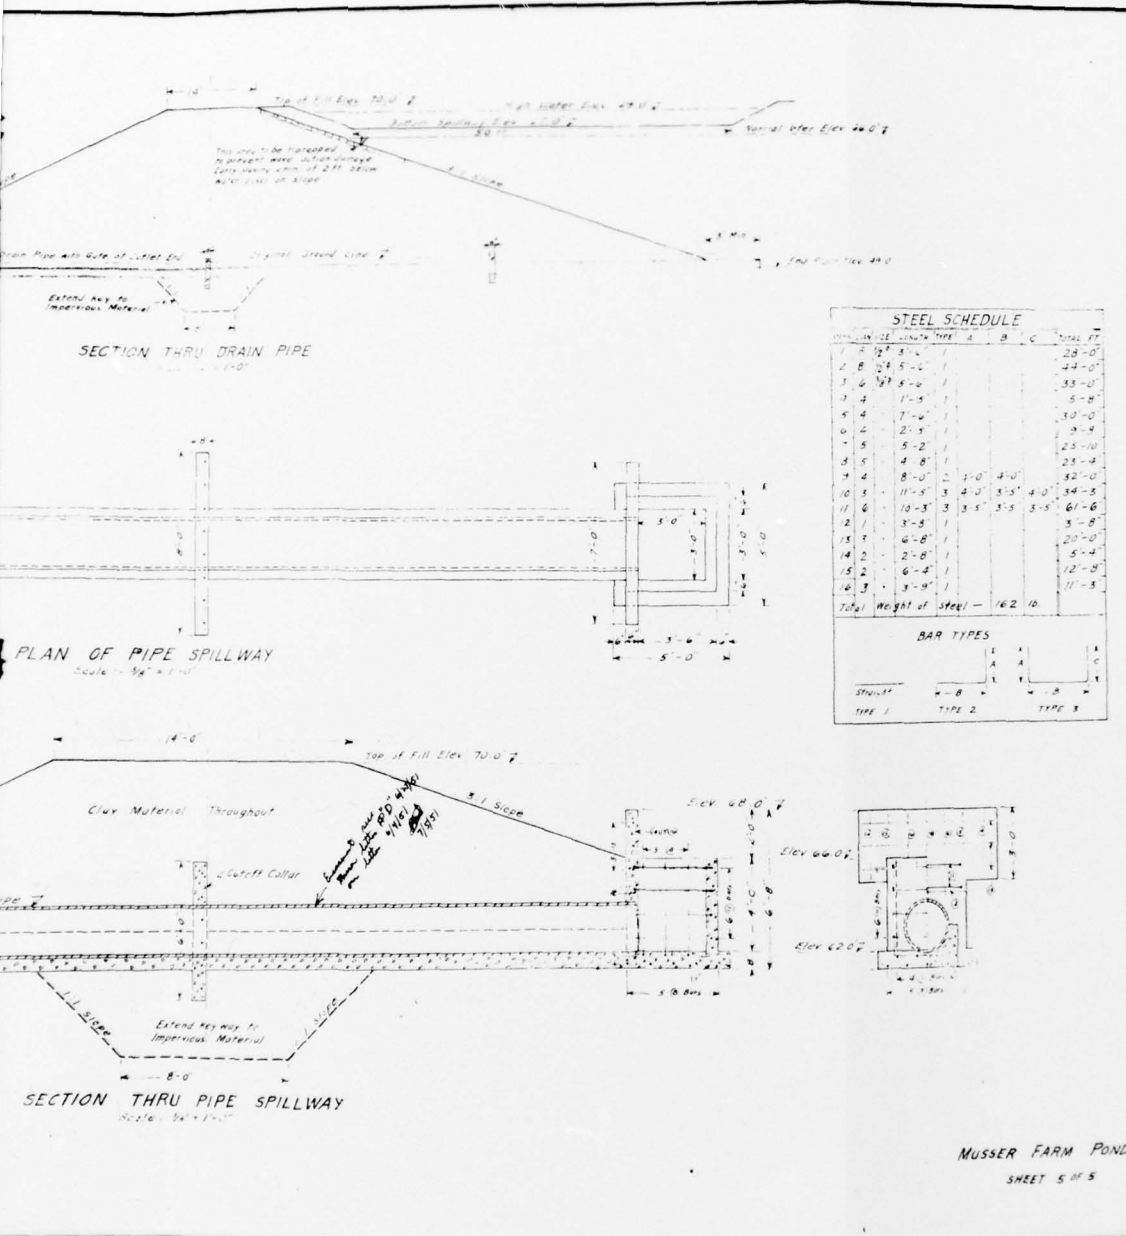
PLATE 3

The pipe is reported to be encased in concrete. Plate 3 illustrates the details of the primary spillway and outlet pipe. The profiles of the primary and emergency spillways and the cross sections of the emergency spillway discharge channel are shown on Plates 4 and 5.

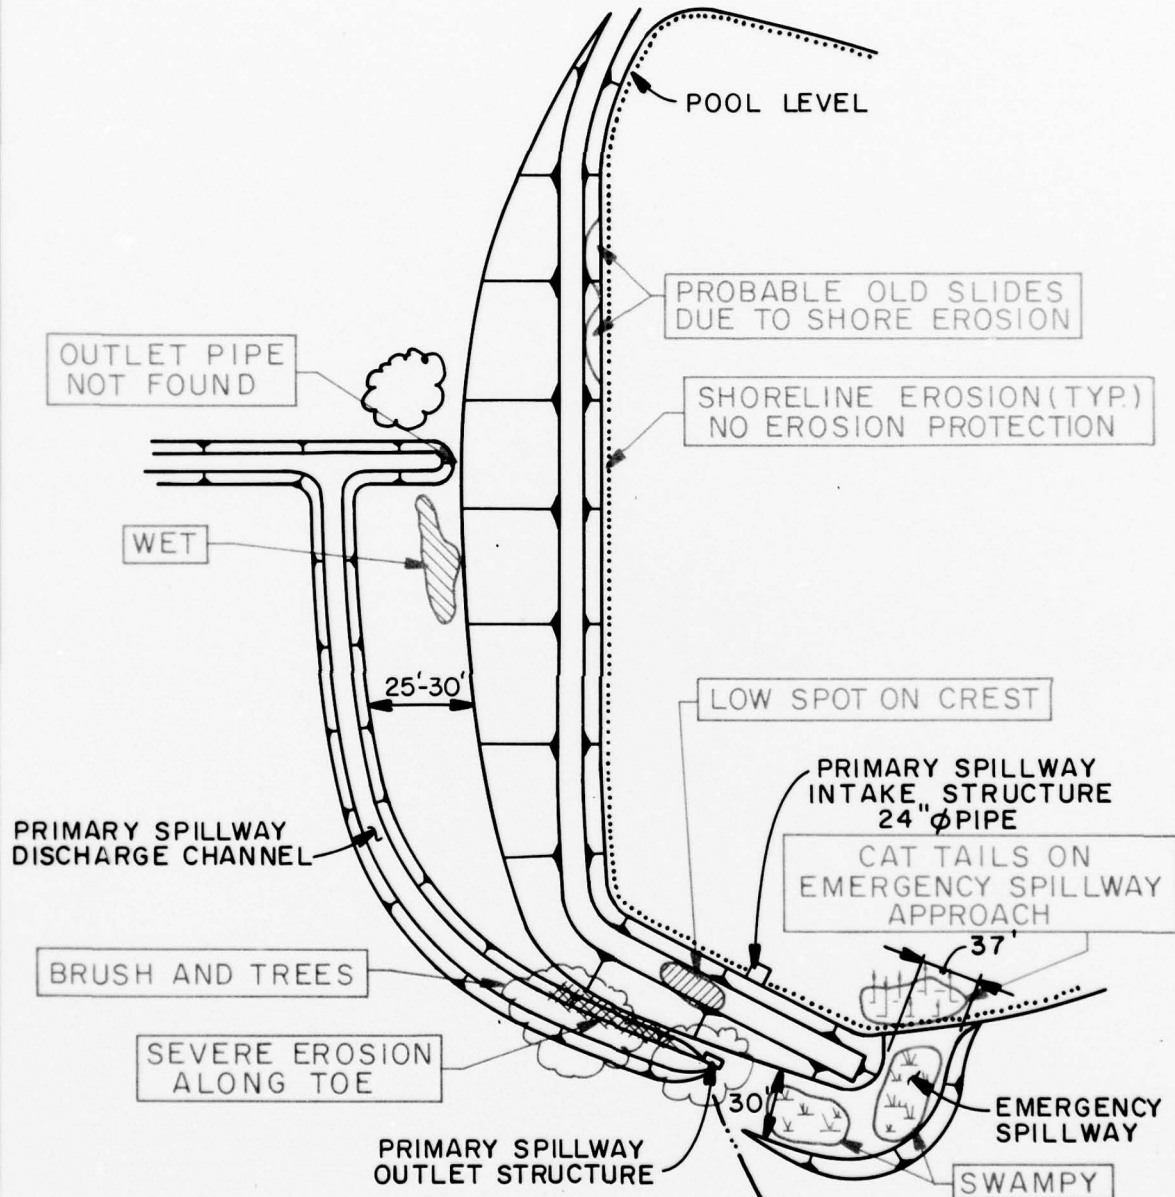
The crest of the dam was surveyed relative to the emergency spillway crest level. The freeboard was found to range from 1.7 feet in the vicinity of the primary spillway to 5.9 feet near the right abutment. The dam crest profile is illustrated on Plate 7.

- POOL LEVEL DATE OF INSPECTION = 0.1 FT. ABOVE PRIMARY SPILLWAY CREST.
- EMERGENCY SPILLWAY FREEBOARD: 1.7 FT.
