PENNSYLVANIA **LEVEL**  
**SHANGRI-LA DAM**

NDI - PA 00248  
PA DER 15-295

PHASE I INSPECTION REPORT  
NATIONAL DAM INSPECTION PROGRAM

Name of Dam: Shangri-La Dam ID #PA00248  
State Located: Pennsylvania  
County Located: Chester  
Stream: Broad Run  
Coordinates: Latitude 39° 47.0', Longitude 75° 44.4'  
Date of Inspection: (June 12, 1979),

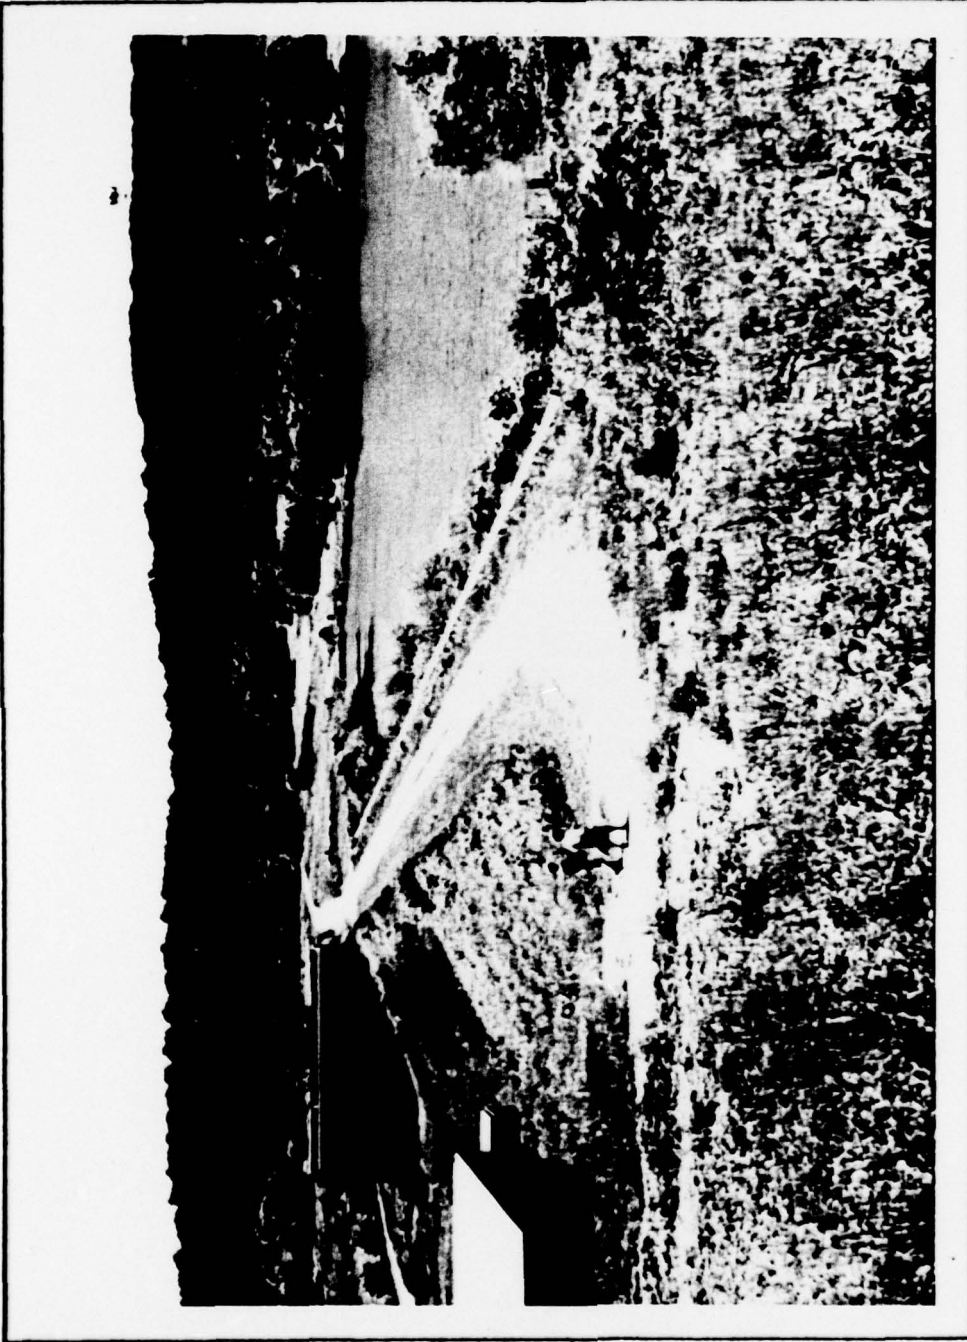
*OVERVIEW  
SHANGRI LA DAM, CHESTER COUNTY, PENNSYLVANIA*

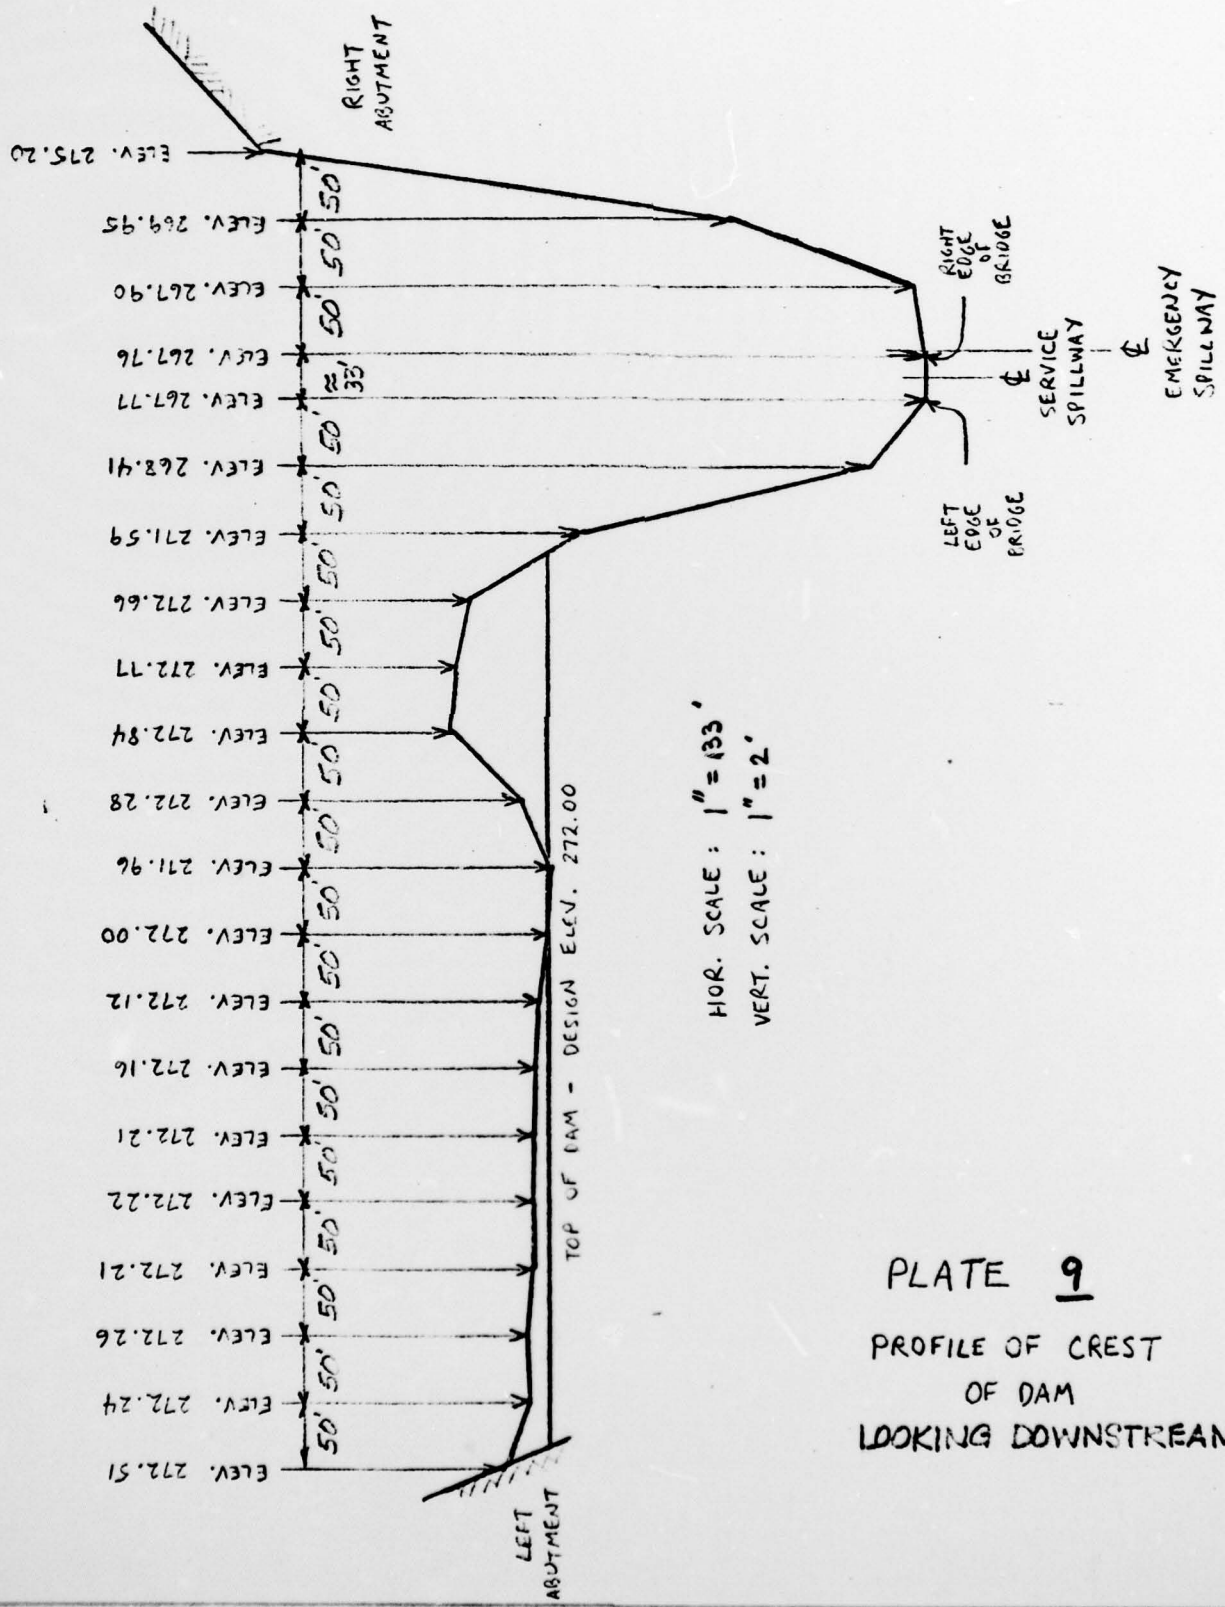
PLATE 9  
PROFILE OF CREST  
OF DAM  
LOOKING DOWNSTREAM

The design drawings indicate that the knoll located immediately to the left of the emergency spillway was to be cut to the top of dam design elevation (Elev. 272.0). However, the survey of the dam crest revealed that the knoll ranges from 8 to 10 inches above design elevation (see Plate 9 in Appendix E).
