BELLWOOD DAM

NDI ID. No. PA - 00524

PHASE I INSPECTION REPORT
NATIONAL DAM INSPECTION PROGRAM

JUNE 1979

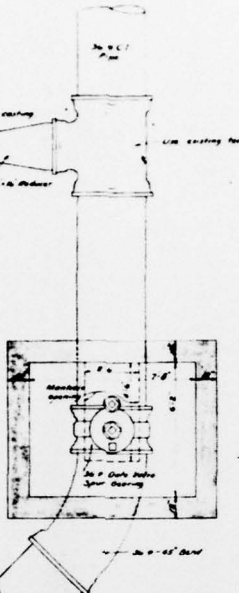
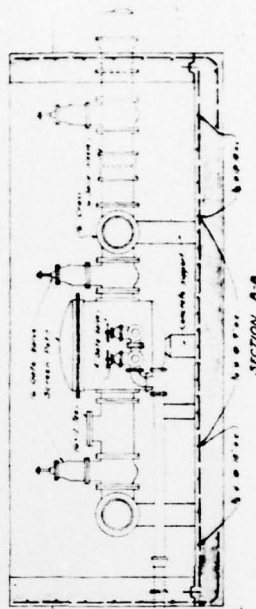
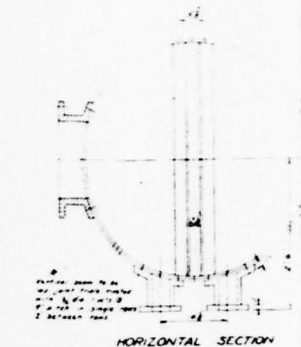
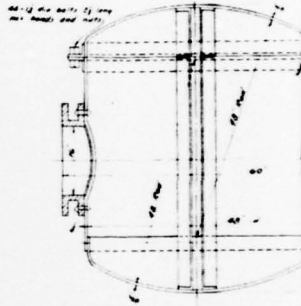
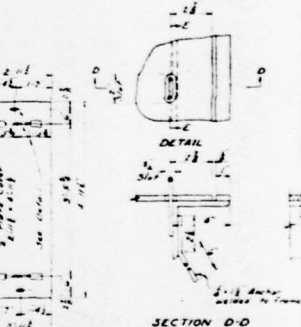
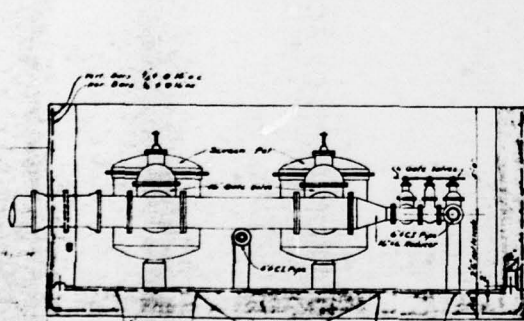
FIGURE 6

c) Gate House and Valves. The gate house is a concrete block structure that contains control valves and water treatment equipment (see Photograph 10 and Figure 6). The valve system consists of six 16-inch diameter gate valves and two screen pots for regulating the supply line. Three 6-inch diameter valves are available for providing minimum downstream flow requirements.
