*(6) National Dam Inspection Report*  
**MARCEL LAKE DAM**

NDI - PA 00402,  
PA DER 52-149.

PHASE I INSPECTION REPORT,  
NATIONAL DAM INSPECTION PROGRAM

Name of Dam: Marcel Lake Dam            ID # PA-00402  
State Located: Pennsylvania  
County Located: Pike  
Stream: Dingman's Creek  
Coordinates: Latitude 41° 15.2' Longitude 74° 57.4'  
Date of Inspection: November 22, 1978

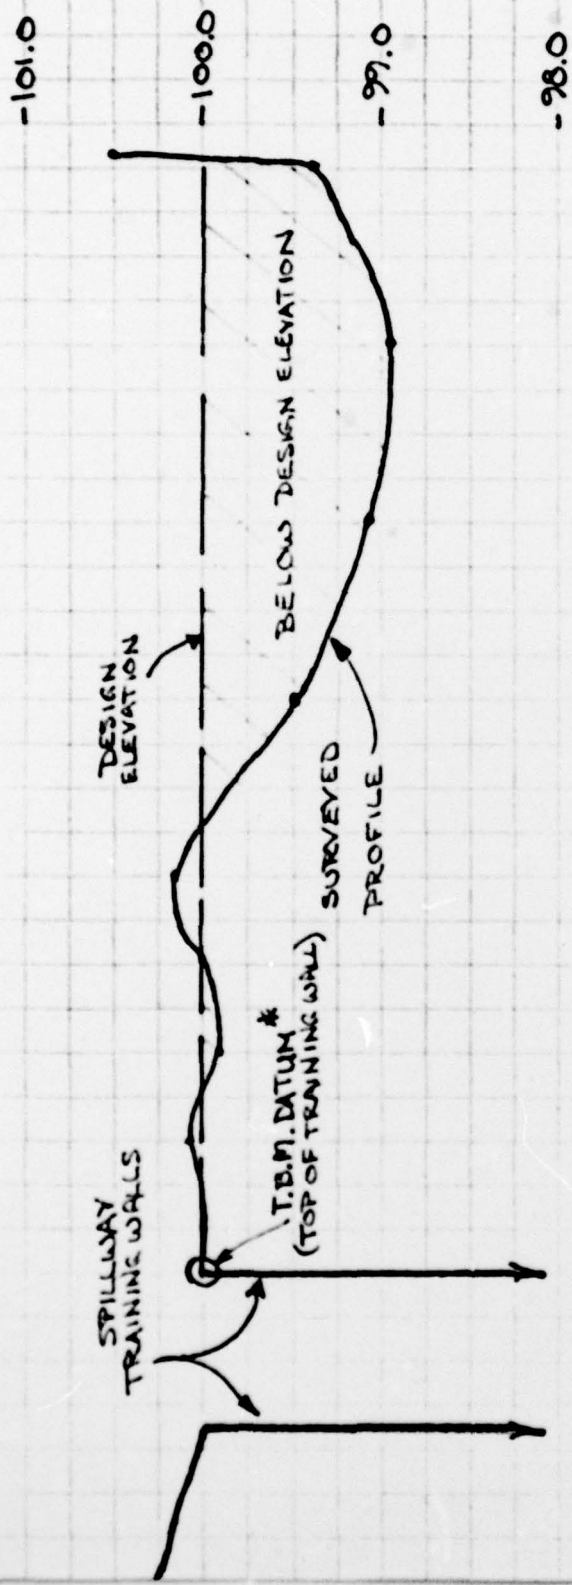
PLATE  
5

The downstream face and the top of dam are characterized by undulating surfaces, heavy grass cover, burrow holes, and occasional small trees and bushes. Review of the top of dam survey reveals that about 400 feet of the top of dam is below design elevation (See Plate 5 of Appendix E). Measurements of the slope of the downstream face revealed variations of from 1.7H:1V to 2H:1V.

The top of the dam is an undulating surface. The top of the dam survey reveals that about 400 feet of the top of the dam is below design elevation (Refer to Appendix E, Plate 5).
