**PENNSYLVANIA
NDS ID PA. 00777
DER ID 45-1**

LAKE NAOMI DAM

PHASE I INSPECTION REPORT NATIONAL DAM INSPECTION PROGRAM

JULY 1979

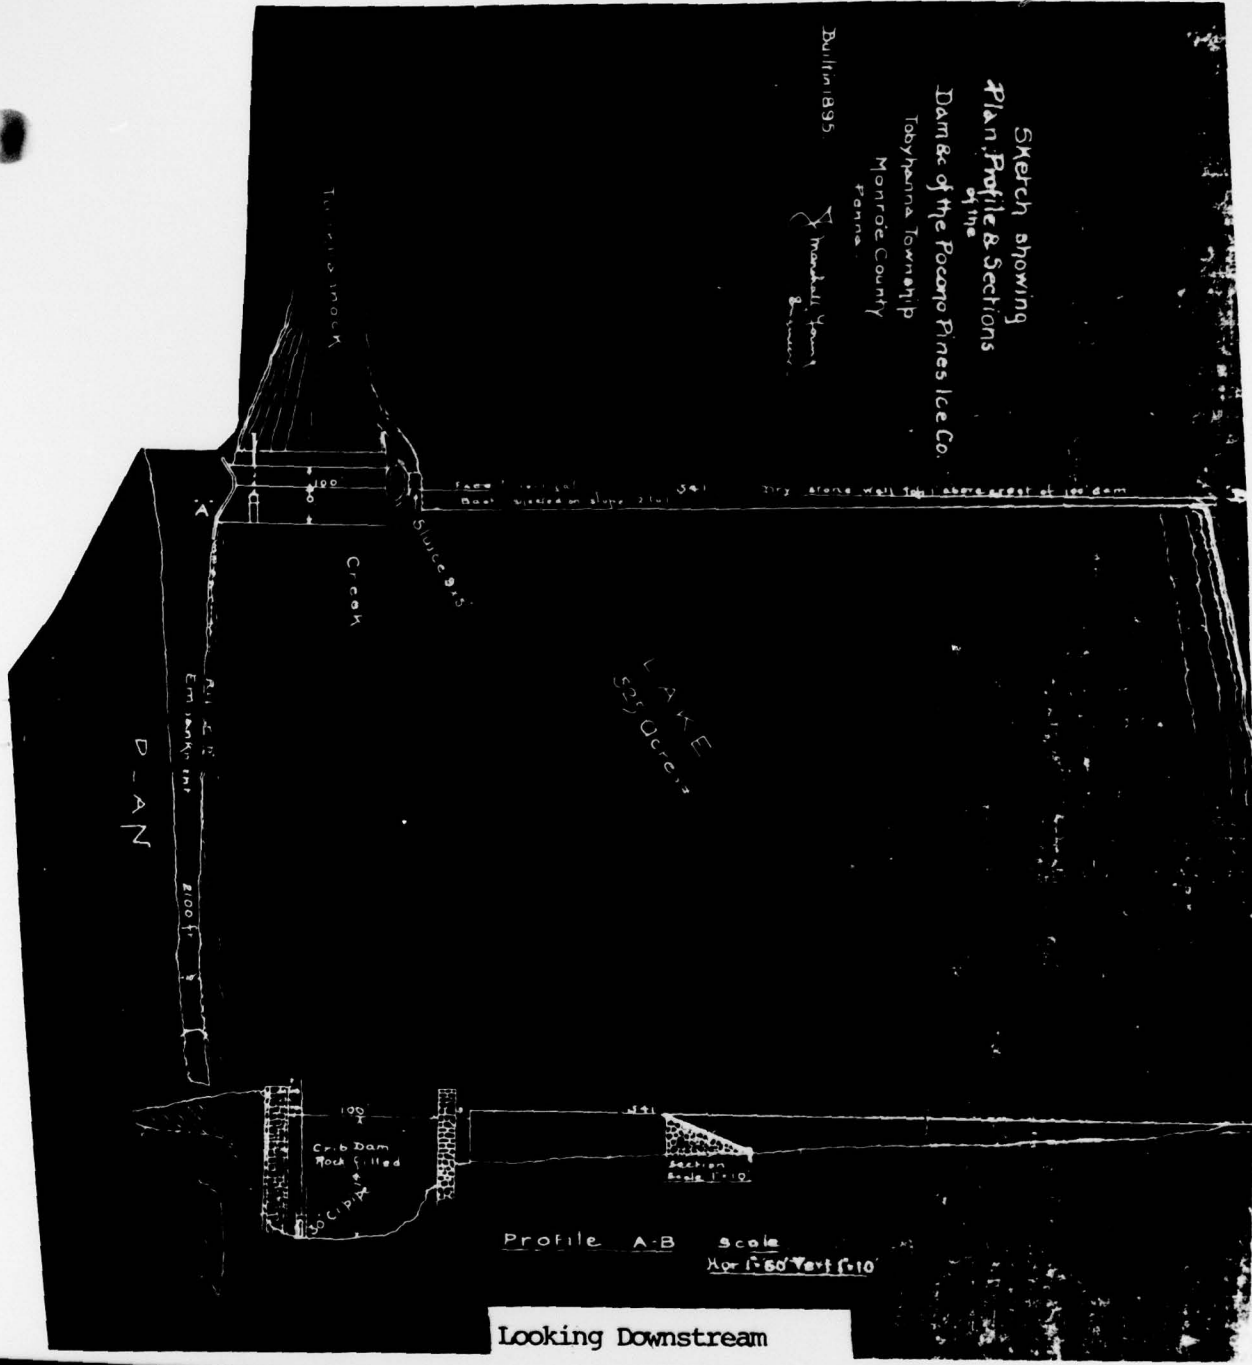
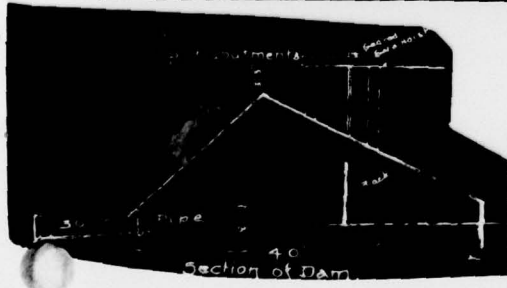
PLATE 2

is located as shown on Plate 2, to the right of the main spillway adjacent to the auxiliary spillway. Some slight leakage was noted at the lower corners of the gate. It is noted that a backhoe or bulldozer is required to raise this gate. The discharge area beyond the gated spillway is considered to be in fair condition. Erosion is considered probable if significant quantity of discharge passes through the gate.

3. Auxiliary Spillway. The auxiliary spillway, located to the right of the wooden sluice gate and shown on Plate 2, is currently being used as a beach. The known construction and repair history is reported in Section 1. Visual inspection revealed a fine gravelly sand beach, 31 to 49 feet wide. The downstream slope is composed of rock, broken concrete and some brush. Significant quantities of seepage were flowing through the stone and concrete. The crest surface is not resistant to erosion and it is believed that significant erosion and failure would occur as a result of large flows through the auxiliary spillway.

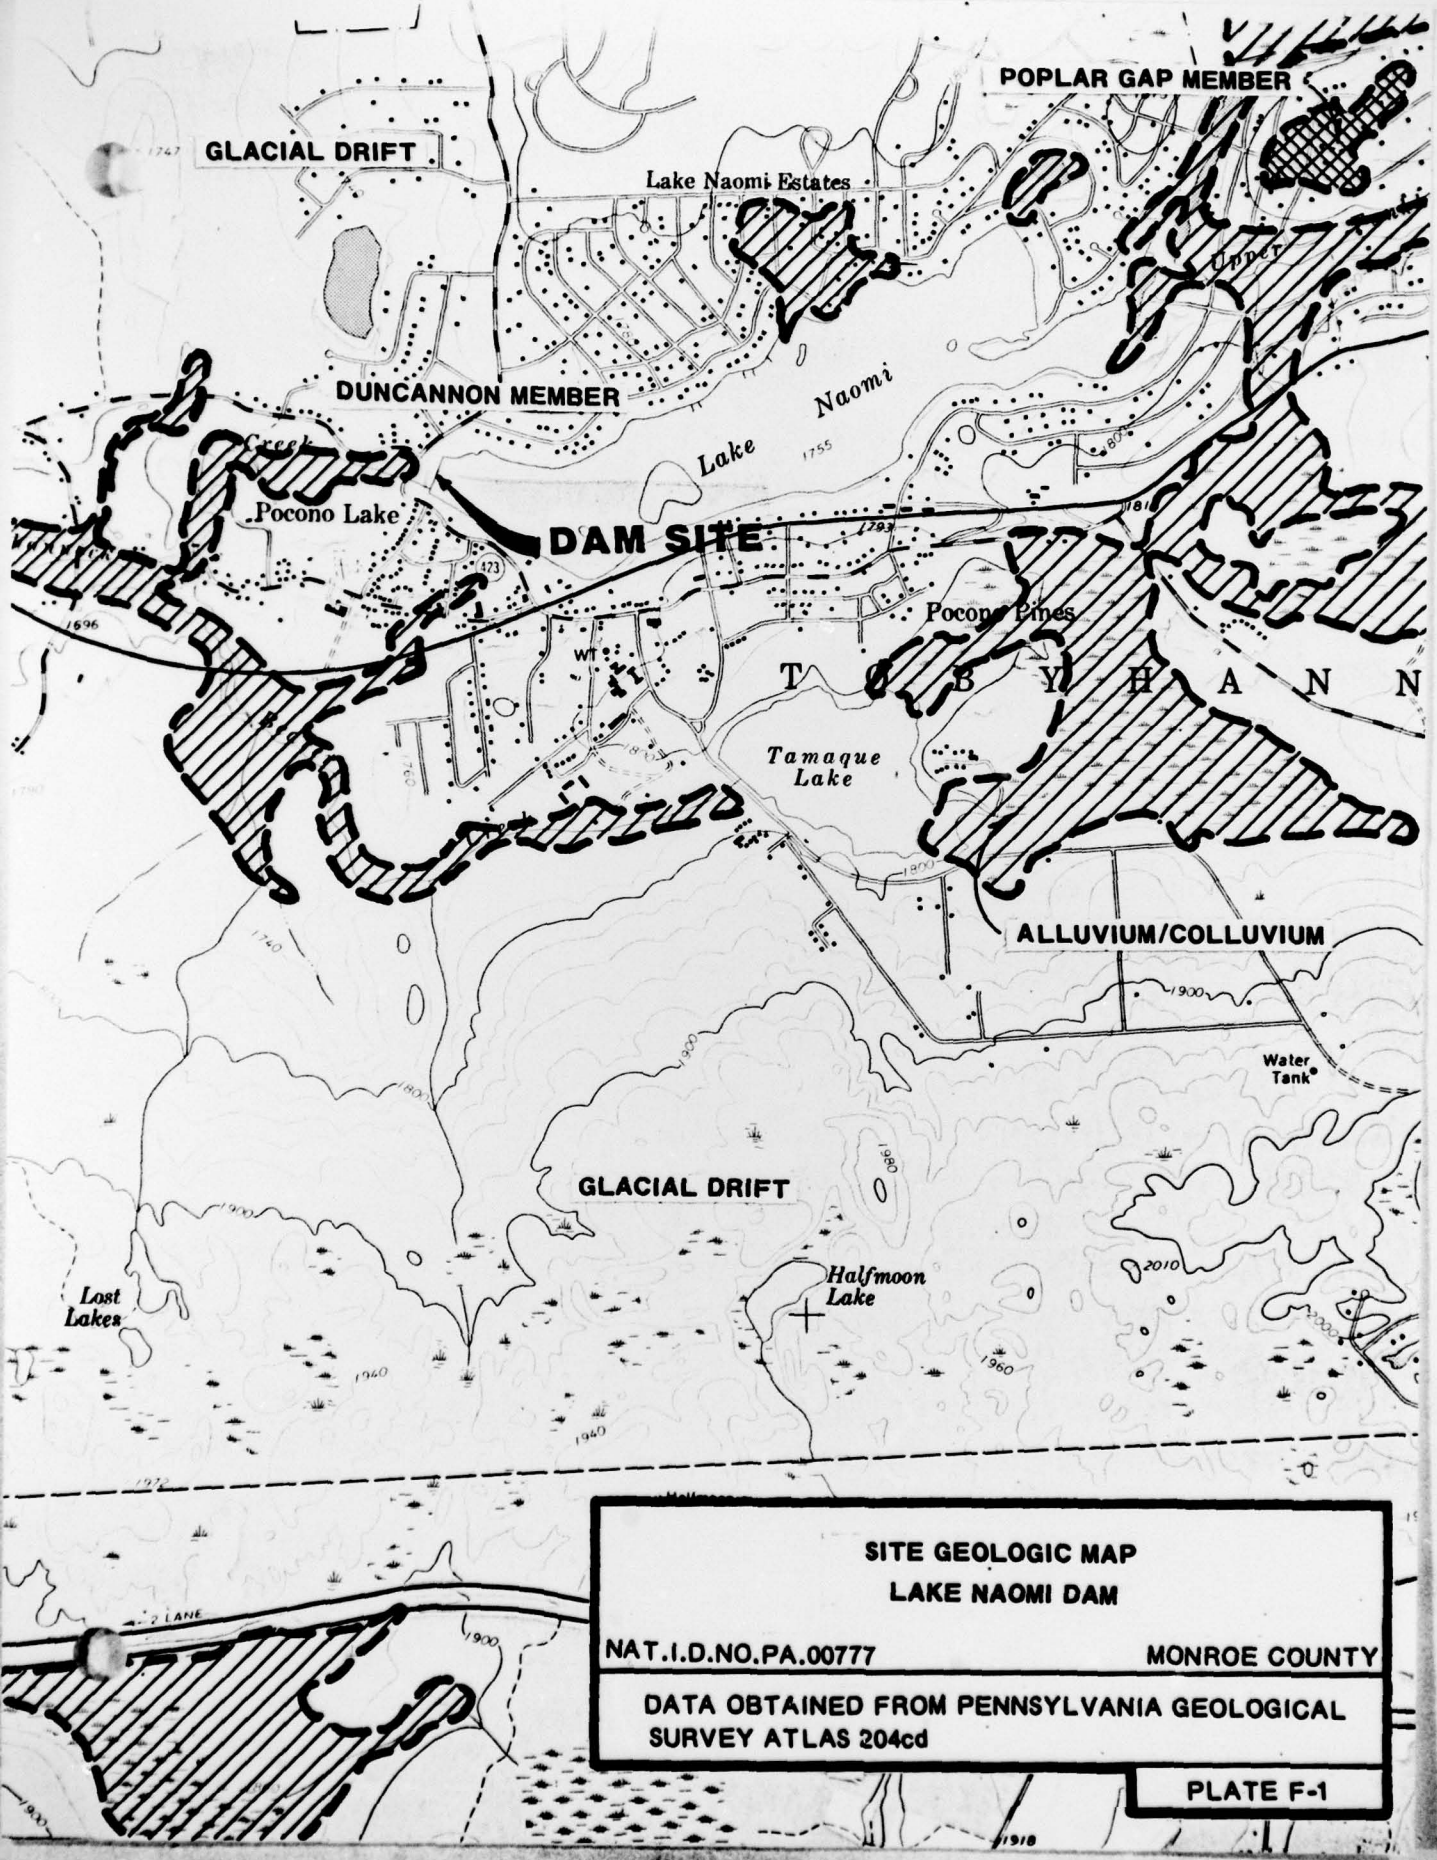
**SITE GEOLOGIC MAP
LAKE NAOMI DAM**

Lake Naomi Dam is located in the Pocono Plateau Section of the Appalachian Plateaus Physiographic Province. As shown on Plate F-1, the dam site and surrounding region, as is much of northeastern Pennsylvania, are overlain by a partial mantle of Wisconsin age glacial drift, having localized deposits of alluvium and colluvium. The bedrock in the site region belongs to the Upper Devonian age Catskill Formation. The sandstone beds of the Duncannon Member are exposed immediately downstream from the dam. Rock bedding strikes to the northeast and dips nine degrees to the northwest (approximately downstream). Two sets of rock joints are well developed. One joint set strikes east-northeast and the other strikes north-northwest. Both joint sets have near vertical dips. This has resulted in an overall blocky form to the rock outcrops.

The downstream direction of bedding dip, joint pattern and shallow depth to rock are conditions which could contribute to the seepage observed during the field inspection.
