PHASE I REPORT  
NATIONAL DAM INSPECTION PROGRAM

NAME OF DAM: Raccoon Creek State Park Dam  
STATE LOCATED: Pennsylvania  
COUNTY LOCATED: Beaver County  
STREAM: Traverse Creek, a tributary of Raccoon Creek  
SIZE CLASSIFICATION: Intermediate  
HAZARD CLASSIFICATION: High  
DATE OF INSPECTION: December 13, 1978 and April 16, 1979

RACCOON CREEK STATE PARK DAM  
NDI I.D. NO. PA-262  
DECEMBER 13, 1978

PHASE I REPORT  
NATIONAL DAM INSPECTION PROGRAM  
RACCOON CREEK STATE PARK DAM  
NDI I.D. NO. PA-262  
DER I.D. NO. 4-34

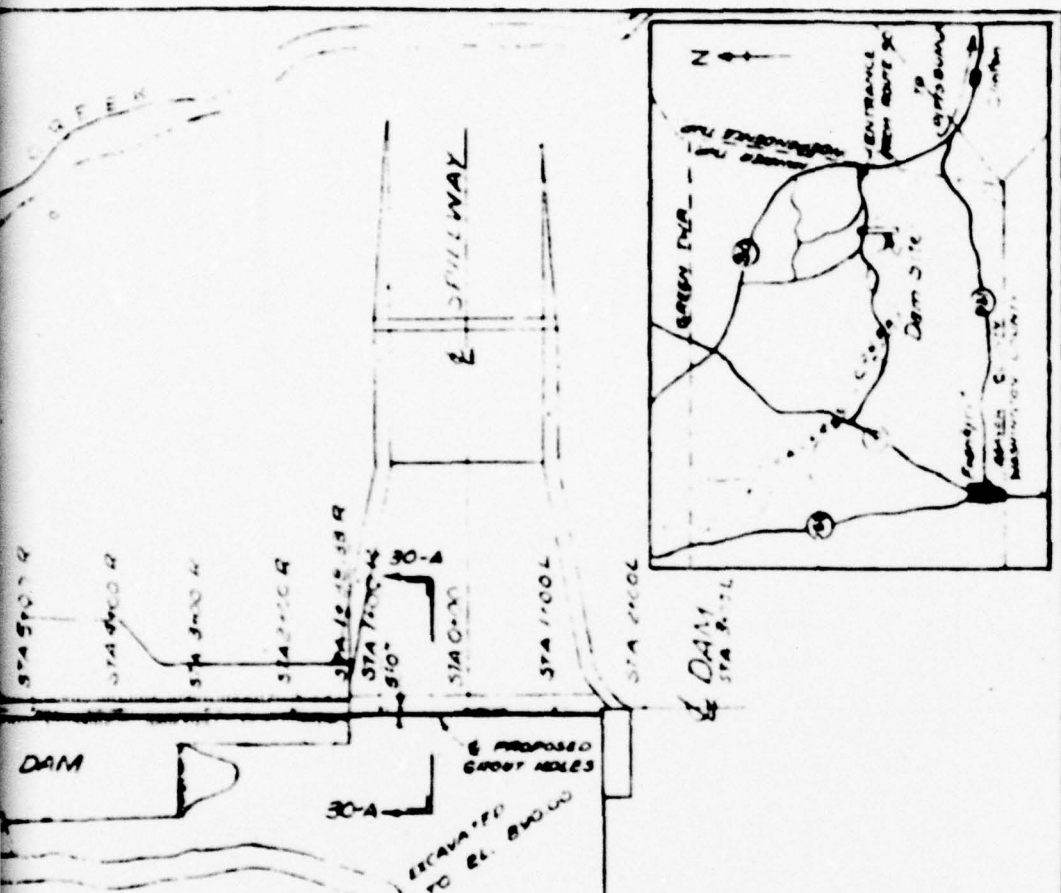
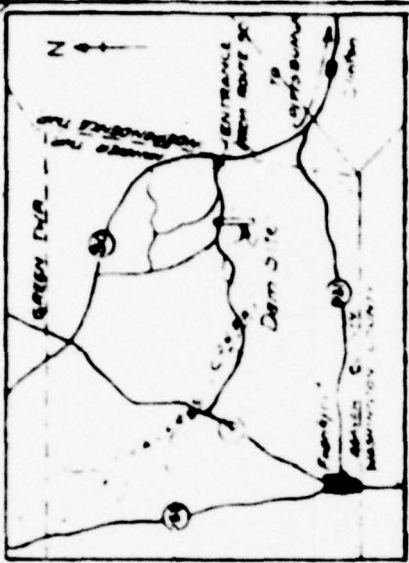
PLATE 5

- d. The available information indicates that a 150-foot long section of the foundation on the left side of the original streambed was grouted through holes drilled at 5-foot centers extending to a depth of 25 feet below the base of the cutoff trench. Plates 5 and 6 illustrate the locations of grout holes through the spillway and the right side of the embankment, which was performed after the completion of the dam.

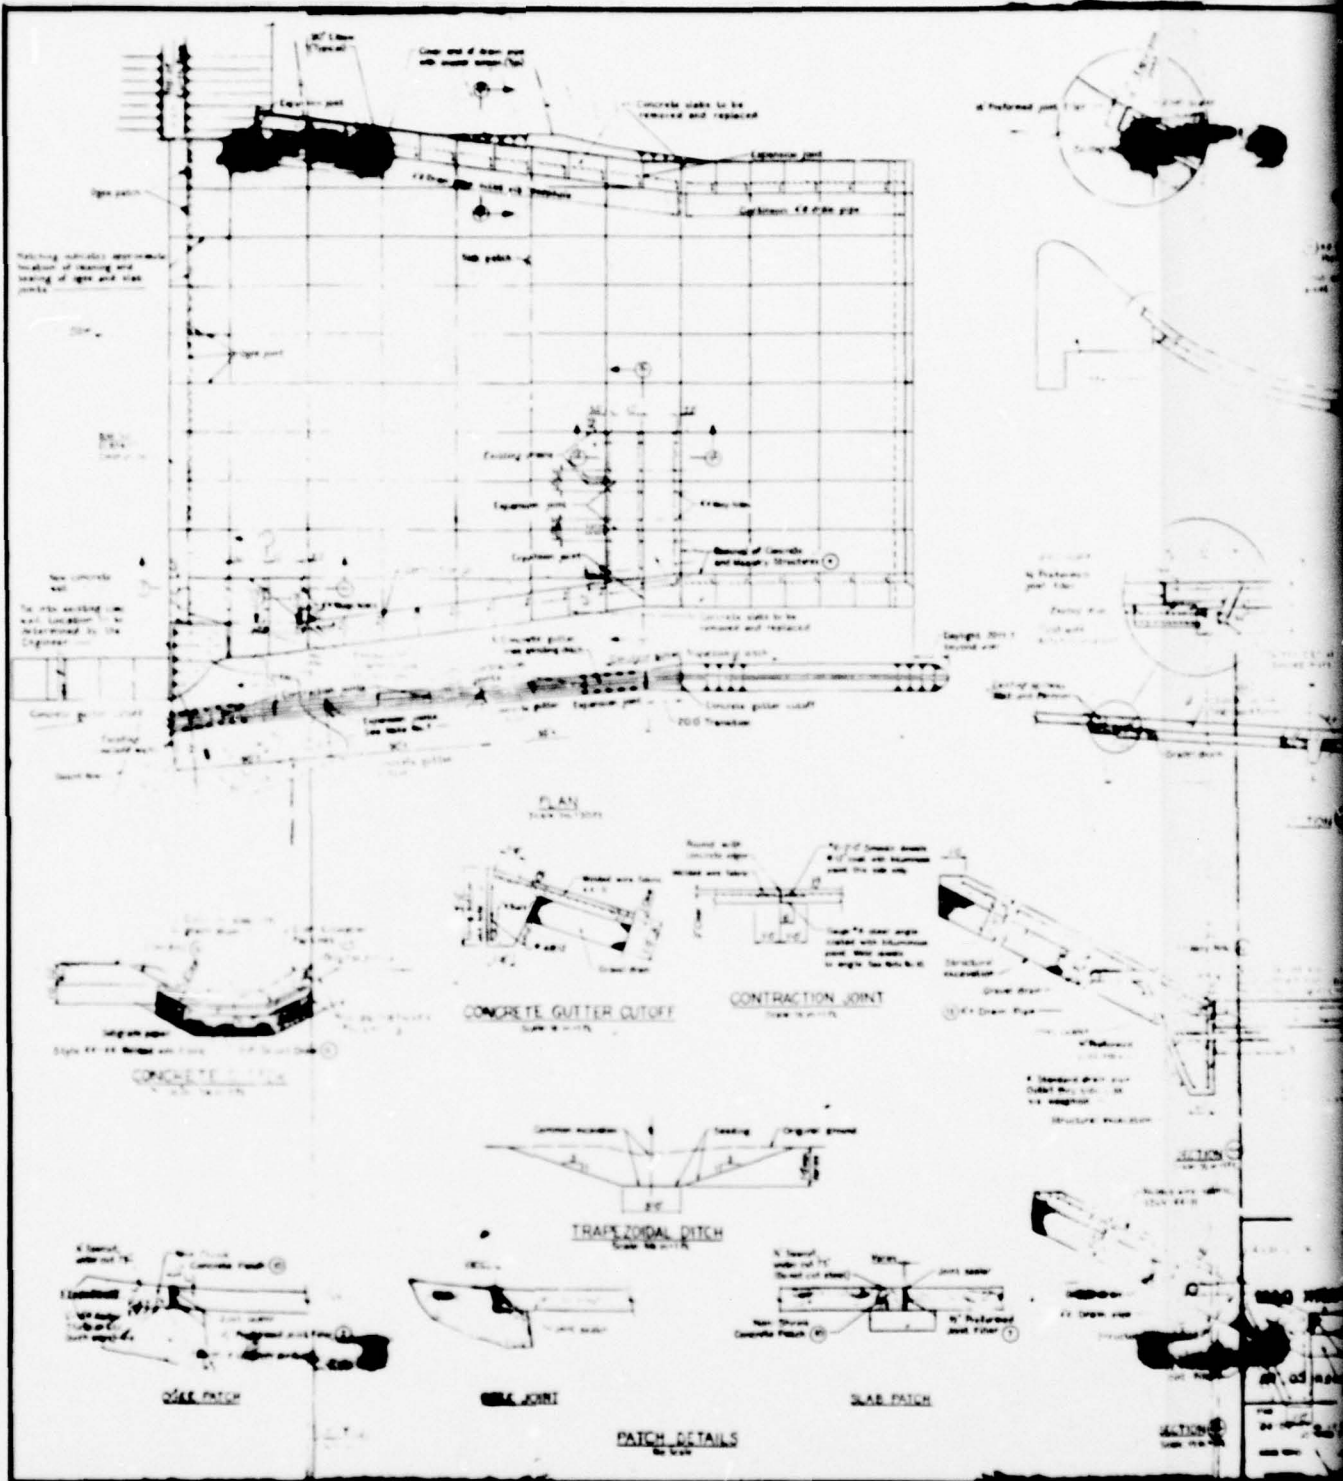
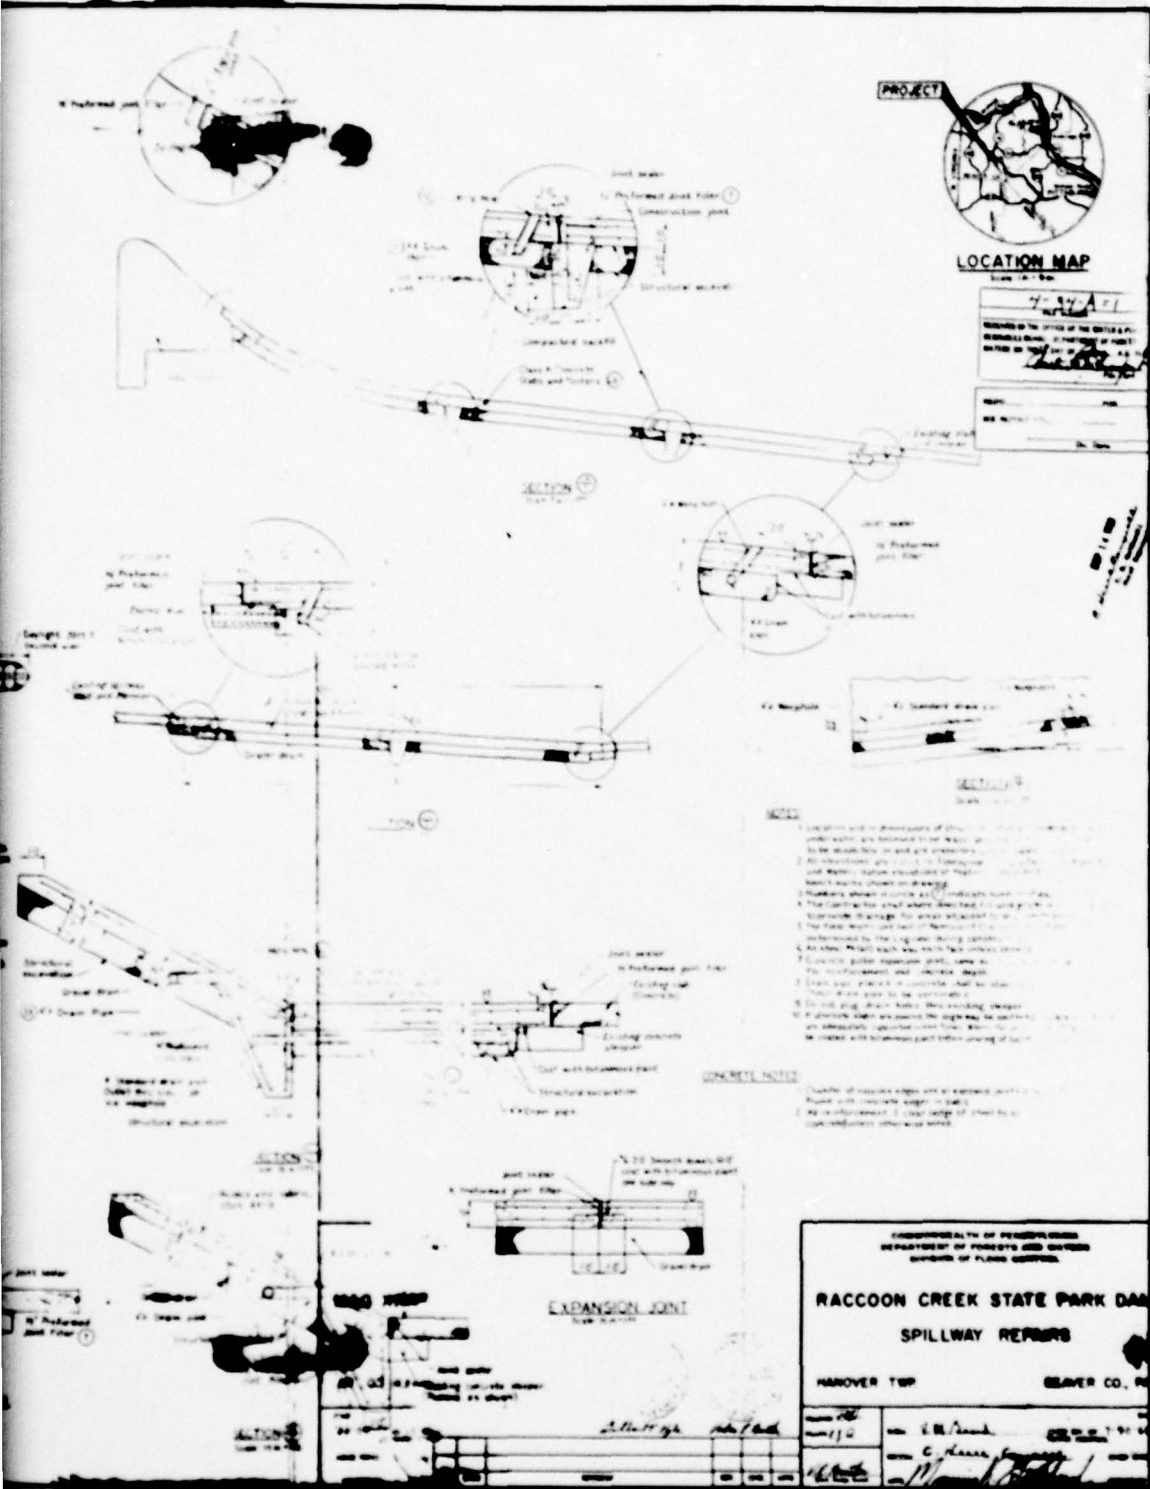
PLATE 7

The available information indicates that due to continued deterioration of the concrete in the spillway structures, these structures were renovated and partially rebuilt in 1965. The extent of repairs is shown on Plates 7 and 8.
