PENNSYLVANIA
DEER VALLEY LAKE DAM

NDS I.D. No. PA - 00230
PENNDER I.D. No. 56 - 76

PHASE I INSPECTION REPORT
NATIONAL DAM INSPECTION PROGRAM

AUGUST 1979

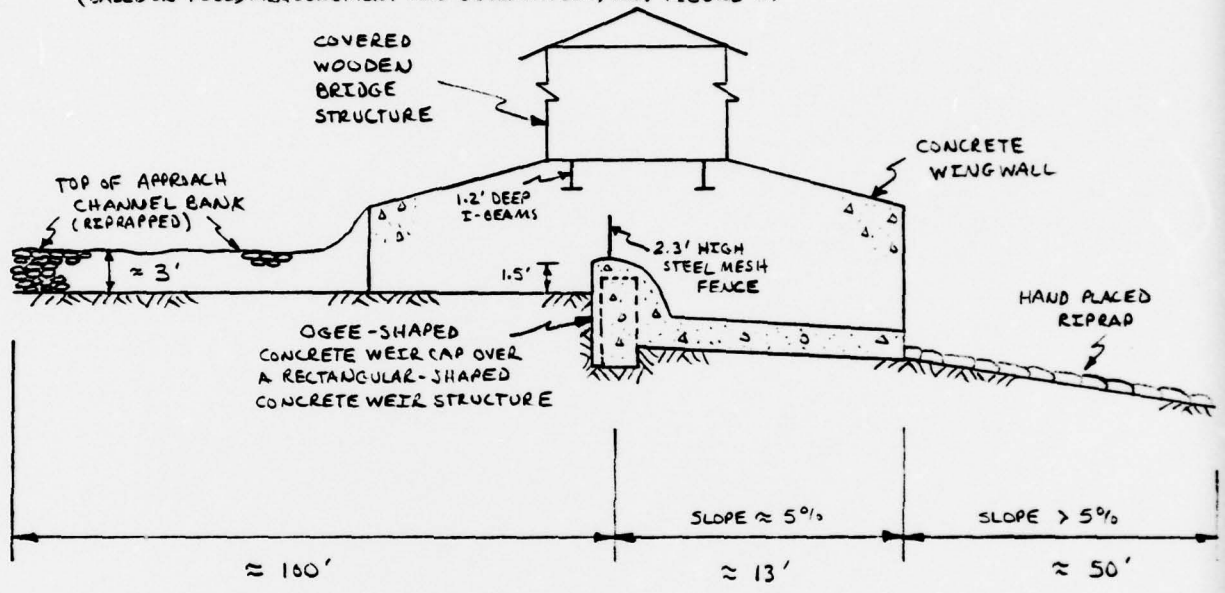
- PROFILE OF SPILLWAY : (NOT TO SCALE)
 (BASED ON FIELD MEASUREMENT AND OBSERVATION, AND FIGURE 5)

1. Spillway. The spillway structure was found to be in good condition with minor deficiencies that included scaling of the ogee-like weir crest (see Photograph 4) and minor cracking and spalling of the wingwalls. A 2.3-foot high chain link fish screen obstructs free flow over the weir crest; however, the Camp Director stated that the screen is removed under high flow conditions. In addition, temporary boat docks are located immediately upstream of the spillway approach channel entrance which could cause spillway blockage during major flooding.

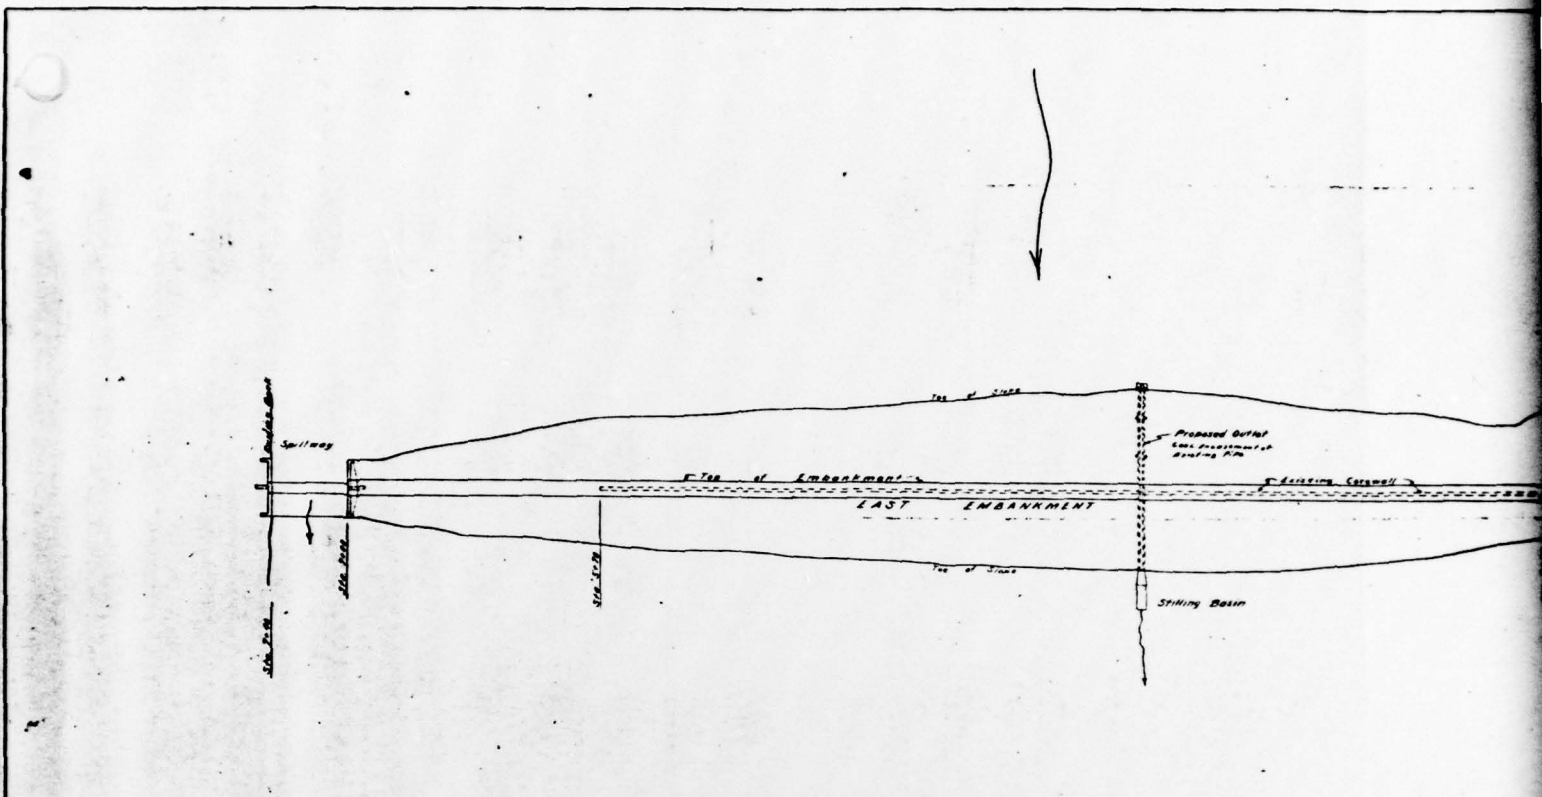
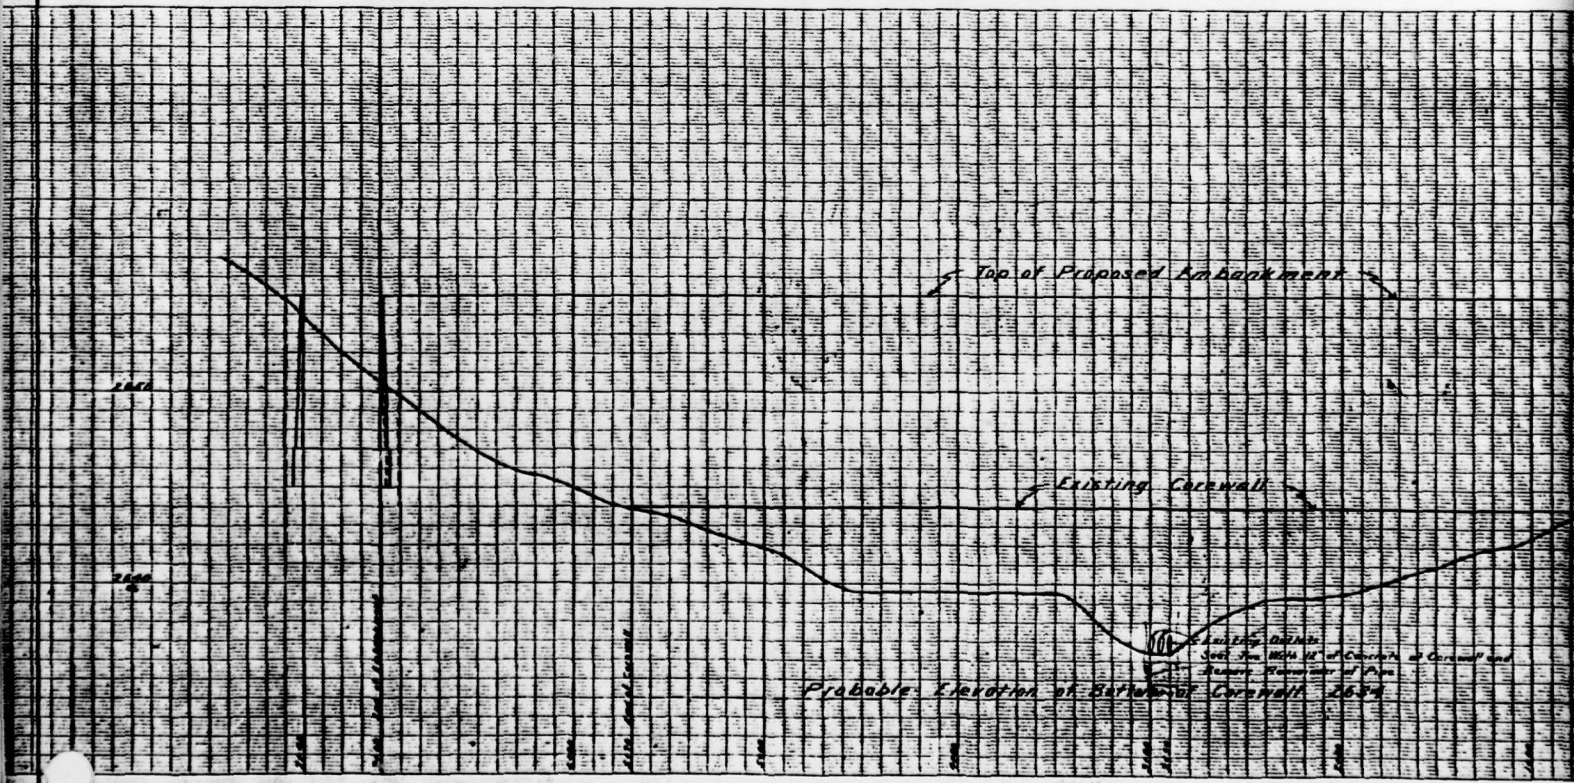
FIGURE 1 - DEER VALLEY LAKE DAM
 GENERAL PLAN : FIELD INSPECTION NOTES

b. Embankment. Observations made during the visual inspection revealed the embankment to be in fair condition. The upstream slope is protected by durable, well-graded riprap (see Photographs 2 and 6). The downstream slope is heavily vegetated with high grass, weeds and small shrubs and appears infrequently maintained (see Photograph 5). No seepage was observed through the downstream face; however, seepage, ponding, and swamp-like conditions occur along the downstream toe throughout the area from the outlet conduit to within 100 feet of the left abutment (see Photographs 7 and 8). No other deficiencies were observed.

c. Take remedial measures to drain the ponded water along the downstream toe and install a weir or weirs under the direction of a registered professional engineer, experienced in the design of earth dams, to measure and evaluate the seepage conditions.
