PENNSYLVANIA
HINCKSTON RUN DAM

NDS LD. No. PA - 00430
PENNDER LD. No. 11 - 9

PHASE I INSPECTION REPORT
NATIONAL DAM INSPECTION PROGRAM

SEPTEMBER 1979

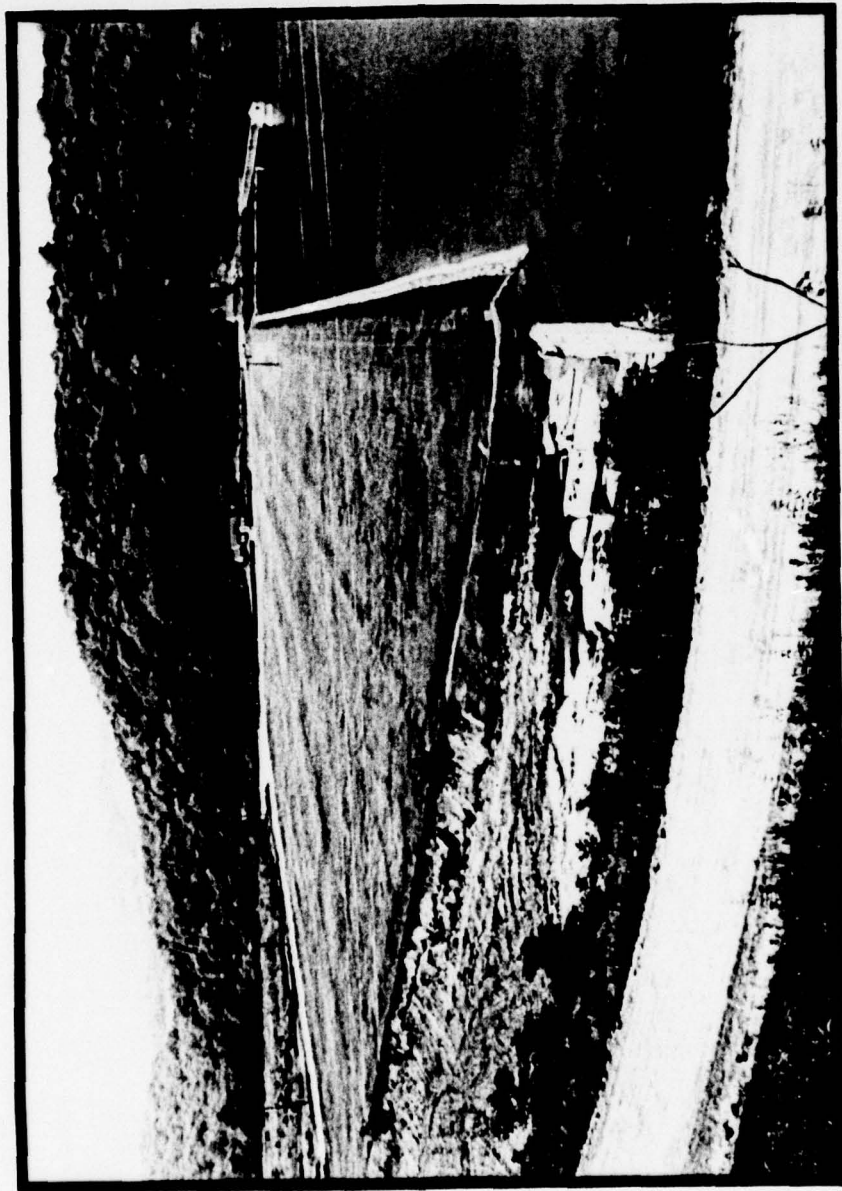
OVERVIEW PHOTOGRAPH

The facility is unique in that the downstream shell area has been utilized as a slag dump (see Figure 3), which has resulted in a minimum embankment crest width of 360 feet (see Overview Photograph and Figure 1).

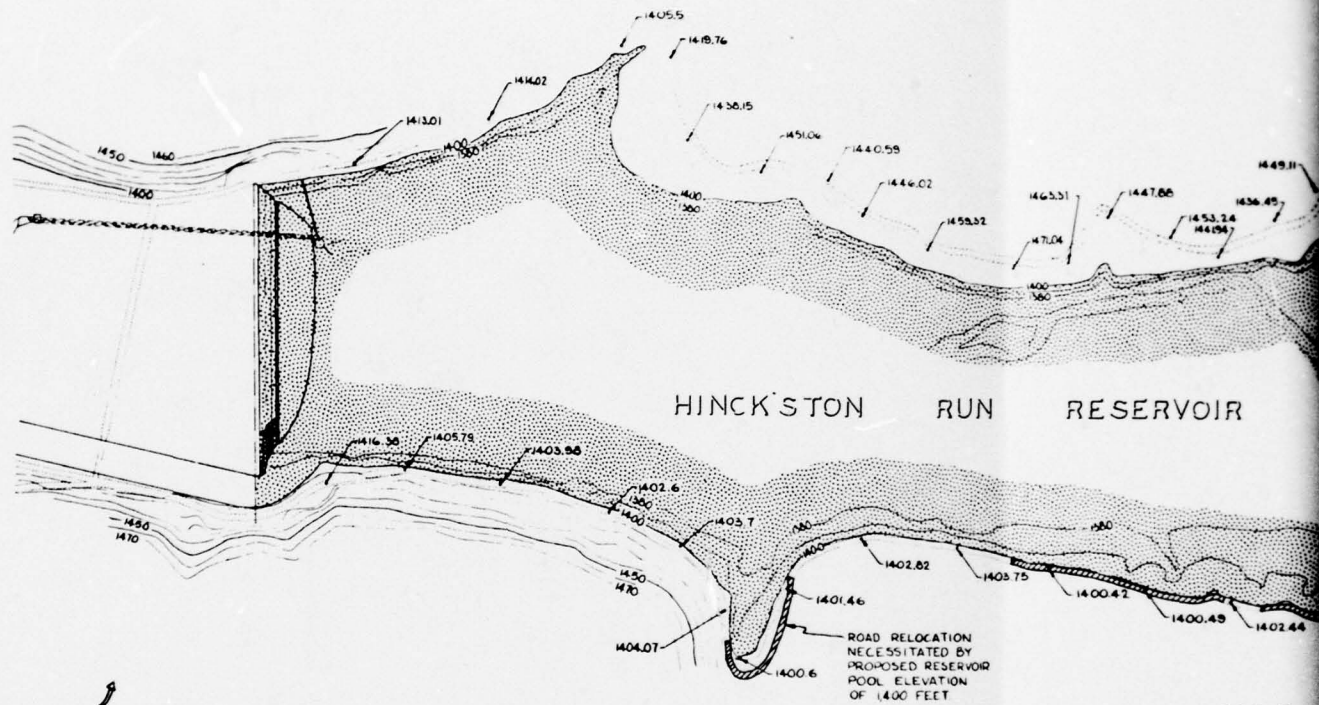
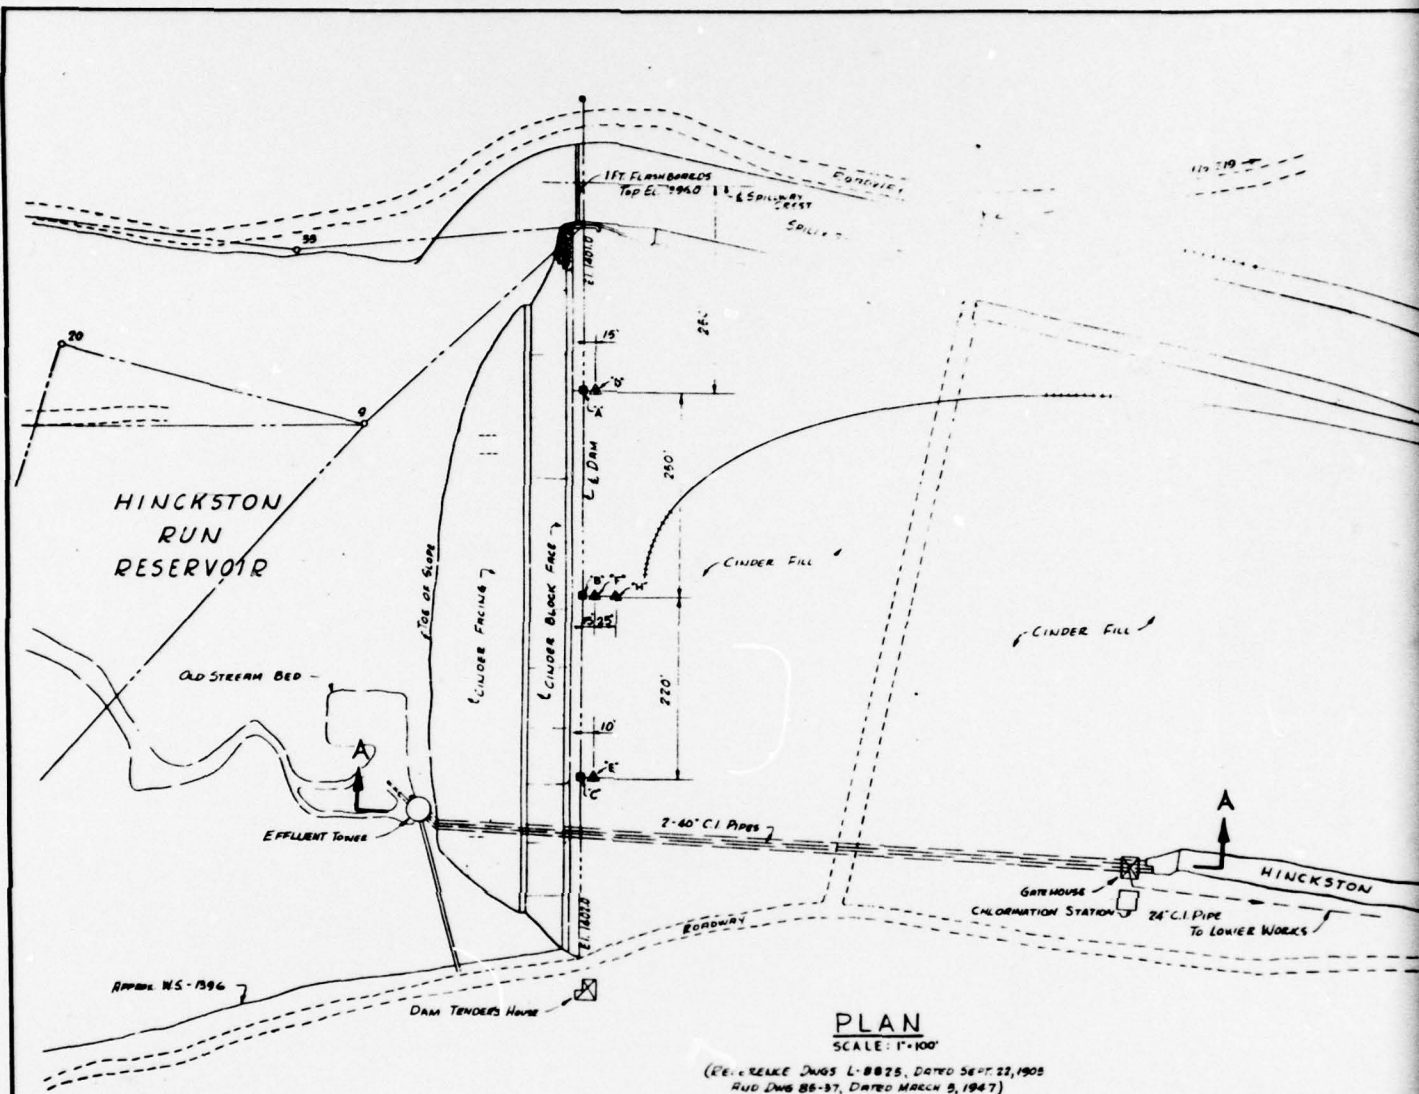
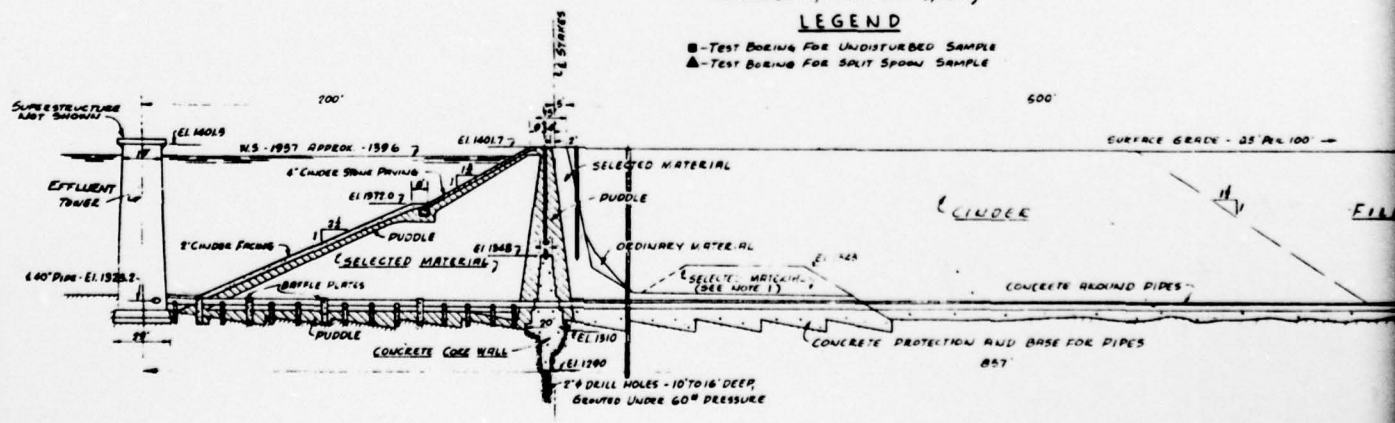
**FIGURE 1 - HINCKSTON RUN DAM
 GENERAL PLAN
 FIELD INSPECTION NOTES**

The downstream portion of the embankment was modified during construction when the "ordinary fill" reportedly reached a height of 22 feet, at which point it was decided to use "cinder" (currently designated as hot-poured slag) as its replacement by utilizing the downstream area as a slag dump. Thus, the embankment with its present configuration, is a unique, massive, slag-buttressed facility with a minimum crest width of about 360 feet (at the right abutment).

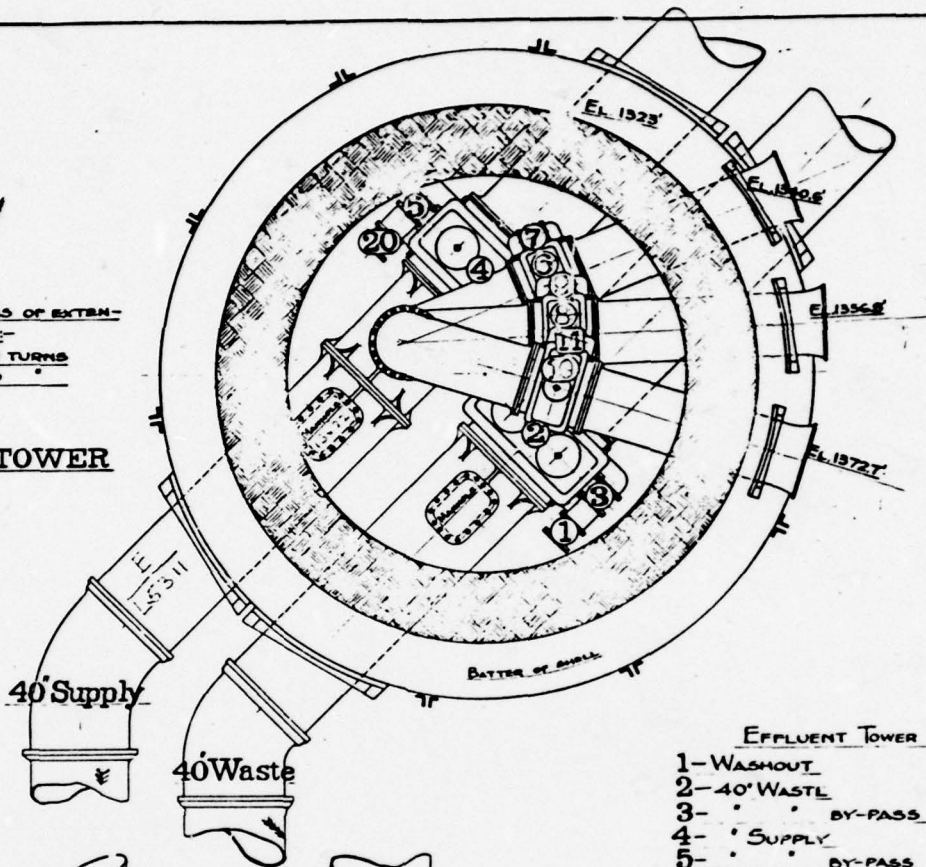
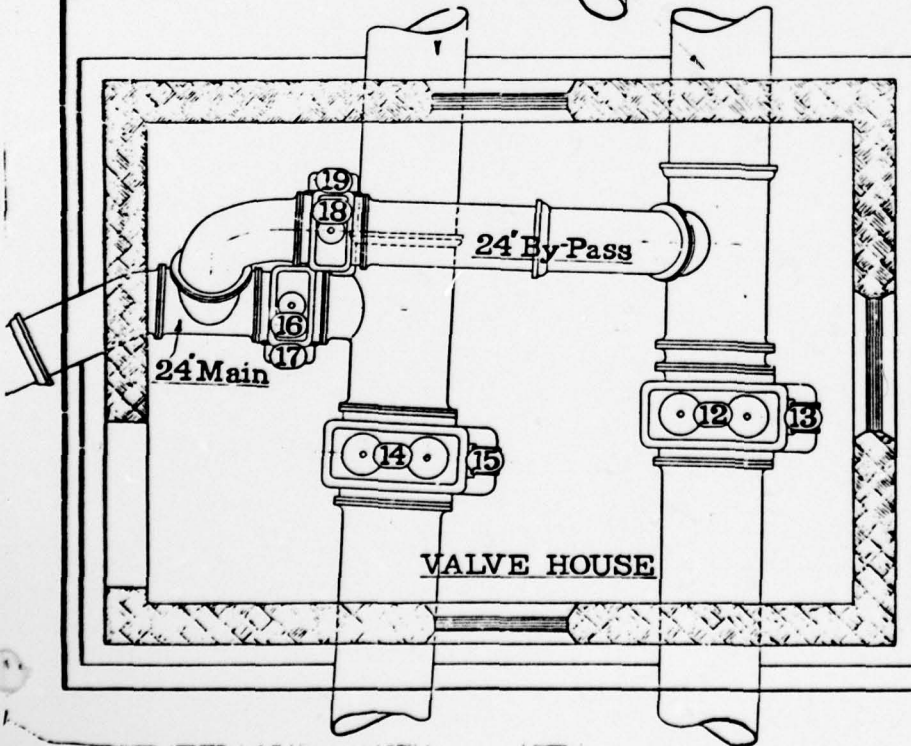
FIGURE 6

Valves are located within intake tower, but are reportedly inoperable. Control is provided by valves in downstream valve house (see Figure 6).

b. Outlet Works. The outlet works are composed of an intake tower, concrete encased conduits, and a downstream valve house. The intake tower is a cylindrical steel shell (varying from 19 to 23 feet in diameter) which is lined with concrete, and rests on a 28-foot diameter, 7-foot thick masonry foundation. It is located along the upstream toe of the embankment about 200 feet from the right (west) end of the dam. Within the tower, at the operating floor level, are five valve stands previously used to control intake levels and blowoff operation (see Figure 6 and Photograph 9). Modifications have been made to the intakes and all remaining valves are reportedly opened, but probably inoperable.
