PENNSYLVANIA
FOUR-MILE RUN DAM

NDS I.D. No. PA - 00457
PENNDER I.D. No. 65 - 126

PHASE I INSPECTION REPORT
NATIONAL DAM INSPECTION PROGRAM

AUGUST 1979

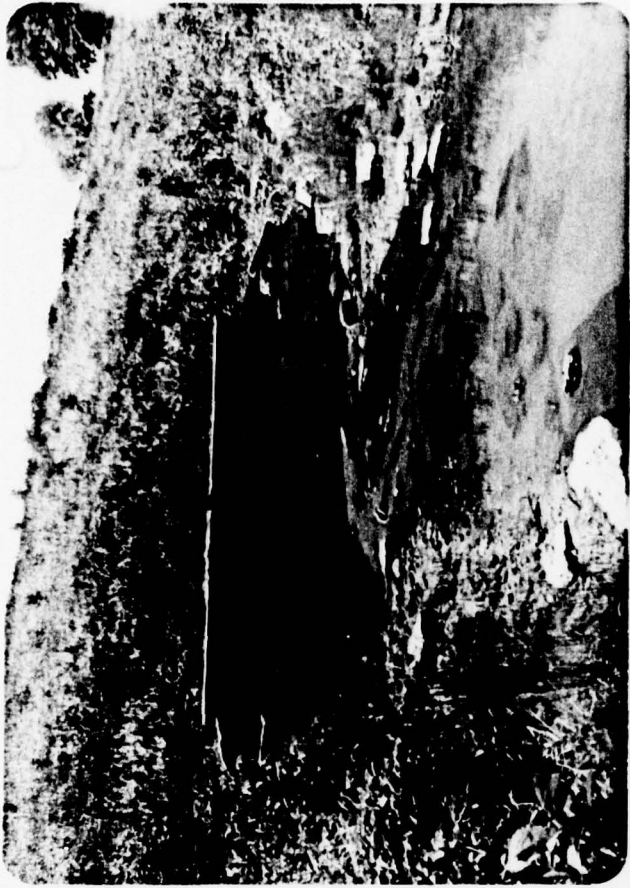
6

b) Outlet Works. The outlet works consists of a reinforced concrete riser and 4-foot square horizontal box culvert which discharges at the downstream embankment toe (see Figure 7 and Photograph 6). Flow through the outlet is controlled via removable stop logs set in grooves within the riser (see Photograph 5).
