PENNSYLVANIA  
VIRGIN RUN DAM

NDS I.D. No. PA - 00196  
PENNDER I.D. No. 26 - 85

PHASE I INSPECTION REPORT  
NATIONAL DAM INSPECTION PROGRAM

GAI CONSULTANTS, INC.  
570 BEATTY ROAD  
MONROEVILLE, PENNSYLVANIA 15146

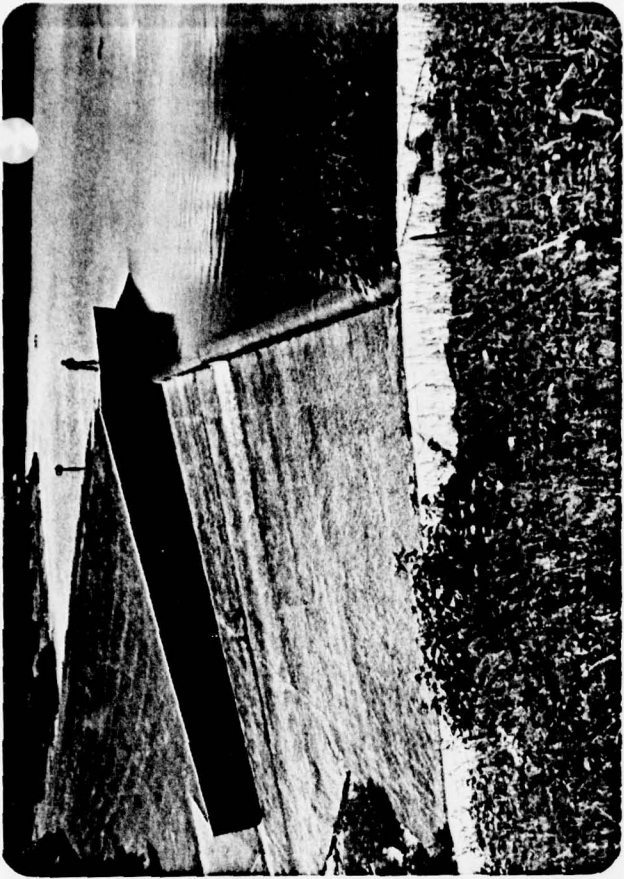
a) Spillway. The spillway at Virgin Run Dam is a trapezoidal-shaped, concrete chute channel, with discharges controlled by a reinforced concrete overflow weir structure, located at the left abutment (see Photograph 2). The spillway channel is partially unlined as it was cut into durable rock (see Figure 5 and Photograph 3). The original design was altered somewhat during construction to include the addition of a concrete apron as shown on Figure 6.

PHOTOGRAPH 2 View of spillway located adjacent the left abutment.

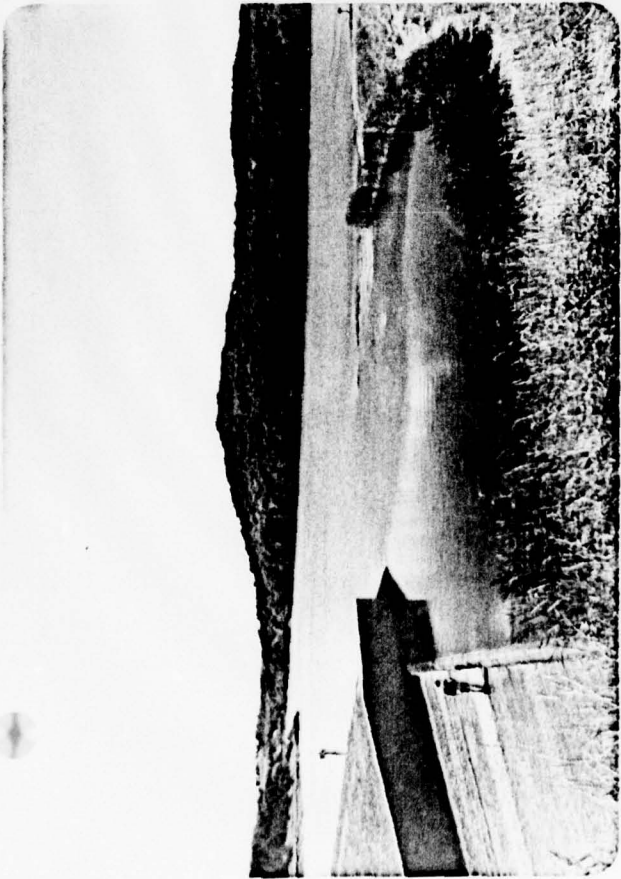
d. Reservoir Area. The area surrounding the reservoir is characterized by gentle to moderate slopes that are generally heavily forested along the southern and eastern shores of the lake (see Photograph 1), but only partially wooded to the west (see Photograph 4). Virgin Run Lake is a

PHOTOGRAPH 1 View, looking south, at Virgin Run Lake and watershed.

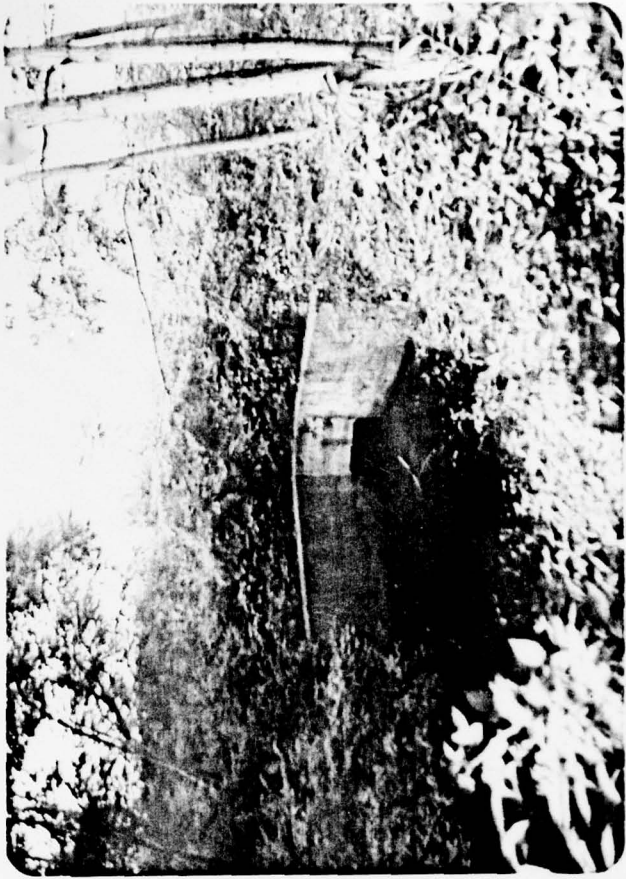
6

b) Outlet Works. The outlet works consist of a reinforced concrete riser (see Figure 4 and Photograph 4) and 3-foot square horizontal box culvert which discharges at the downstream embankment toe (see Photograph 6). Flow through the outlet is controlled via removable stop logs set in grooves within the riser (see Photograph 5).

2. Outlet Works. The outlet works at Virgin Run Dam is in excellent condition. No signs of deterioration were observed on any of the visible exposed concrete surfaces, including a large portion of the interior of the control tower riser (see Photographs 4 and 5). The stop logs were in place although exhibiting some leakage. The 3-foot square discharge culvert could not be entered, however, due to tailwater and discharge through the stop logs (see Photograph 6).

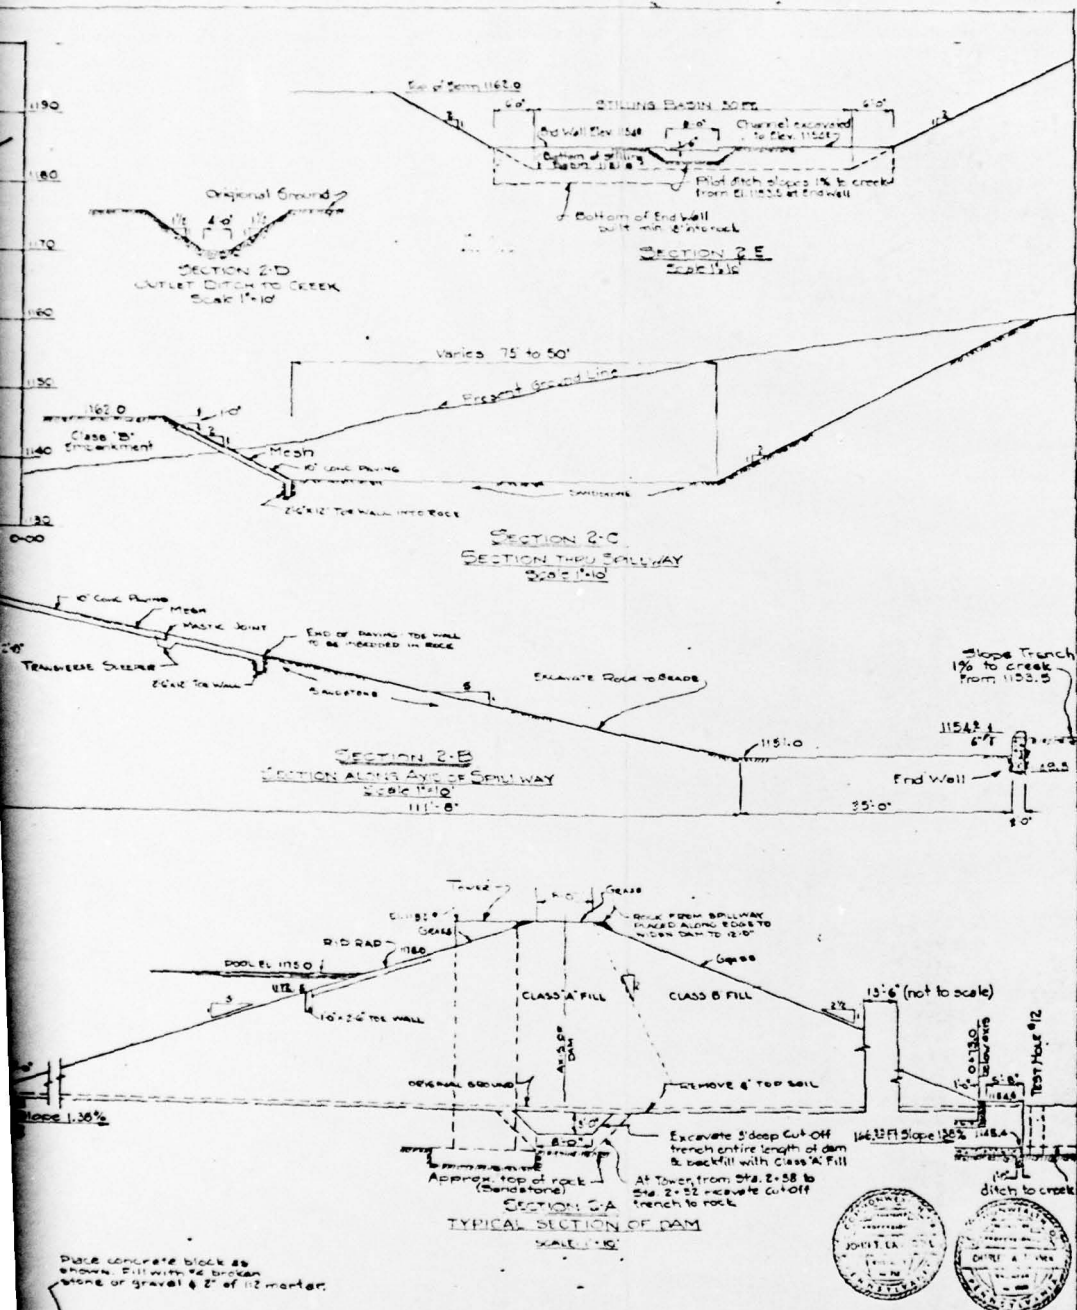
FIGURE 3 2351-2

The dam is 10 feet wide at the crest and has slopes of roughly 3H:1V upstream and 2.5H:1V downstream. Field measurements indicate that additional material was placed along the crest, increasing the top width from the design 8 feet and locally steepening the upper portions of both the upstream and downstream embankment slopes. The upstream face is protected from wave action by a layer of hand-placed concrete block riprap, 8 inches thick, resting on a 6-inch layer of gravel or crushed stone. The riprap layer extends 2.5 feet below and 3 feet above normal pool (see Figure 3 and Photograph 4).

$R_h$  = HYDRAULIC RADIUS = FLOW AREA / WETTED PERIMETER  
FLOW AREA  $\approx A_a \approx 1052 \text{ FT}^2$ , LEFT WALL OF  
APPROACH CHANNEL IS ON A 2H TO 1V SS AND  
VARIES TO 0 FT HEIGHT @ THE ENTRANCE  
(FIG 3), RIGHT WALL (RT WW) OF APPROACH  
CHANNEL AVERAGES ABOUT 6 FT IN EFFECTIVE  
HEIGHT (FIG 5), WETTED PERIMETER  $\approx 100 \text{ FT}$   
 $+ 6 \text{ FT} + 11 \text{ FT} \approx 117 \text{ FT} \Rightarrow R_h \approx \frac{1052 \text{ FT}^2}{117 \text{ FT}}$   
 $\Rightarrow R_h \approx 9.0 \text{ FT}$
