LAKE FORECAST DAM

PHASE I INSPECTION REPORT
NATIONAL DAM INSPECTION PROGRAM

AUGUST 1979

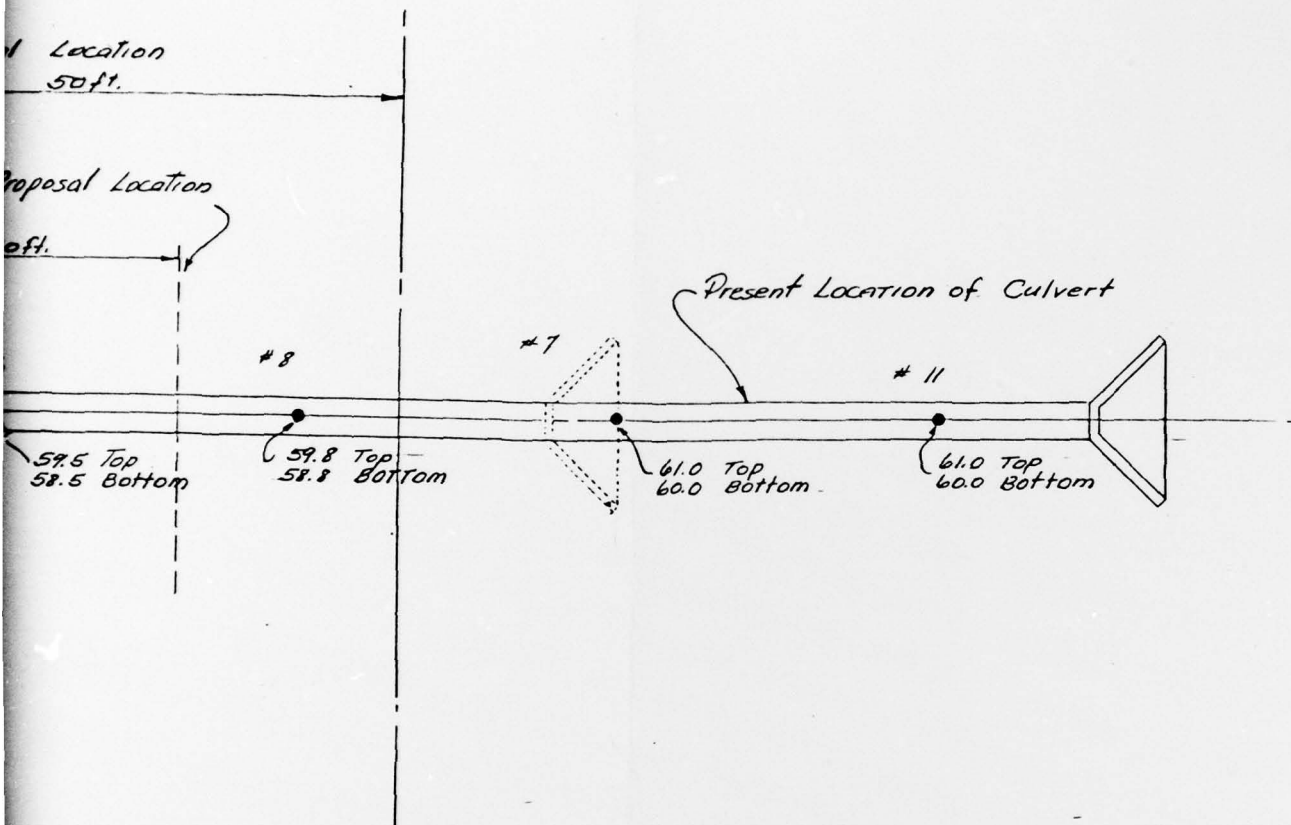
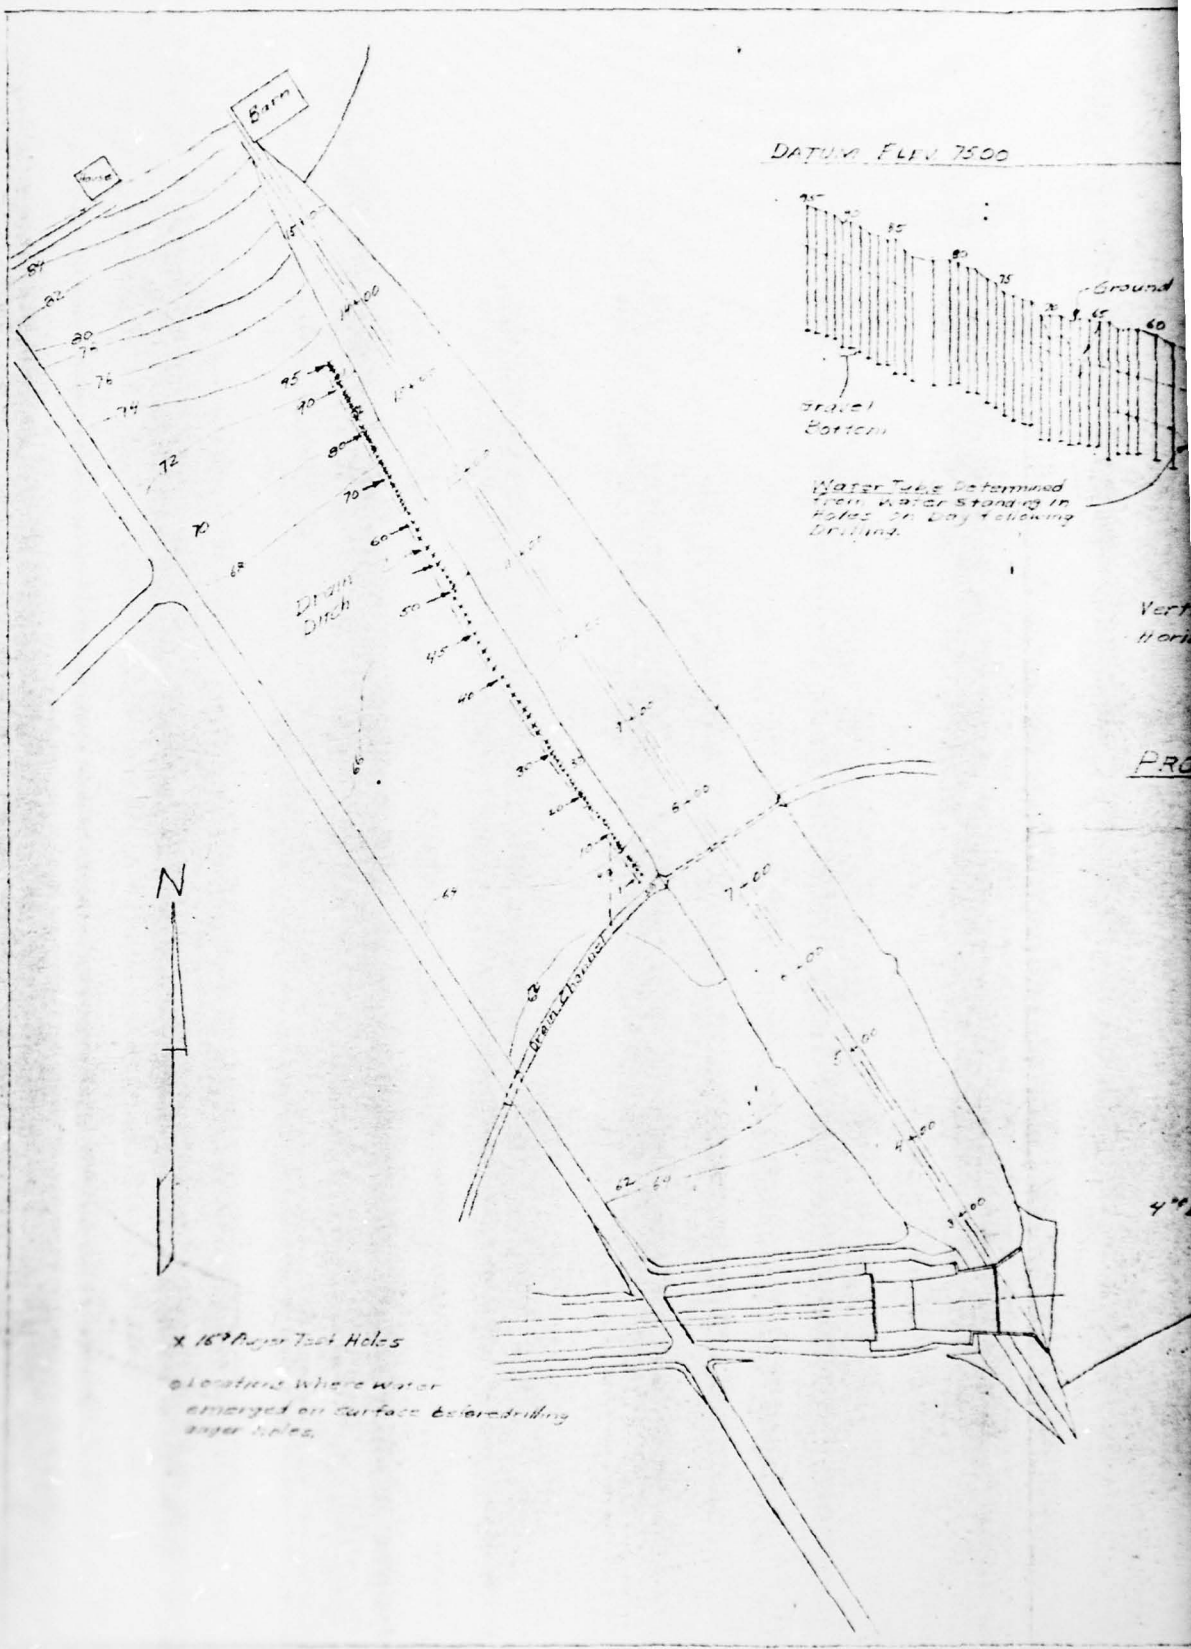
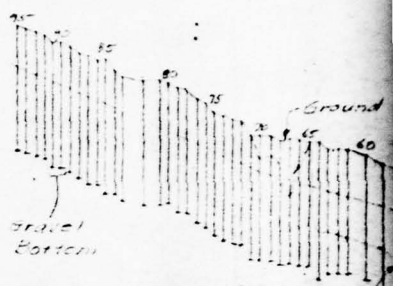
FIGURE 6

3) Plan, locations and descriptions of 11 hand-dug test holes along proposed outlet conduit locations (see Figure 6).

Formation. They also noted that one of the boreholes near the proposed stilling basin showed slight artesian pressure. The investigators presumed that the aquifer involved in the artesian conditions was at the bedrock level where the materials showed tan discoloration. The existence of artesian conditions was reinforced when three sand boils were discovered prior to construction near the proposed toe, and the dam was relocated some 50 feet further upstream (see Figure 6).
