# BRADYS LAKE DAM

## PHASE I INSPECTION REPORT NATIONAL DAM INSPECTION PROGRAM

BRADYS LAKE DAM, MONROE COUNTY  
PENNSYLVANIA

NDS I.D. NO. PA 00782  
DER I.D. NO. 45-8

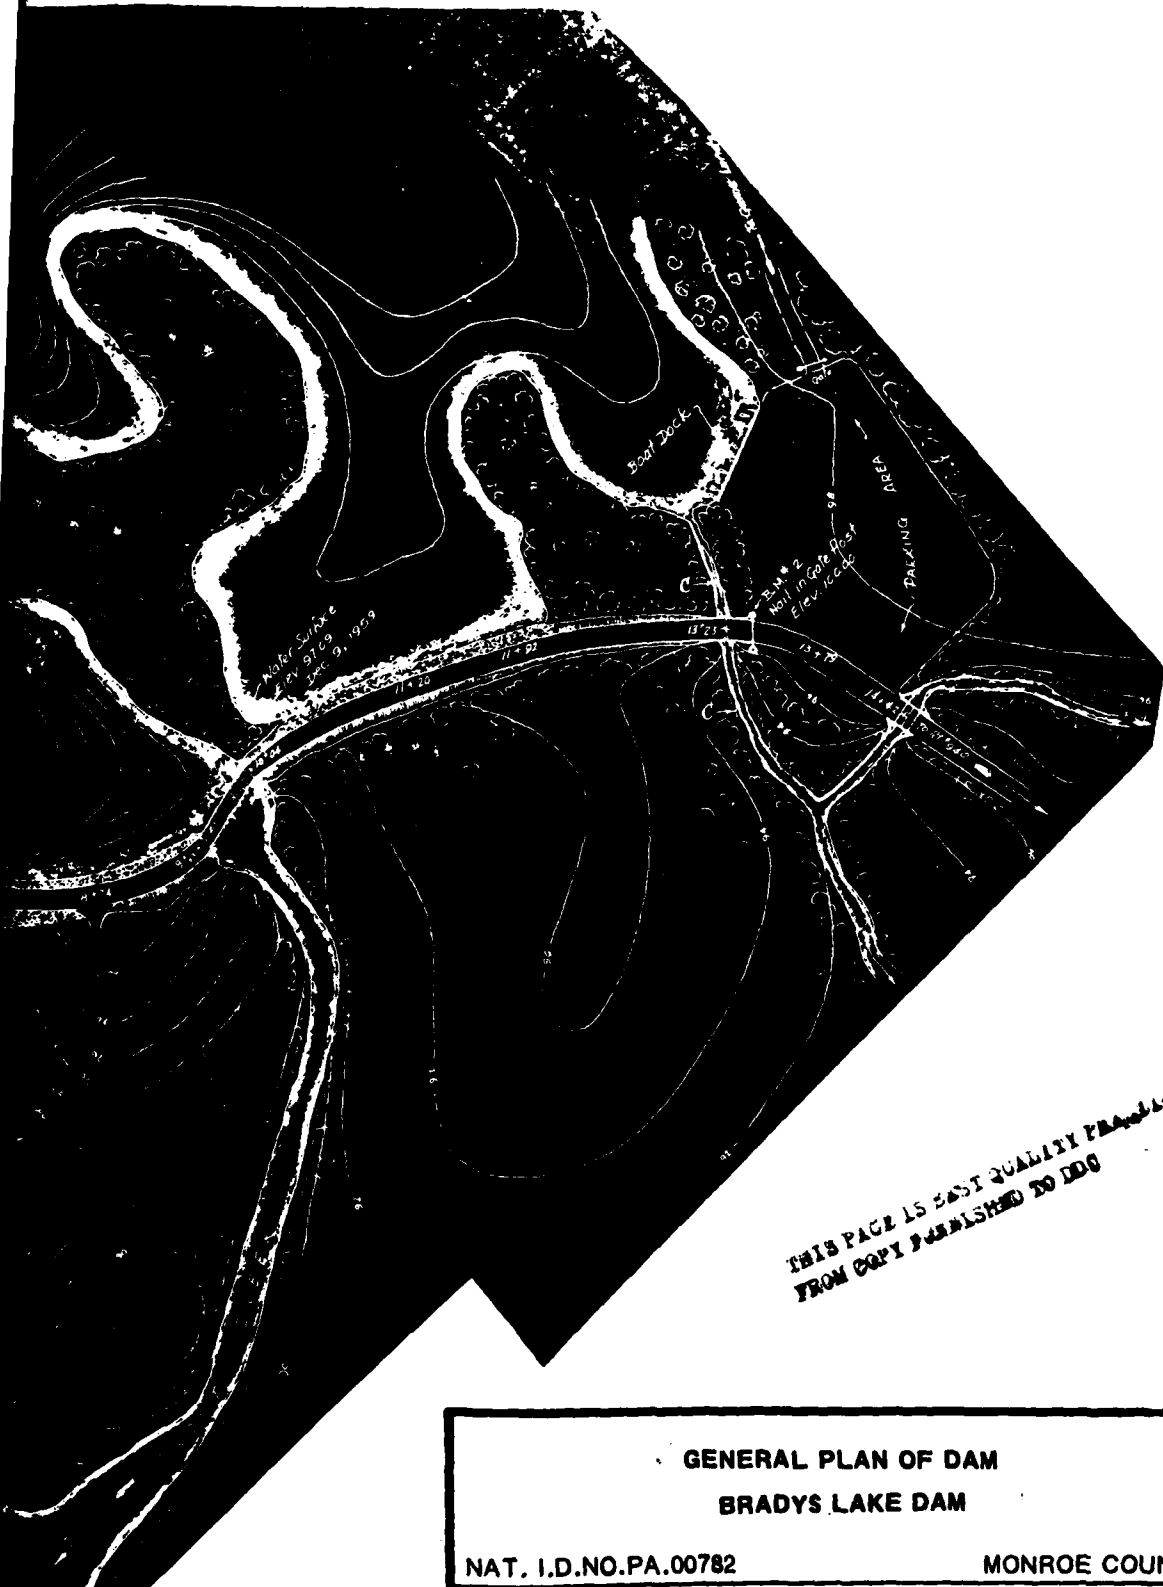
PLATE 2

**GENERAL PLAN OF DAM**  
**BRADYS LAKE DAM**
