MAY 1979

LAKE ALEEDA DAM

(NDI-ID No. V PA-00557)

PHASE I INSPECTION REPORT

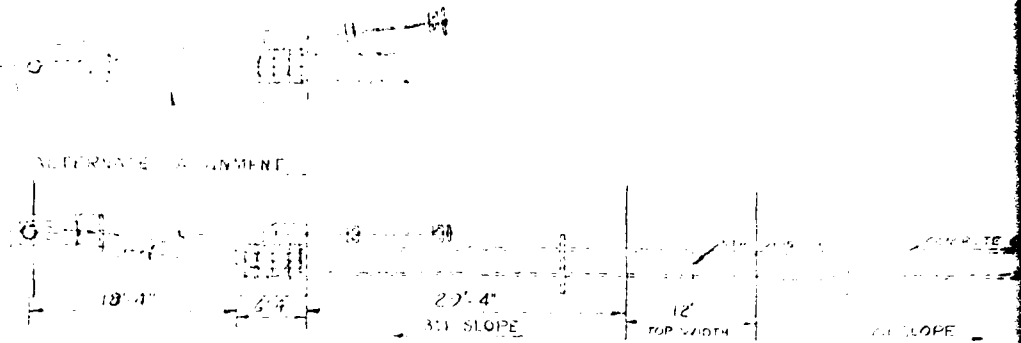
PLAN VIEW OF EMERGENCY  
SPILLWAY  
SCALE 1" = 30'

The width of the auxiliary spillway is not indicated on the design drawings. The auxiliary spillway does not appear to have been constructed entirely in accordance with the design drawings. The design alignment is shown on Plate 3. A plan of the auxiliary spillway, to small scale, is shown on Plate 2. Both these plates indicate that it was the intention of the design to direct the flow away from the toe of the embankment. At present, the potential for flow along the toe of the dam is a serious erosion hazard. The uneven grading in the auxiliary spillway could change the hydraulic control in the auxiliary spillway and cause a reduction in its capacity.
