AN ARCHITECTURAL STUDY OF SOME LOG STRUCTURES IN THE AREA OF TH--ETC(U)

JUL 78 R C CARLISLE, A FERENCI

huntington district  
u. s. army corps of engineers  
September 1978

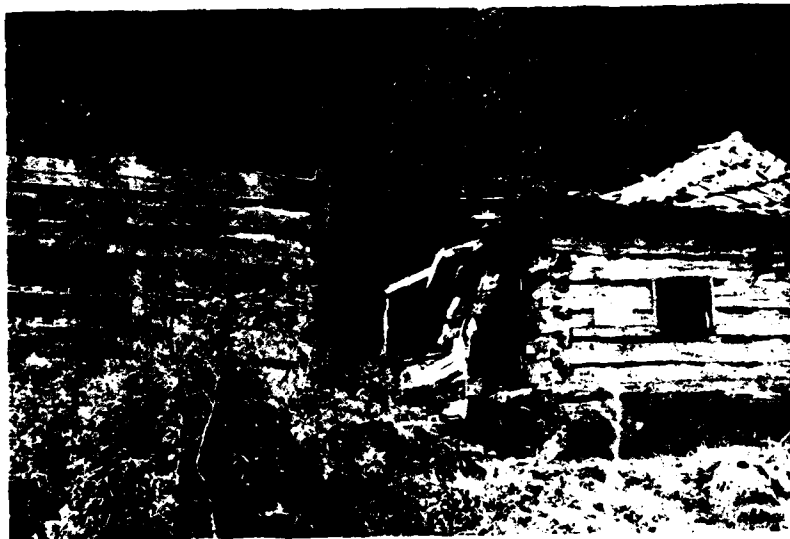
The log dwelling on this tract is an example of a dog trot (or possum trot, turkey trot) log home. The distinguishing architectural characteristics of this type of house (which has both log and frame manifestations) are the use of a floored open hallway between 2 cabins of essentially equal size and construction, the whole of which shares a common roof (Glassie 1969: 88-100). The present structure is a good example, though now much dilapidated, of this architectural type.

Fig. 42: General view of dog trot house on Tract 410. The older of the 2 cabins is probably that on the right of this picture (northwest cabin). Note collapsed shake roof.

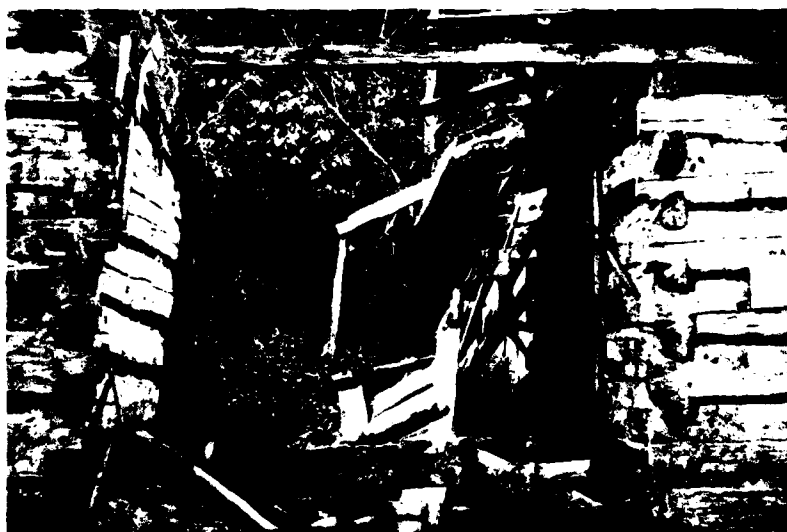
Fig. 43: Detail of dog trot between cabins of dwelling on Tract 410. The dog trot originally was floored. Note notching of logs.

The dog trot is 9'8" wide and covers the intervening space between the 2 cabins. The floor of the dog trot is composed of variable width circular sawed boards which paralleled the adjacent cabin walls. The floor is supported on 5 log floor joists and is ca. 9" above ground surface. There appears to have been a board ceiling which, like the cabin walls, was whitewashed. There is no current evidence of any enclosure or screening of the dog trot.

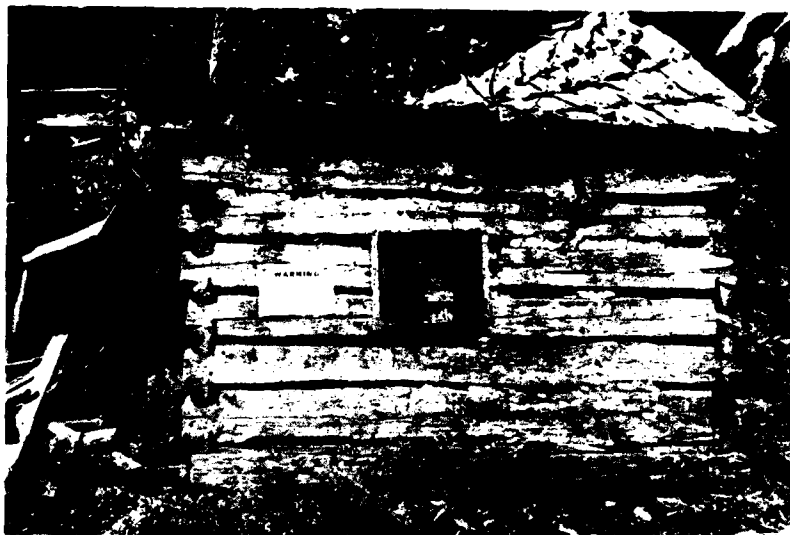
the northeast wall of the cabin is 8'5 1/4". The corners of the sill logs are supported on fieldstone piers ca. 6"-8" high. Note in Fig. 44 that the original height of the cabin may have been somewhat less since the square notched 7th log was originally turned on its side and lay across the diagonally faced eave beams. The height of logs in this wall was probably increased to facilitate roofing with the adjacent cabin. Some of the logs in the northwest face of the northwest cabin show some signs of a prior use. All of the yellow poplar (Liriodendron tulipifera) logs in both cabins are dressed on their interior and exterior surfaces and are decorticated but unworked on superior and inferior faces. The height of individual logs averages ca. 14". The interstices between the logs are closed with a mixture of wooden slats or wedges and common mud chinking. The entire cabin had at one time been whitewashed on its exterior walls.

Fig. 44: Detail of northeast wall of the northwest cabin, Tract 410. Note diagonally faced projecting eave beams and remnants of whitewash.

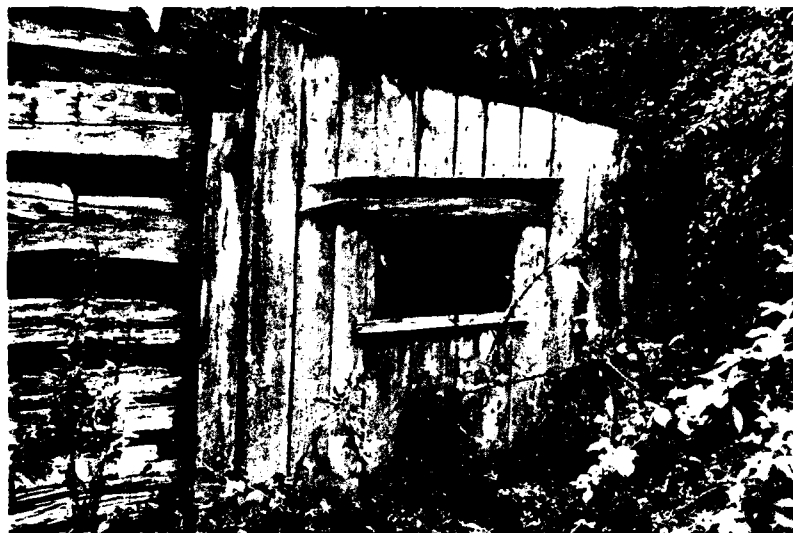
Fig. 46: Detail of frame lean-to (Room 2) on southwest side of the northwest cabin.

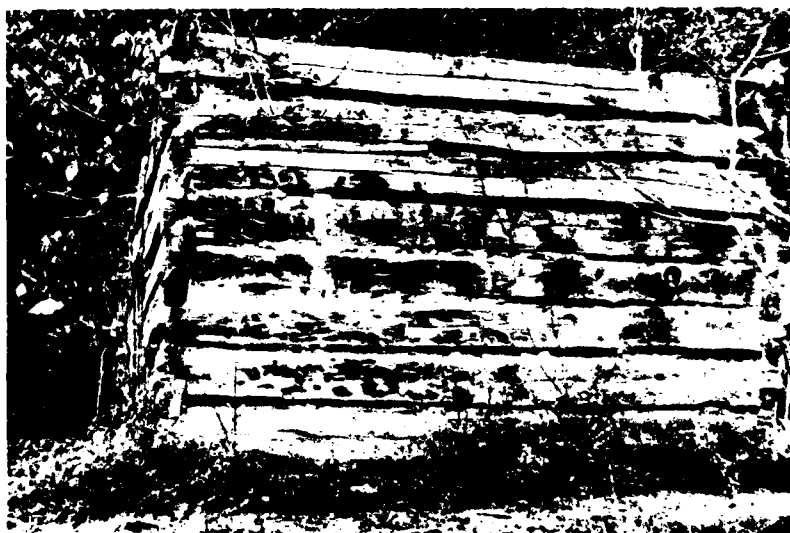
The cabin on the southeast side of the house is of more uniform construction than its counterpart (Fig. 47). Its logs are half dovetail notched and show extensive broadaxing on their exterior faces. The notching quality is functional although not particularly well-executed. The 8 logs

Fig. 47: Northeast wall of southeast cabin, dwelling on Tract 410.

of the northeastern face are all ca. 14"-15" high and are generally decorated but not worked on their superior and inferior faces. Chinking pattern is similar to that described above. Details of the now collapsed and partially disintegrated roof that covered this portion of the house are not available, but in general, the roof construction is similar to that observed above.

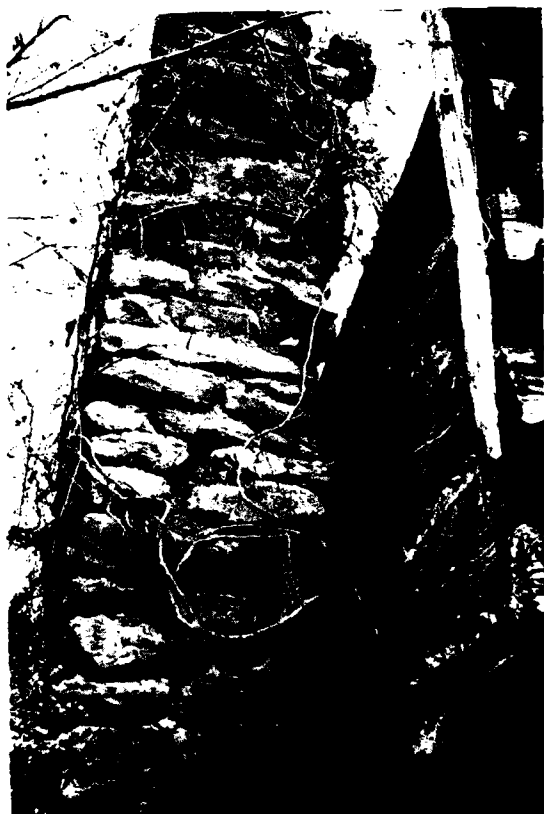
On the southwest wall of the southeast cabin is a large, almost centrally positioned sandstone chimney (Fig. 48) measuring a total of 15'7" in height and laid up with common mud or mud/lime mortar. On either side of the 4'10" wide chimney are 2 diagonally arranged auger holes, the purpose of which is not known.

Fig. 48: Sandstone chimney on southwest side of southeast cabin,  
Tract 410.

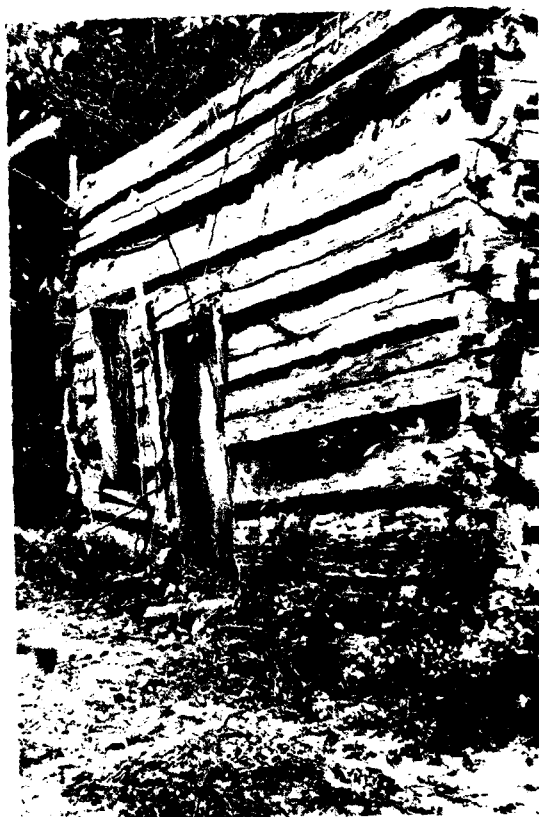
This cabin is entered both from the dog trot and from an exterior door on the southeast wall of the cabin (Fig. 49). Just to the left (ca. 6"-9") of Door 4 are 4 vertically arrayed auger holes ca. 1½"-2" in diameter. These begin 2'3" above the dog trot floor and extend to the top of Door 4 (ca. 6' above the dog trot floor). The function of these is unknown, but they may have once formed or helped to support a partition extending across all or part of the dog trot. This statement, however, is purely hypothetical. Further details on these doors are presented below.

Fig. 49: Southeast wall of southeast cabin, Tract 410. Note Door 5 and Window D.

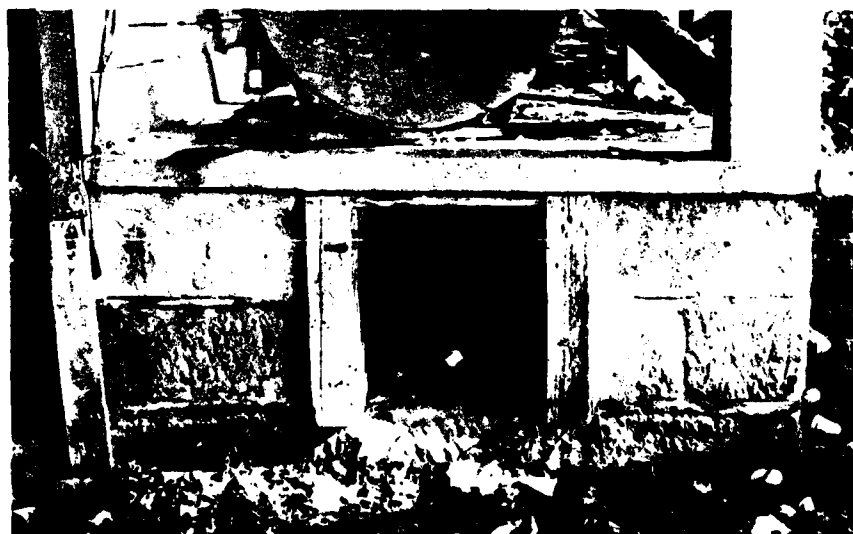
The principal entrance to the building is into Room 1 just off the porch which is constructed of a poured concrete slab overlying a dressed sandstone foundation. An interesting feature of the foundation is that it can be entered through a small doorway on the southwest side (Fig. 53). This area, 5'4" deep, may well have been used either for cold storage or perhaps as a pet pen. To judge from the details of construction, the porch was certainly built at the time of the erection of the extensive frame addition. Another important feature of the porch area is that it is approached by way of a dressed sandstone walkway and horse mount. The 5 large sandstone slabs forming this feature extend for 10'10" beyond the 3 sandstone steps which mount the porch. The steps themselves are 4' in width with a step-up of 6" and a tread width of 1'4". Total vertical rise of the steps to the porch is 2'1".

Fig. 53: Detail of cool box or pet pen beneath porch, Building 1, Tract 411.

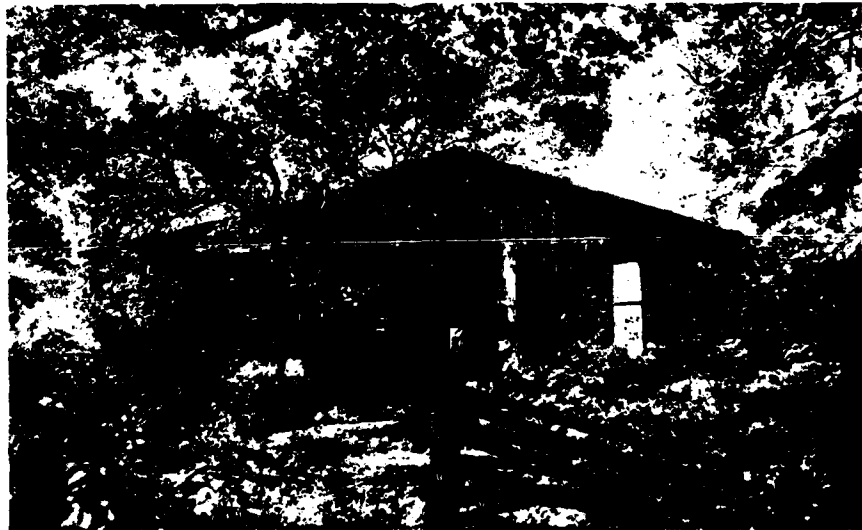
Building 4 is a large (37'x52') general purpose and tobacco barn and is constructed astride a small stream. It is entirely of frame construction and of the 5 buildings in the complex, is the most distant from Building 1 (Fig. 60).

Fig. 59: General view of Building 4, Tract 411. Note runway through short axis of barn to the right. A small stream passes down the hollow and through the opening in the barn walls at left.

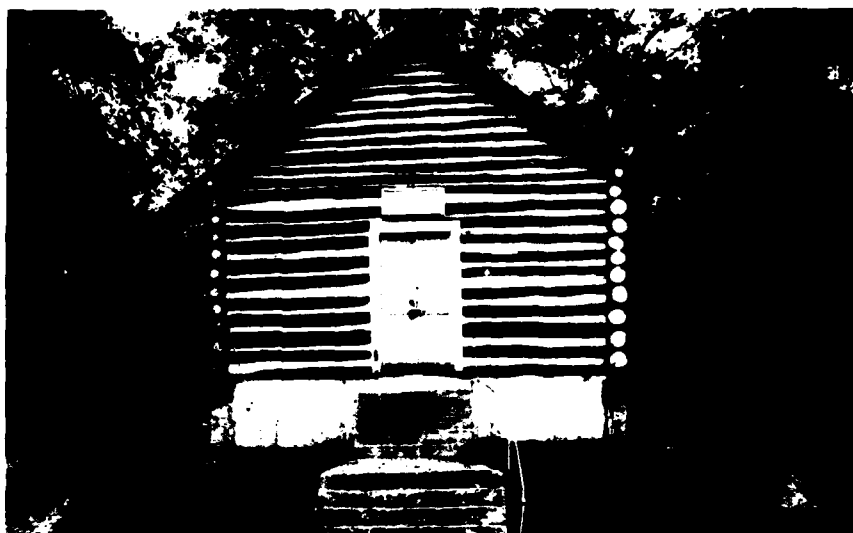
The logs from which the chapel is constructed are decorticated, whole, and exclusively saddle notched. Yellow poplar (Liriodendron tulipifera) appears to have been the wood of choice. Logs vary markedly in their average thickness ranging from 6"-10" and averaging ca. 7"-8". Individual logs demonstrate a pronounced taper from one end to the other. This potential construction limitation was circumvented by stacking the logs in the southwest and northeast walls in opposing taper directions (Fig. 63). Progressively shorter logs rise in both the southeast and northwest walls to form the gables.

Fig. 63: Main entrance on the southeast side of Carter Chapel, Tract 914. Note the difference in diameter of logs at left and right.

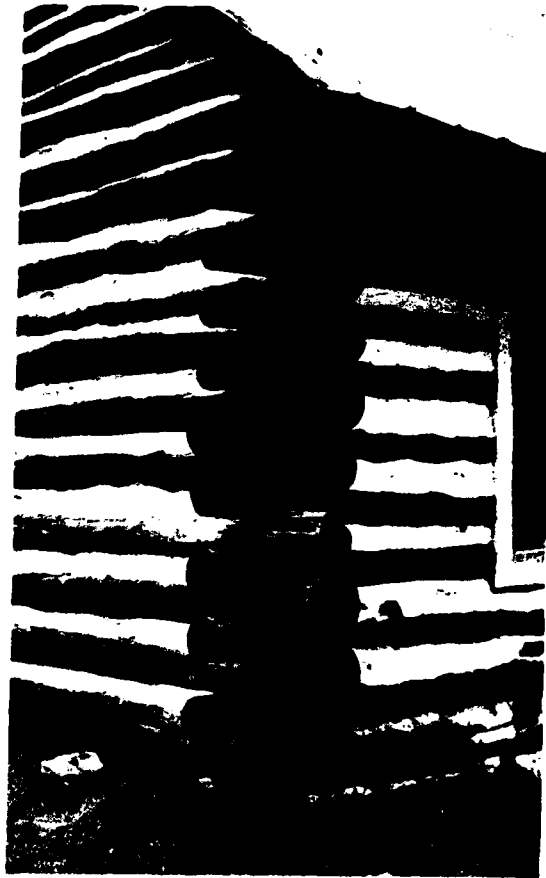
Fig.-67: Detail of saddle notching on logs of Carter Chapel.

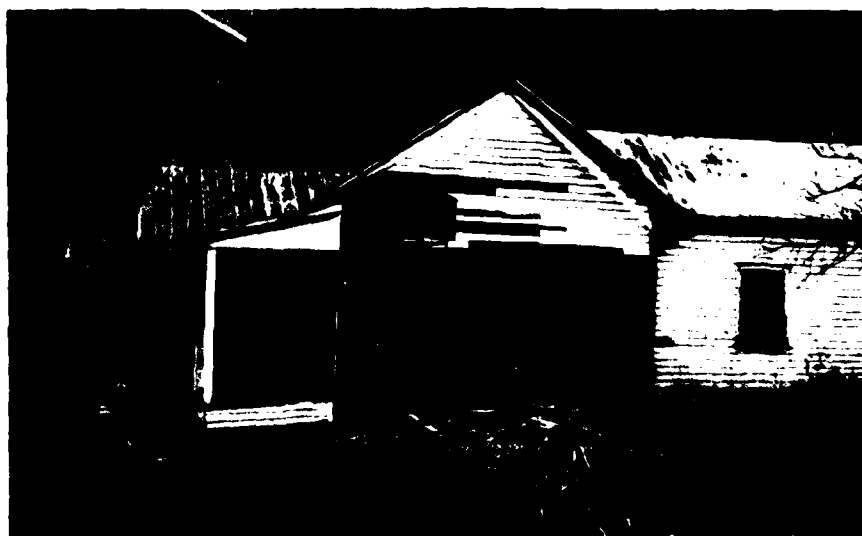
Fig. 74: Detail of log construction northwest wall of Building 1, Tract 921. This is the northeast side of the dwelling and is the main entrance. Logs have been matchmarked for dismantling and later reconstruction.

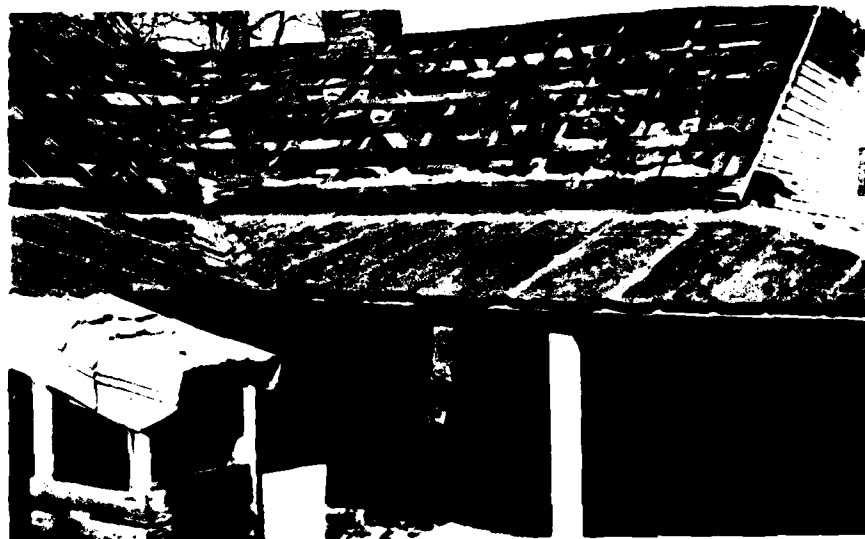
Fig. 77: Detail of porch additions to southwest and southeast walls Building 1, Tract 921. Note frame well head at left.

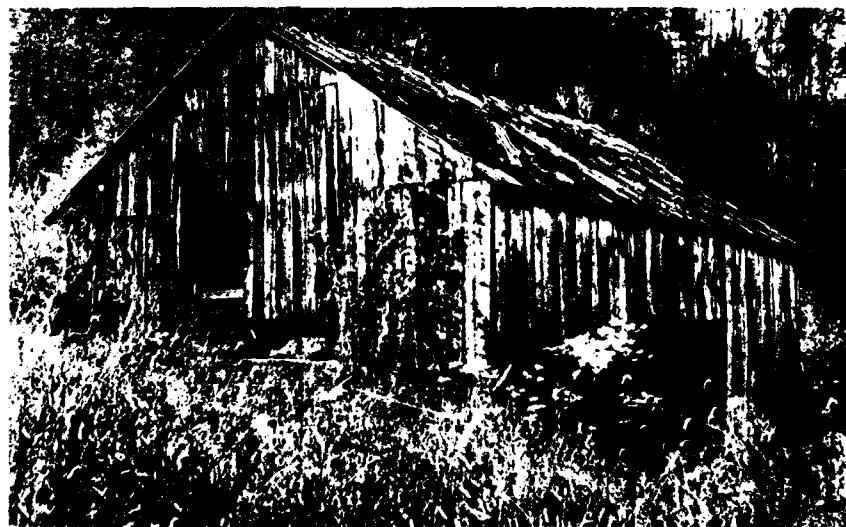
Fig. 81: General view of combination frame and log barn, Building 2, Tract 921 northeast and southeast walls. Note logs in southeast wall.

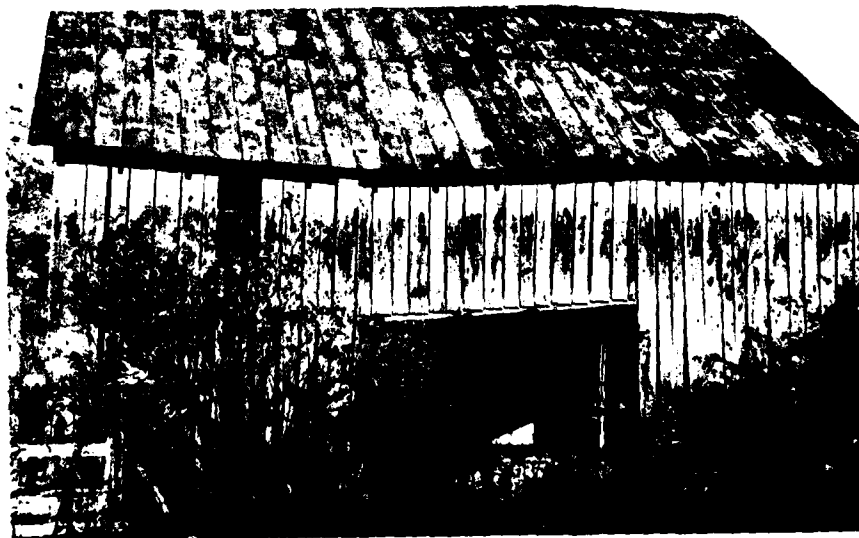
Fig. 83: General view of southwest wall of Building 2, Tract 921. Note runway and use of board rafters.

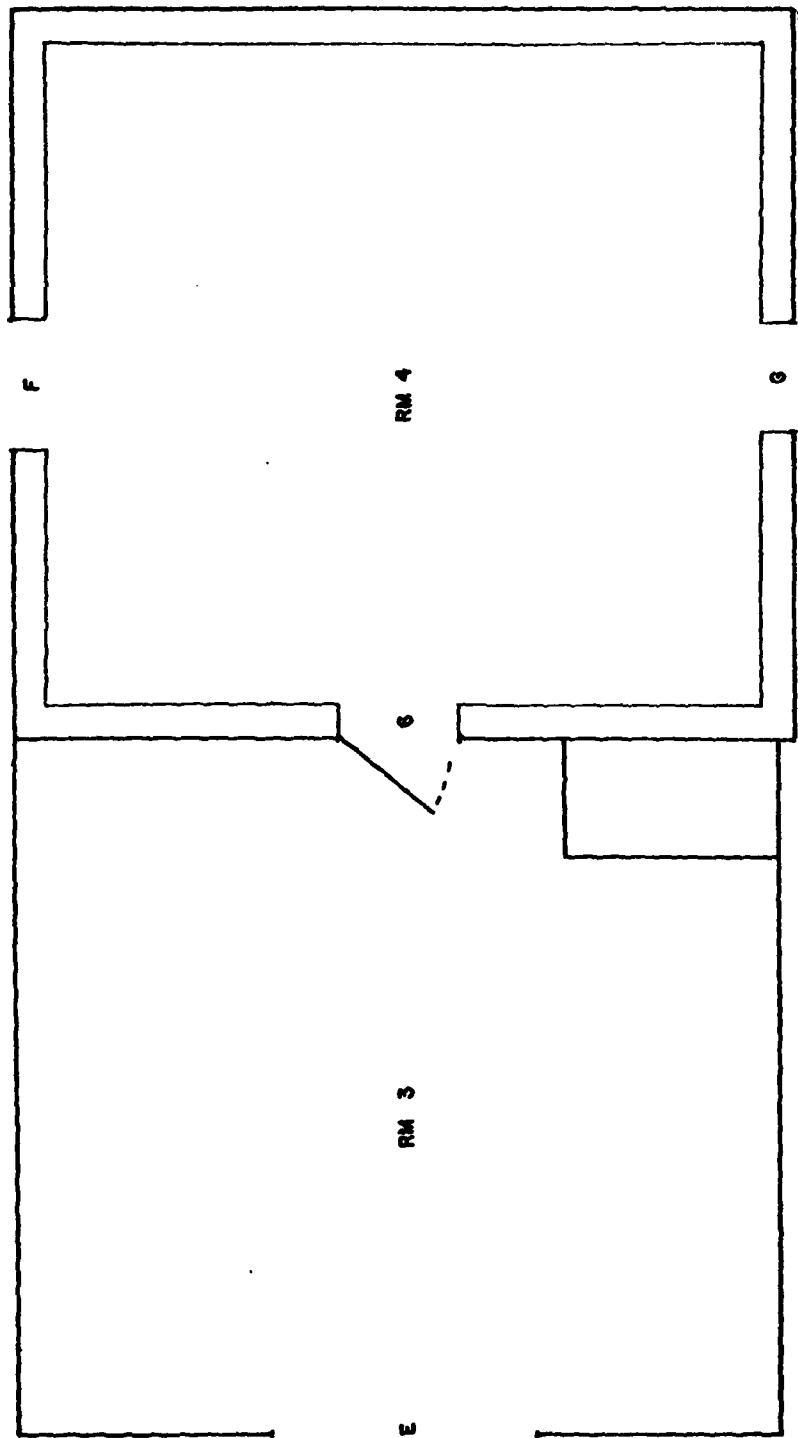
Fig. 89: Floor plan of Rooms 3 and 4, dwelling on Tract 1014.

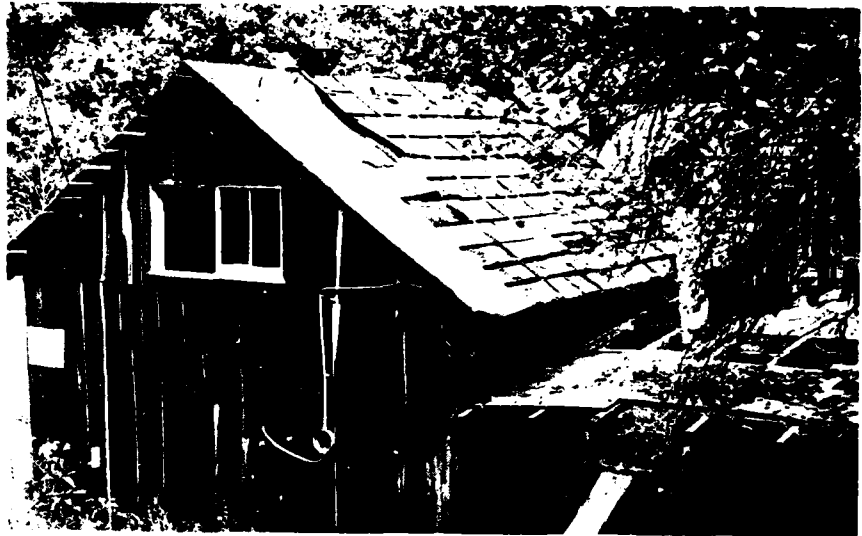
The structure on this tract is currently reached by foot along a poorly maintained gravel and dirt road from the south. The frame addition on the southwest side of the structure is first encountered as one approaches the dwelling (Fig. 90). The main entrance of the log portion of the structure is on the northeast, facing Horse Picture Branch (Fig. 91). The log section is nearly square measuring 16' across the northeast wall and 15'4" along the southeast wall.

Fig. 90: Southwest side of log and frame dwelling on Tract 1014 as it is approached. In the right foreground is a concrete block cool cellar and well cover.

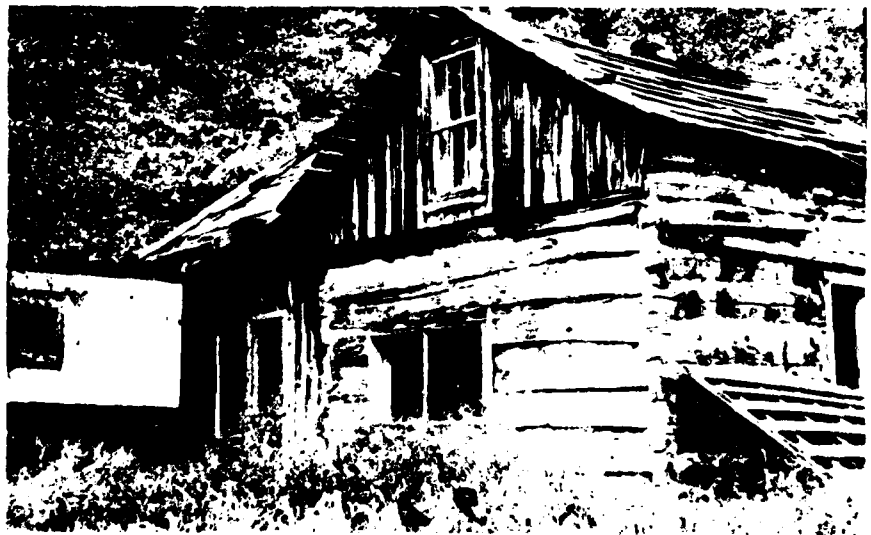
The southeast wall of the structure is similar in most details to those walls described above. Note, however, that a large section of the log portion of the wall was removed for the addition of Window A (Fig. 93). Moreover only 8 logs are used in this wall of the structure, and the gable is composed of circular sawed milled lumber applied vertically with common wire nails (cf. northwest wall). The rake of the roof is again formed by a projection of the underlayment boards.

Fig. 93: Southeast wall of log portion of dwelling on Tract 1014. Contrast gable construction with that on opposing wall.

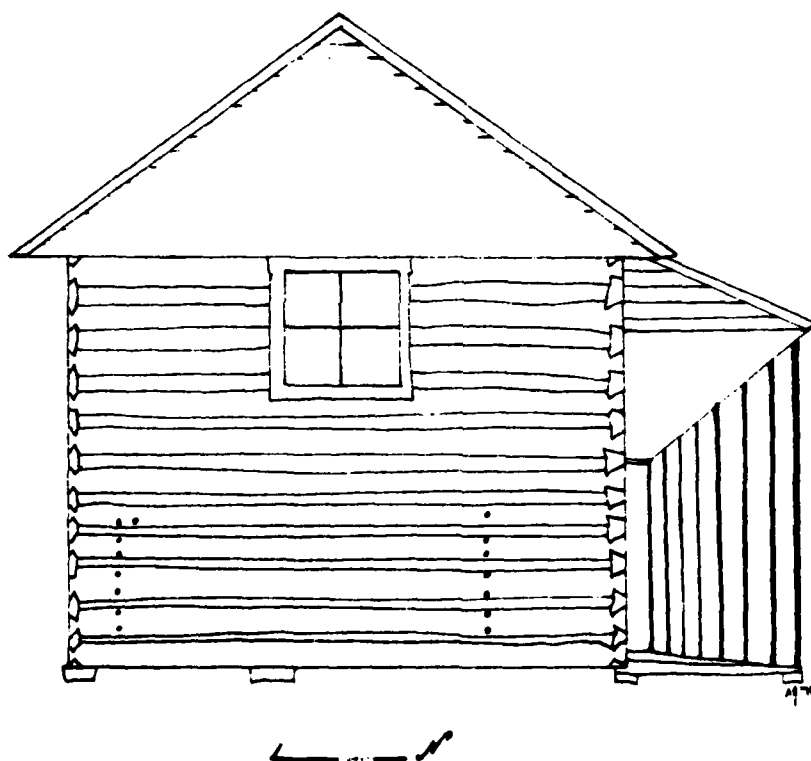
Fig. 96: Drawing of western face of western cabin Horton/Kitchen home showing detail of auger holes in this side of the building.

An interesting architectural feature is found on the western wall of the western cabin and the north wall of the eastern cabin. This consists of a series of 1 1/4" diameter auger holes symmetrically arranged (usually 4 per log) (see Figs. 96,102-104). The purpose of these is not known, but a number of them contain the remnants of white oak (*Quercus* sp.) dowels or tenons which perhaps were once employed to "tie in" a lean-to on each side of the building. The lean-to on the north wall may have rested on the porch floor which ran the length of the house. There is no current trace of the kitchen wing once known to have intersected the north wall of the structure.

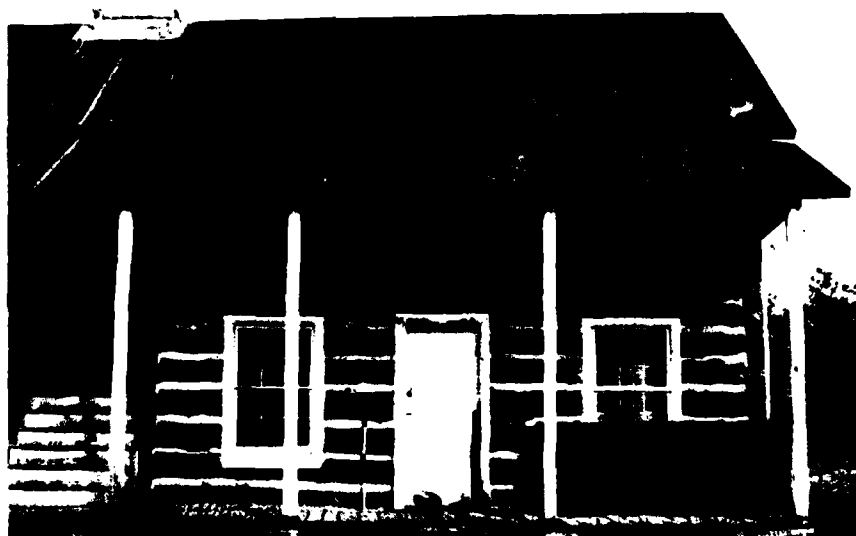
Fig. 100: Detail, south face of eastern cabin of the Horton/Kitchen home. Note porch flooring and roof supports.

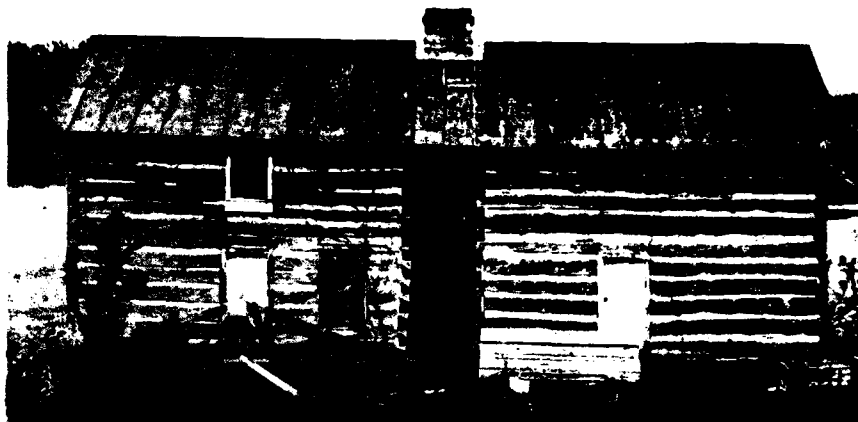
Fig. 101: Current north face of saddlebag Horton/Kitchen home. The space between the 2 cabins was once used for storage and a porch ran the length of the building.

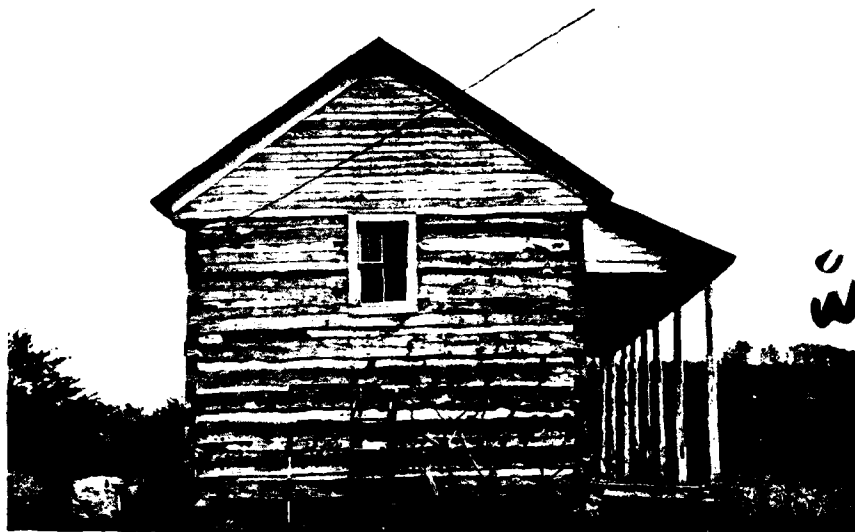
Fig.104: Western side of western cabin Horton/Kitchen home. Note  
 auger holes at left. Compare with Fig. 96 above.
