PHASE I REPORT  
NATIONAL DAM INSPECTION PROGRAM.

NAME OF DAM: Milburn Spring Dam  
 STATE LOCATED: Pennsylvania  
 COUNTY LOCATED: Bedford  
 STREAM: Unnamed tributary of Cumberland Valley Run  
 SIZE CLASSIFICATION: Small  
 HAZARD CLASSIFICATION: High  
 OWNER: Borough of Bedford  
 DATE OF INSPECTION: November 19 and December 12, 1979

(NLI ID Number P1 0023,  
 DEF ID Number 57)  
 Susquehanna River Basin, Unnamed  
 Tributaries of Cumberland Valley  
 Run, Bedford County  
 Pennsylvania, Phase I  
 Inspection Report

PHASE I REPORT  
NATIONAL DAM INSPECTION PROGRAM  
MILBURN SPRING DAM  
NDI I.D. PA-239  
DER I.D. 5-7

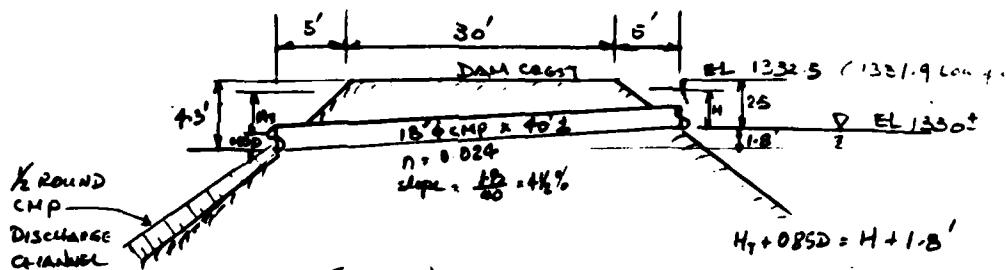
SECTION @ SPILLWAY  
(NOV 19 1979 SURVEY).

THE SPILLWAY OF THE DAM CONSISTS OF AN 18"  $\phi$  CMP OVERFLOW PIPE AS SHOWN BELOW.

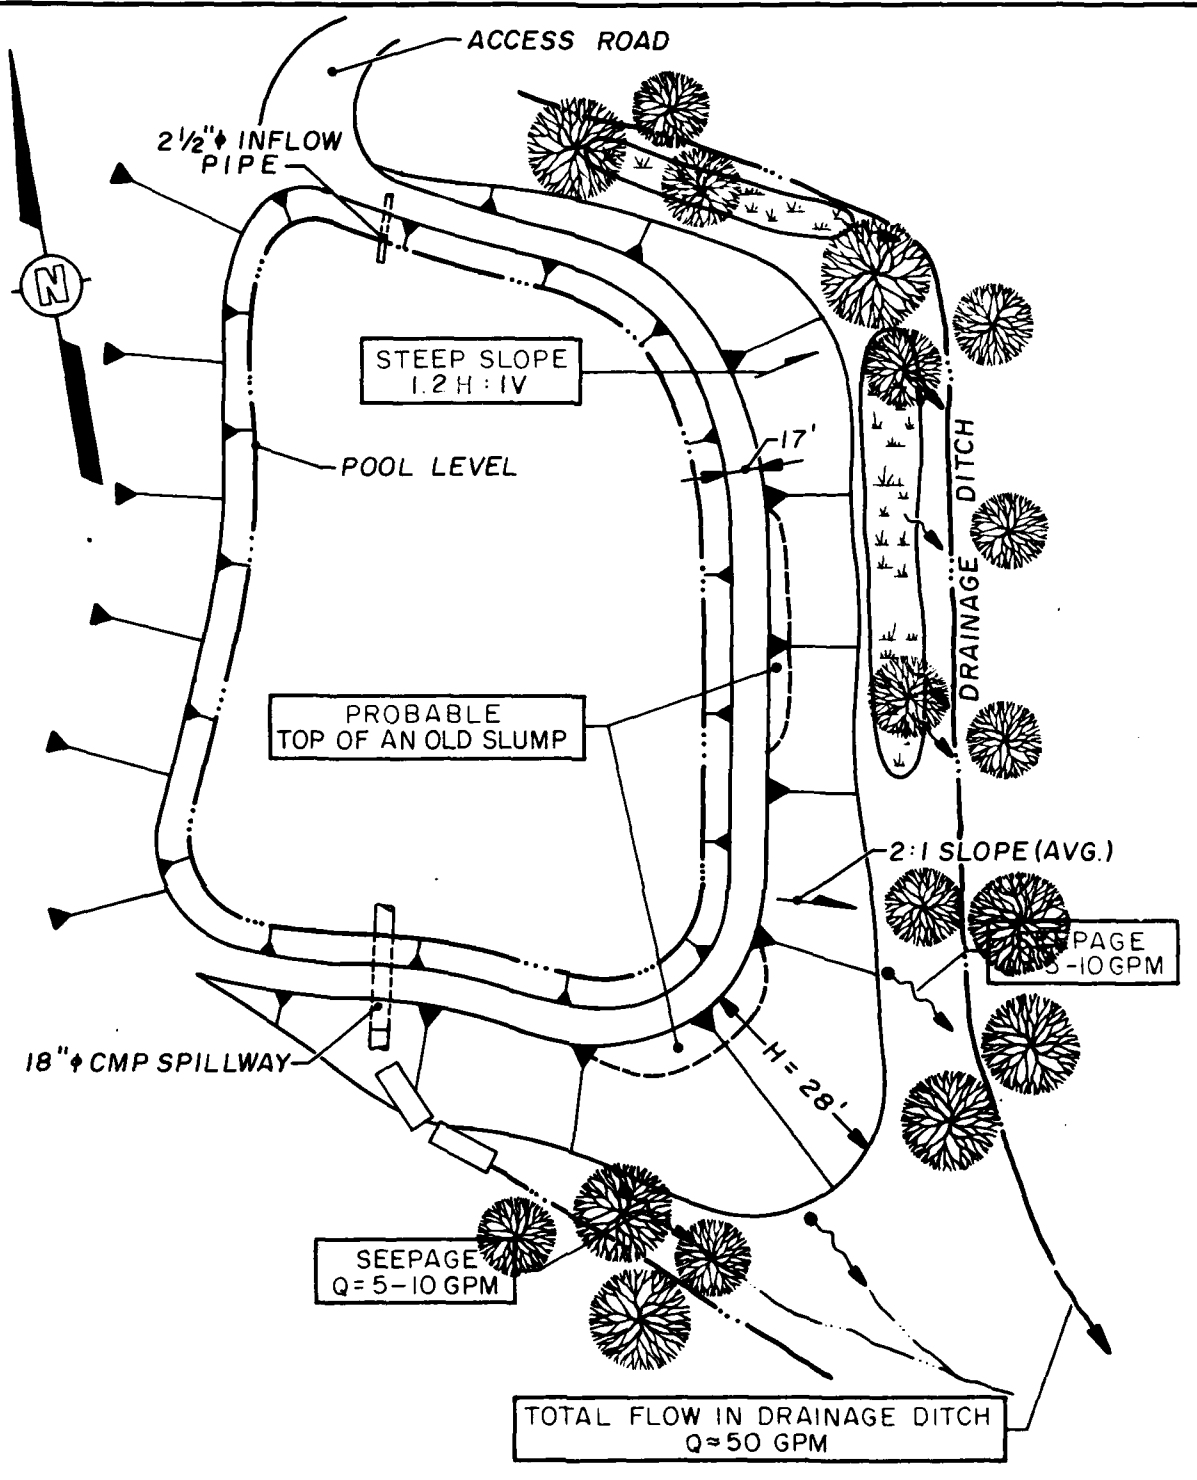
1. POOL LEVEL DATE OF INSPECTION:  
0.2 FT. ABOVE SPILLWAY PIPE  
INVERT
2. SEE PLATE 3 FOR INLET AND  
OUTLET PIPE LOCATIONS.
