LEHIGH RIVER BASIN,  
POHOPOCO CREEK, PENNSYLVANIA .

BELTZVILLE LAKE.

CONDITION REPORT.  
DAM, OUTLET WORKS & SPILLWAY  
PERIODIC INSPECTION REPORT, NO. 1,

JULY 1970.

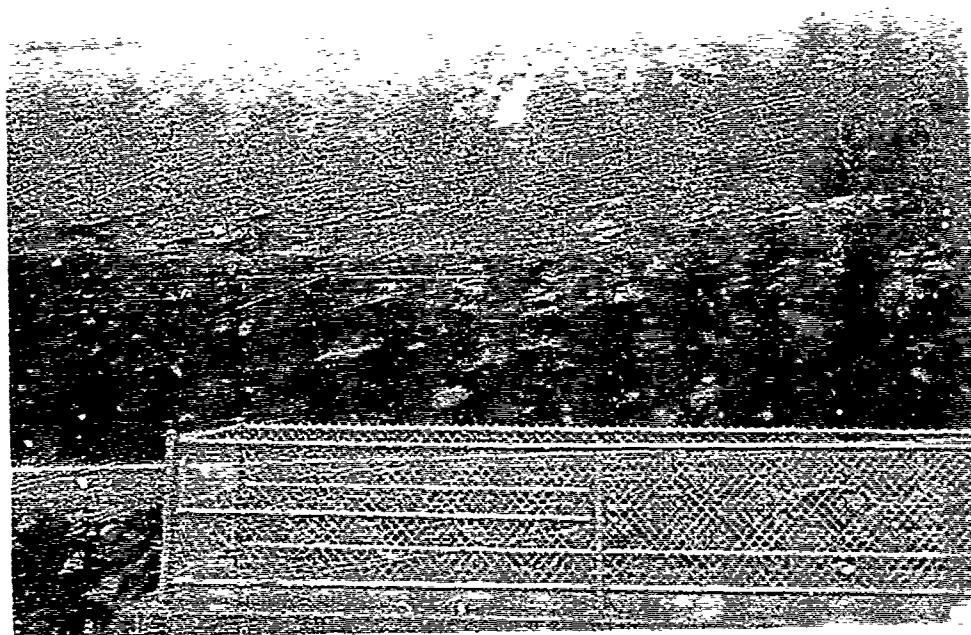
(3) Outlet works area: Photographs 6, 7 and 8 show areas of possible future erosion problems and were taken for comparison purposes only. Captions identify the area.

Photo No. 8      Eroding of overburden down to  
bedrock - right bank above  
outlet works.
