**DEVELOPMENT OF A PAVEMENT MAINTENANCE  
MANAGEMENT SYSTEM  
VOLUME VI: M&R GUIDELINES --  
VALIDATION AND FIELD APPLICATIONS**

**MOHAMED Y. SHAHIN  
CONSTRUCTION ENGINEERING RESEARCH LABORATORY  
CHAMPAIGN, ILLINOIS 61820**

**DECEMBER 1979  
INTERIM REPORT  
SEPTEMBER 1977 - JULY 1979**

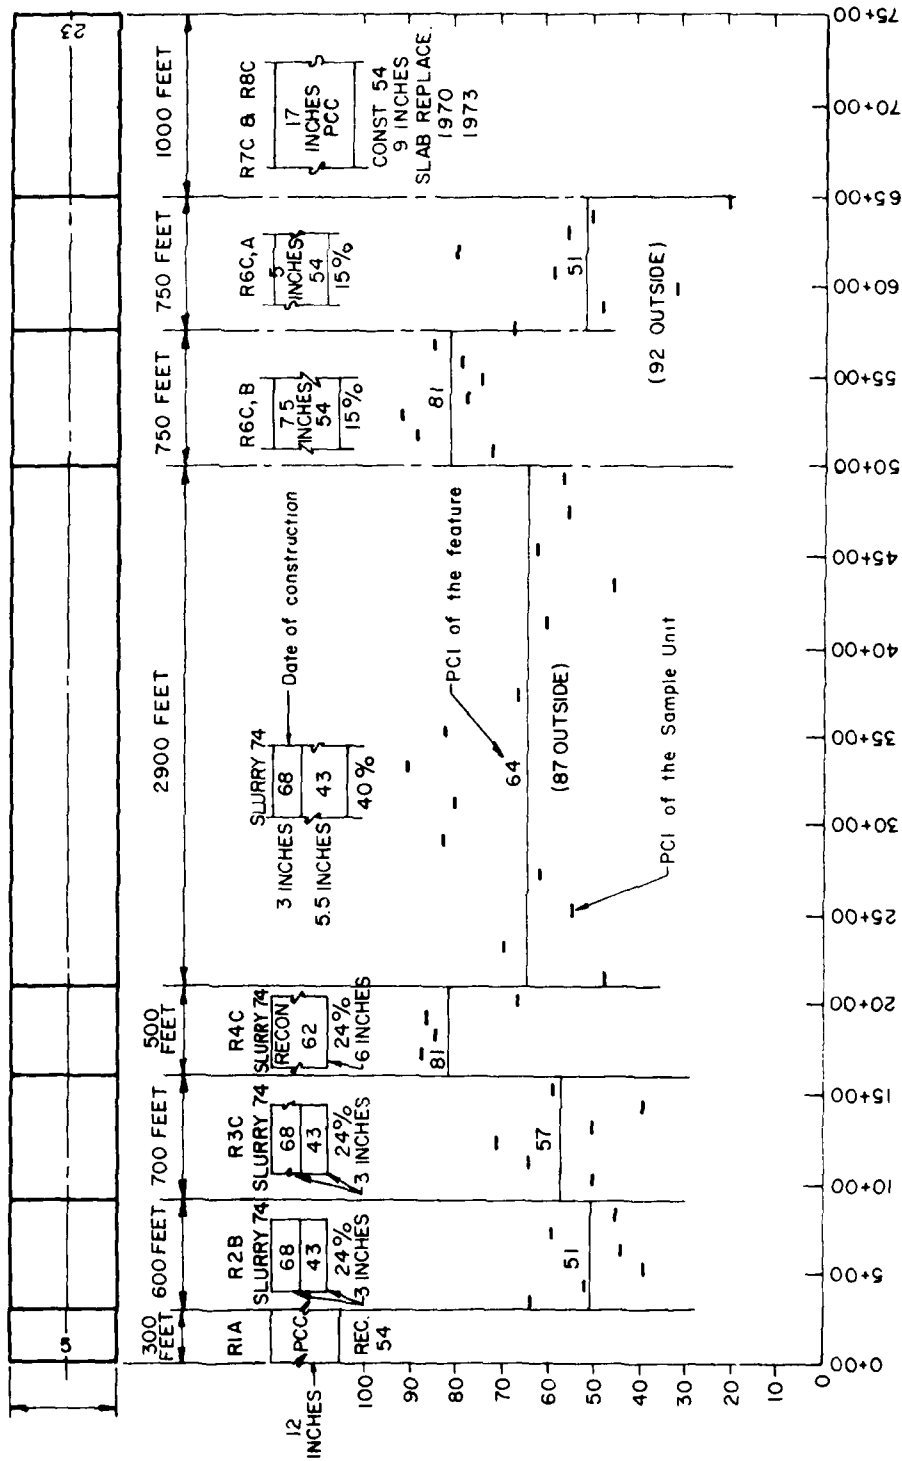
Figure 20. Construction History of Entire Runway and PCI Profile for Central 75 Feet.

Sample units were alternately surveyed and skipped throughout the entire length of the central 75 feet of the AC runway portion. Each sample unit was 50 feet long. Figure 20 is a plot of the PCI along the runway. Table 6 summarizes the estimated distress found in each pavement feature (extrapolated based on the number of sample units surveyed) and the corresponding deduct values. Figures 21 through 25 are representative photographs of different pavement features in the runway.

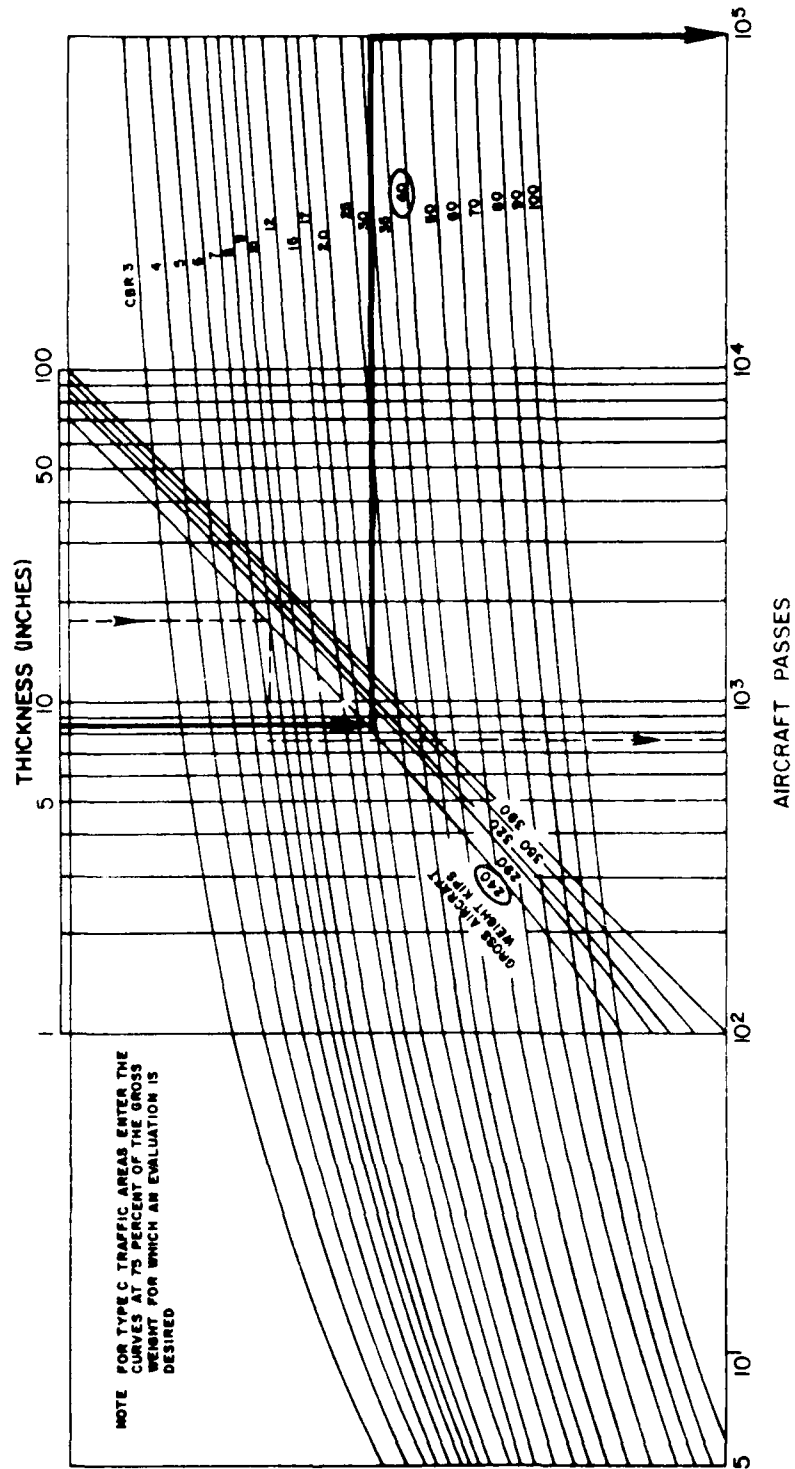
Figure 29. Load-Carrying Capacity Evaluation for Feature R5C.

A similar evaluation was performed for feature R5C (Figure 27). It should be noted that the load-carrying capacity (Figure 29) was not determined to be deficient (item 5, Figure 27); however, load-associated distress caused 53 percent of the total deduct value (item 4a). In addition, it should be noted that there is localized random variation (item 2a). The lowest sample unit PCI value for the feature is 42, which is lower than the sample unit critical minimum PCI value of 48 determined from Figure 4 for a mean PCI of 54.

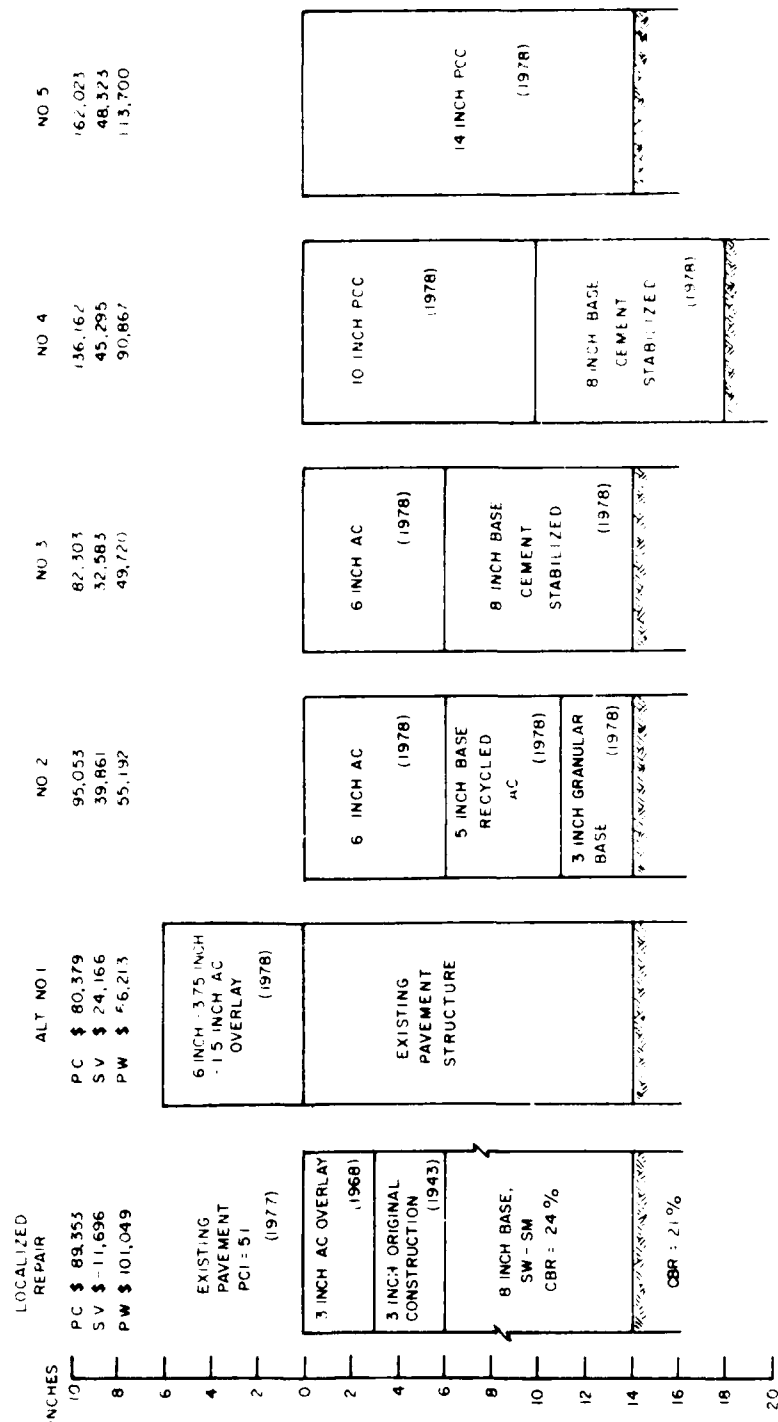
Figure 30. Repair Alternatives for Feature R2R.

Feature R2B (Figure 26) has a PCI of 51 and therefore a "fair" rating. No localized or systematic variation was observed. The long-term rate of deterioration was determined from Figure 8 to be normal, based on a PCI of 51 after 10 years since overlay. The load-associated distress caused 74 percent of the total deduct value. Also, using Airfield Pavement Evaluation Curves (Figure 28), the load-carrying capacity was determined to be deficient for C-141 aircraft. The estimated number of aircraft passes to failure was 50, and the pavement had already been subjected to much more than that.

Alternative 1:

Overlay the entire feature with AC. The cross-section of the overlay will be as shown below. Localized repair, e.g., full-depth patching, must be performed before overlaying.

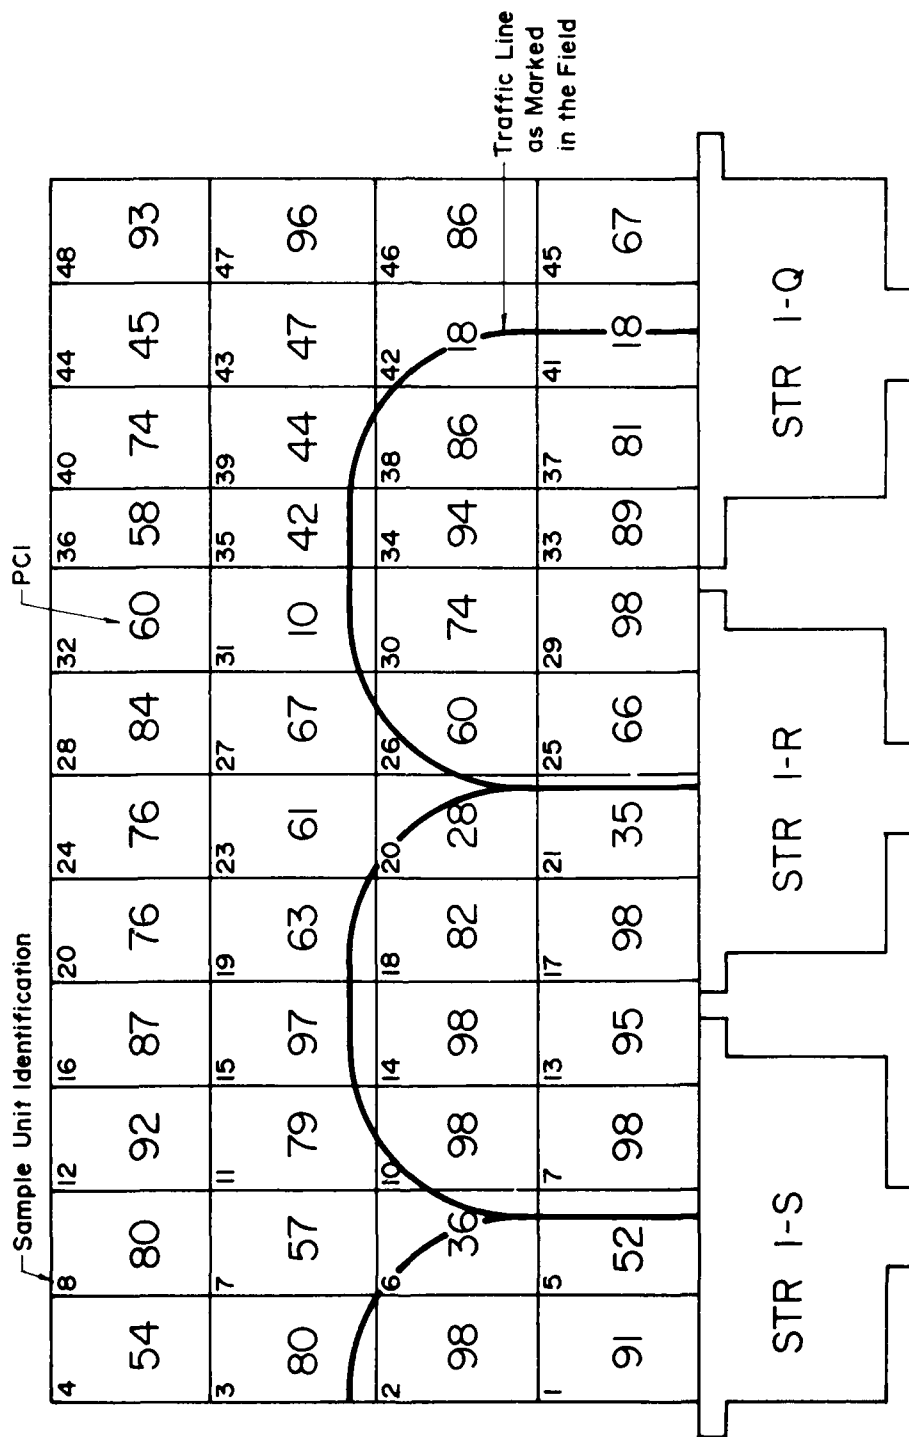
Figure 39. PCI for Individual Sample Units.

The apron was surveyed in March 1978 by the base engineer, command engineer, and project staff to determine the optimum repair alternative. The feature consisted of 48 sample units, each of which was surveyed and the PCI determined (see Figure 39). Each sample unit consisted of 24 slabs, except sample units 33 through 36, which each contained 18 slabs. The slab size was 12 1/2 x 15 feet. Each sample unit was surveyed individually because after surveying several of the sample units at random, it was found that the PCI ranged from 10 to 98; thus, the standard deviation was very high. Therefore, it was decided that each slab should be surveyed to have accurate information for analyzing various M&R alternatives. Table 11 summarizes distress types, severities, and quantities for the feature.

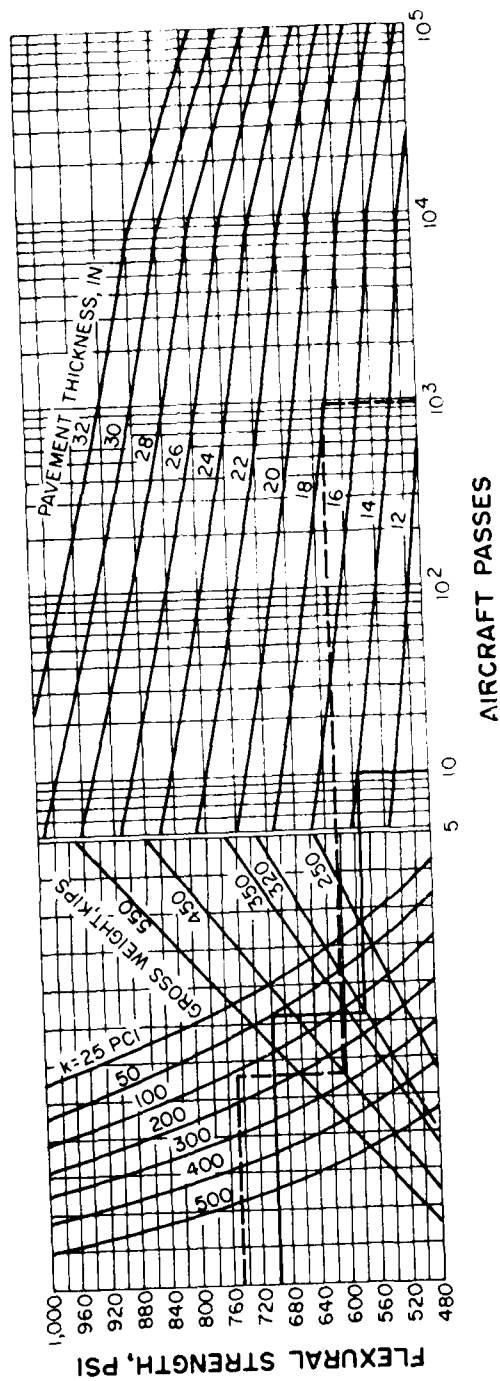
Figure 45. Load-Carrying Capacity Evaluation for Concrete Apron.

By substituting into Equation 7,  $h_n$  is computed to be 14 inches. As shown in Figure 45, the number of load repetitions until cracking is determined to be 10. Therefore, the load-carrying capacity was classified as deficient.
