DELAWARE RIVER BASIN

SCS PA 477  
BERKS COUNTY, PENNSYLVANIA

NDS I.D. NO. PA 00720  
DER I.D. NO. 6-457

PHASE I INSPECTION REPORT  
NATIONAL DAM INSPECTION PROGRAM

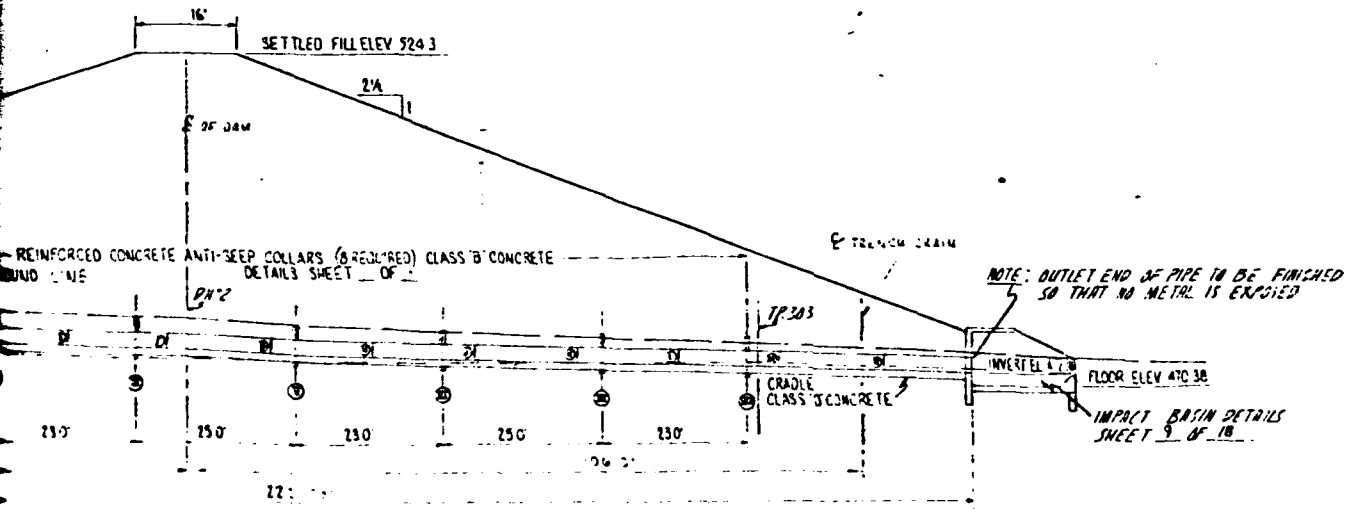
PROFILE OF PRINCIPAL SPILLWAY  
NOT TO SCALE

NOTE: THIS NUMBER IS 512.8 ON THE DESIGN DRAWING AND ON PLATE 7
