**WANGAUM FALLS DAM**

Number  
NDI NO. PA-00141  
Number  
DER NO. 64-102

**PHASE I INSPECTION REPORT.**

**NATIONAL DAM INSPECTION PROGRAM.**

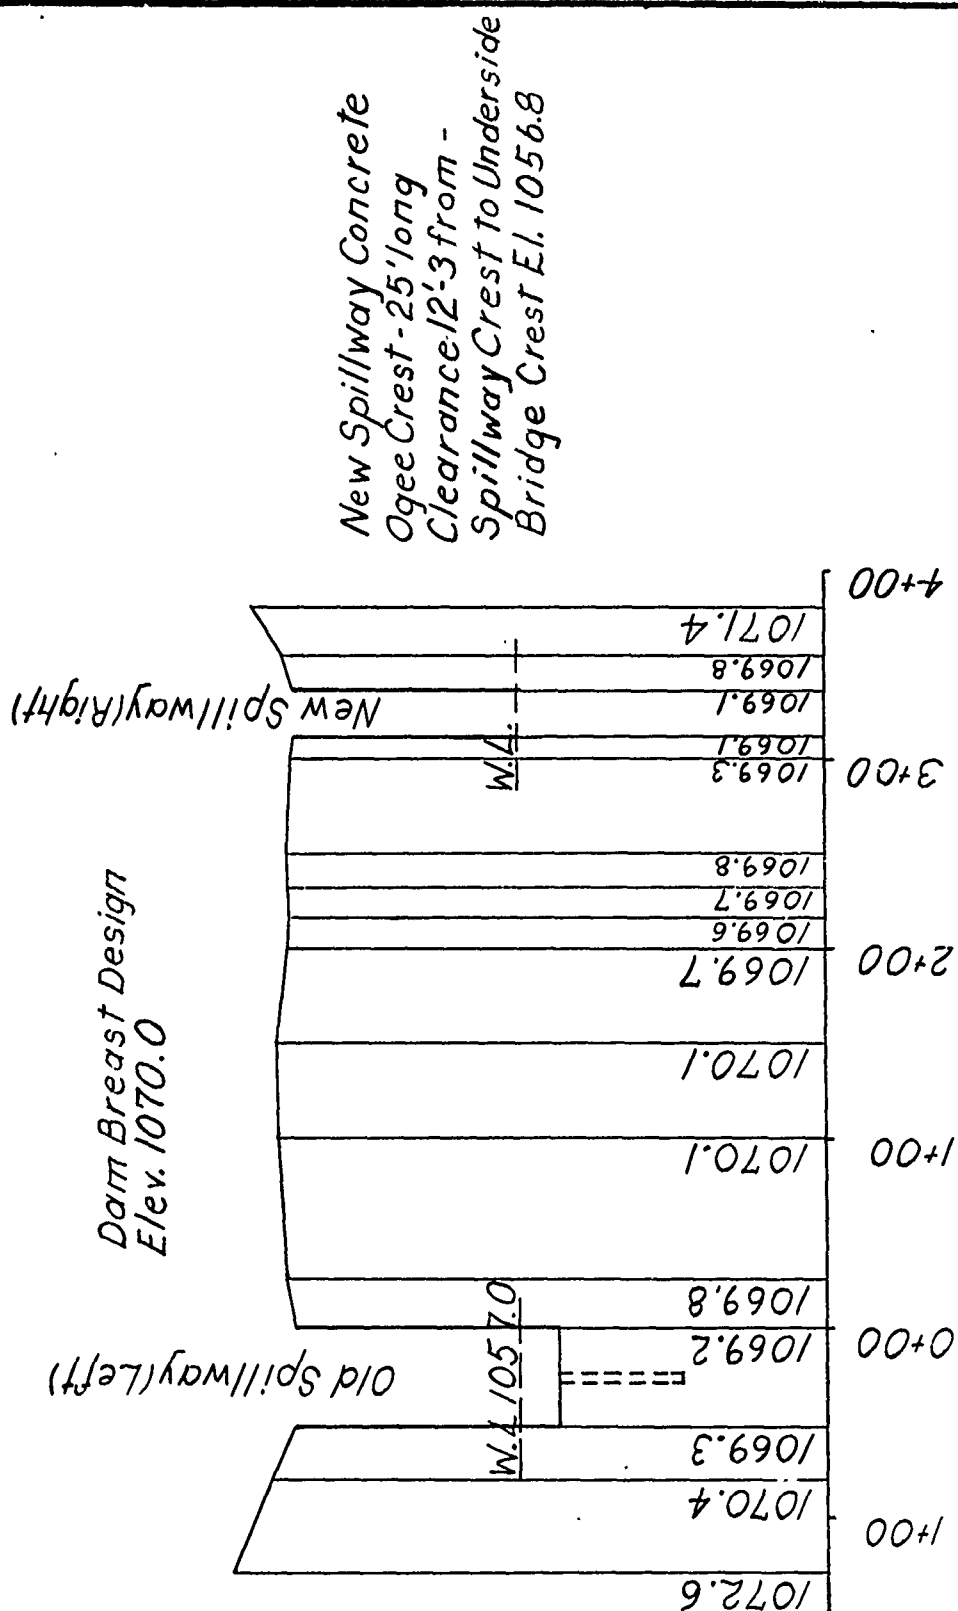
**INSPECTION SURVEY  
PLATE A-I**

The downstream slope has a considerable growth of weeds and heavy brush at several locations (See Plate A-I). Seepage was not detected on the slope, but a wet area was noticed along the toe. Drainage is poor in this area and there is no toe drain. A large flow of water (estimated 40 g.p.m.) was observed at the toe adjacent to a high ridge next to the right spillway. The water was clear and appears to originate from the spillway through the cracked rocks of the spillway. A pond has been constructed about 70 feet beyond the toe. This pond is fed through a siphon from the reservoir and is used to raise bait fish.
