PENNSYLVANIA  
NDS ID PA. 00620  
DER ID 46-145

# MARTINS DAM

PHASE I INSPECTION REPORT  
NATIONAL DAM INSPECTION PROGRAM

JANUARY 1980

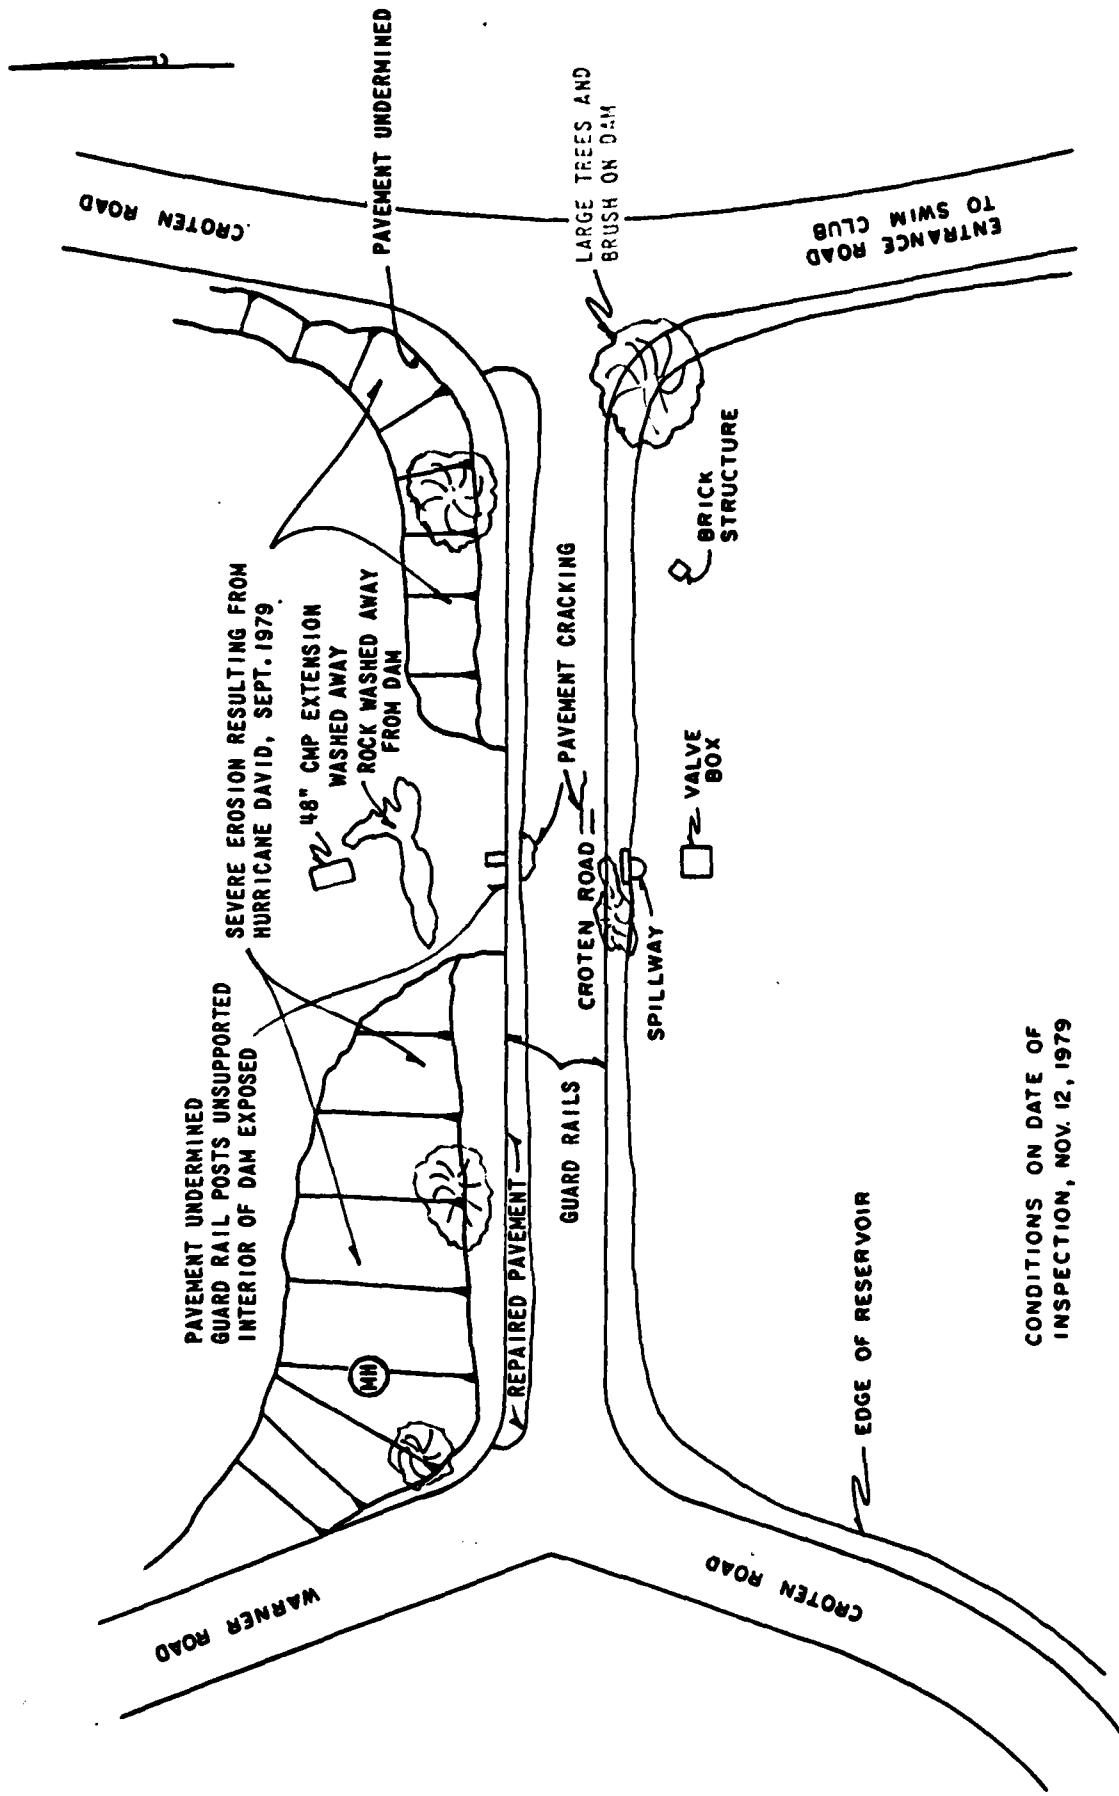
FIELD OBSERVATION PLAN  
MARTINS DAM

CONDITIONS ON DATE OF INSPECTION, NOV. 12, 1979
