ST. GEORGES BRIDGE. BRIDGE INSPECTION REPORT NUMBER 11A.(U)

| REPORT DOCUMENTATION PAGE | | READ INSTRUCTIONS<br>BEFORE COMPLETING FORM |
|---|---|---|
| 4. TITLE (and Subtitle)<br>Bridge inspection report no 11A, St. Georges<br>Bridge, Delaware | | 5. TYPE OF REPORT & PERIOD COVERED<br>Bridge inspection report no.<br>11A, Contract Report, 1979 |

The findings and recommendations of the 1979 inspection of the St. Georges Bridge (Route designation, U.S. Route 13) which crosses the Chesapeake and Delaware Canal was undertaken for the Department of the Army, U.S. Corps of Engineers by Howard Needles Tammen & Bergendoff (HNTB) and are submitted herein. A location map is presented in Drawing 1-0.

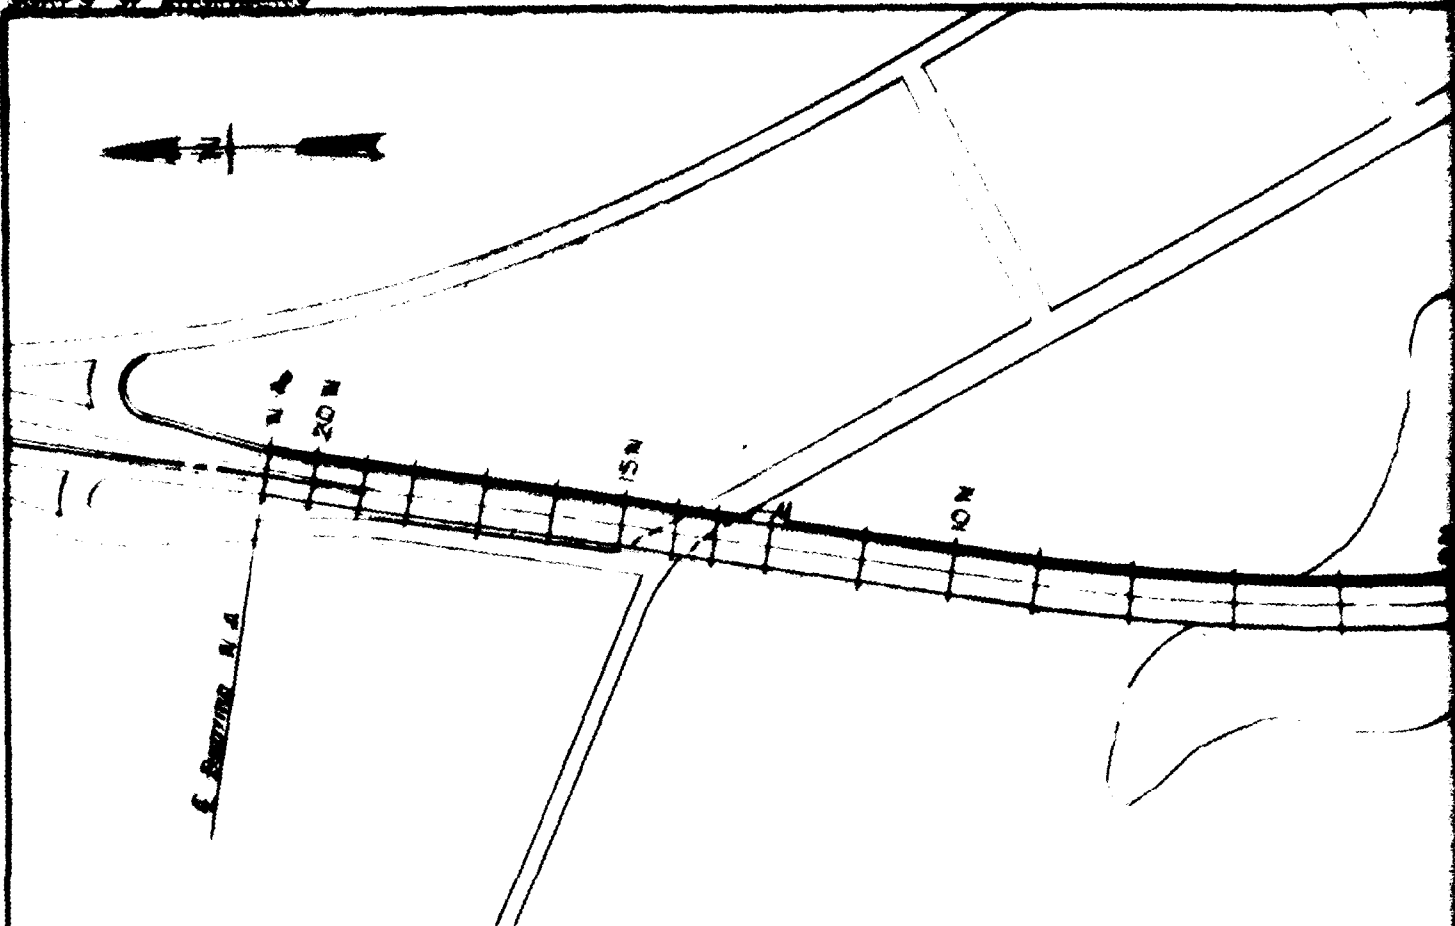
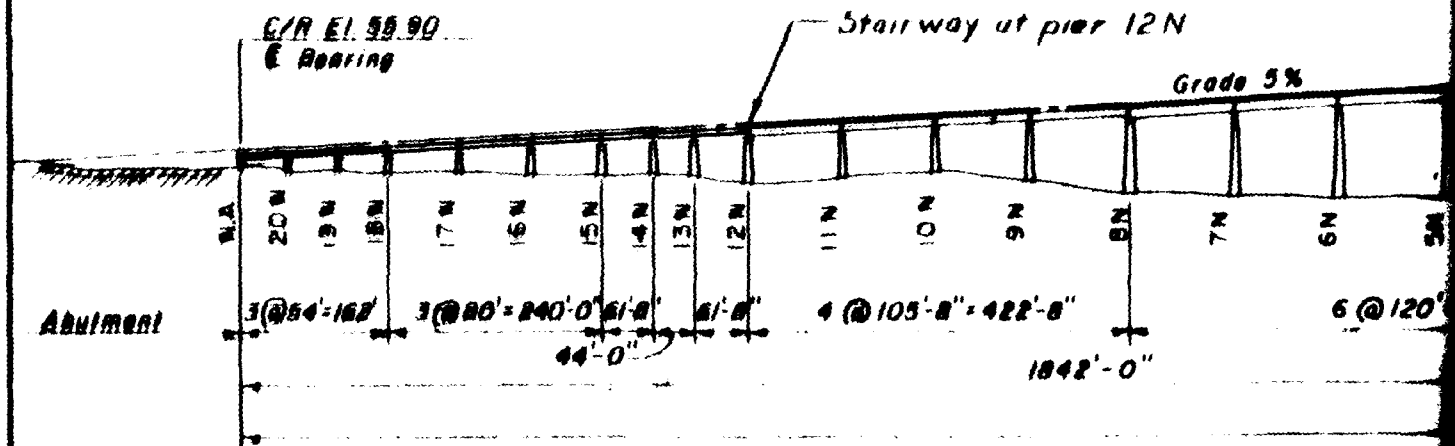
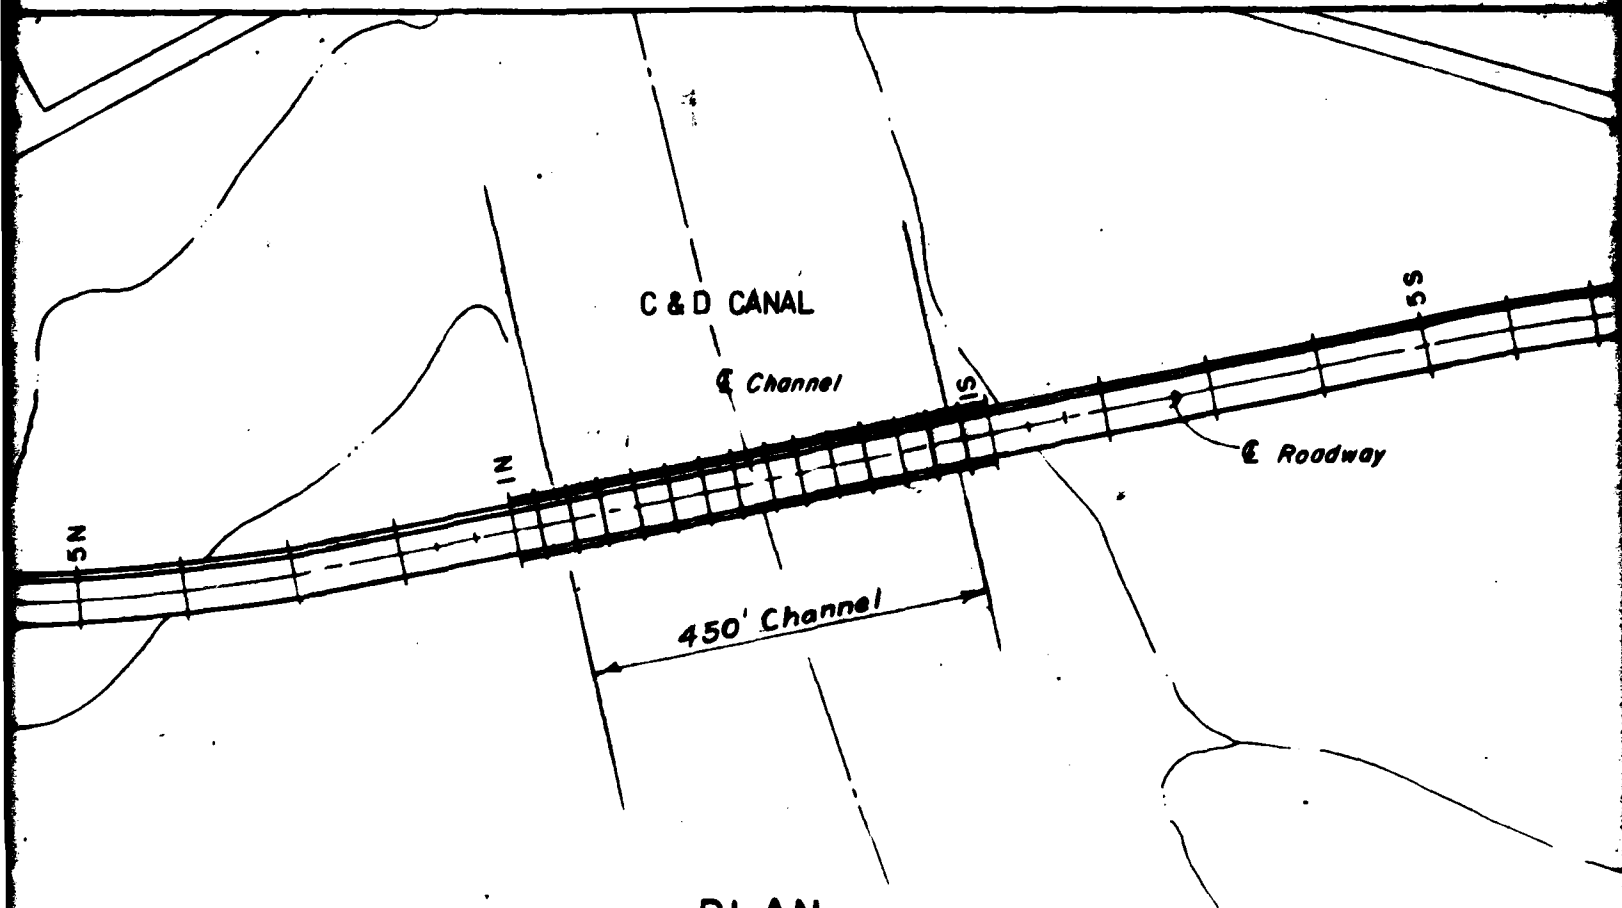
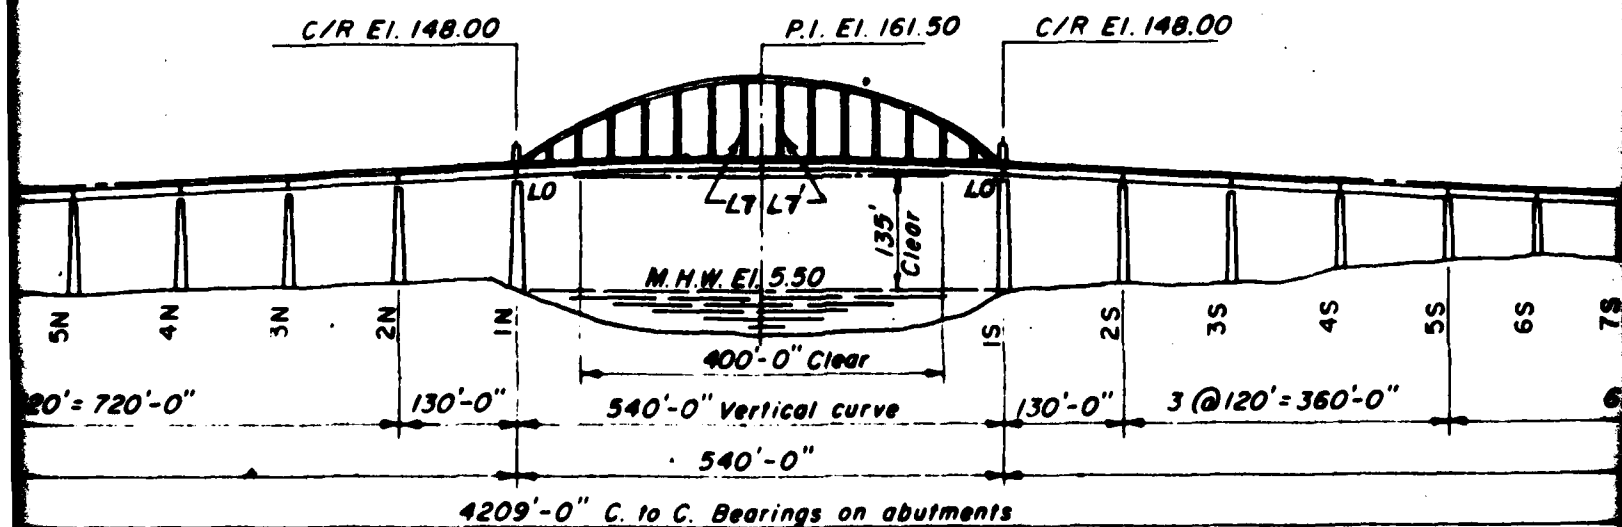
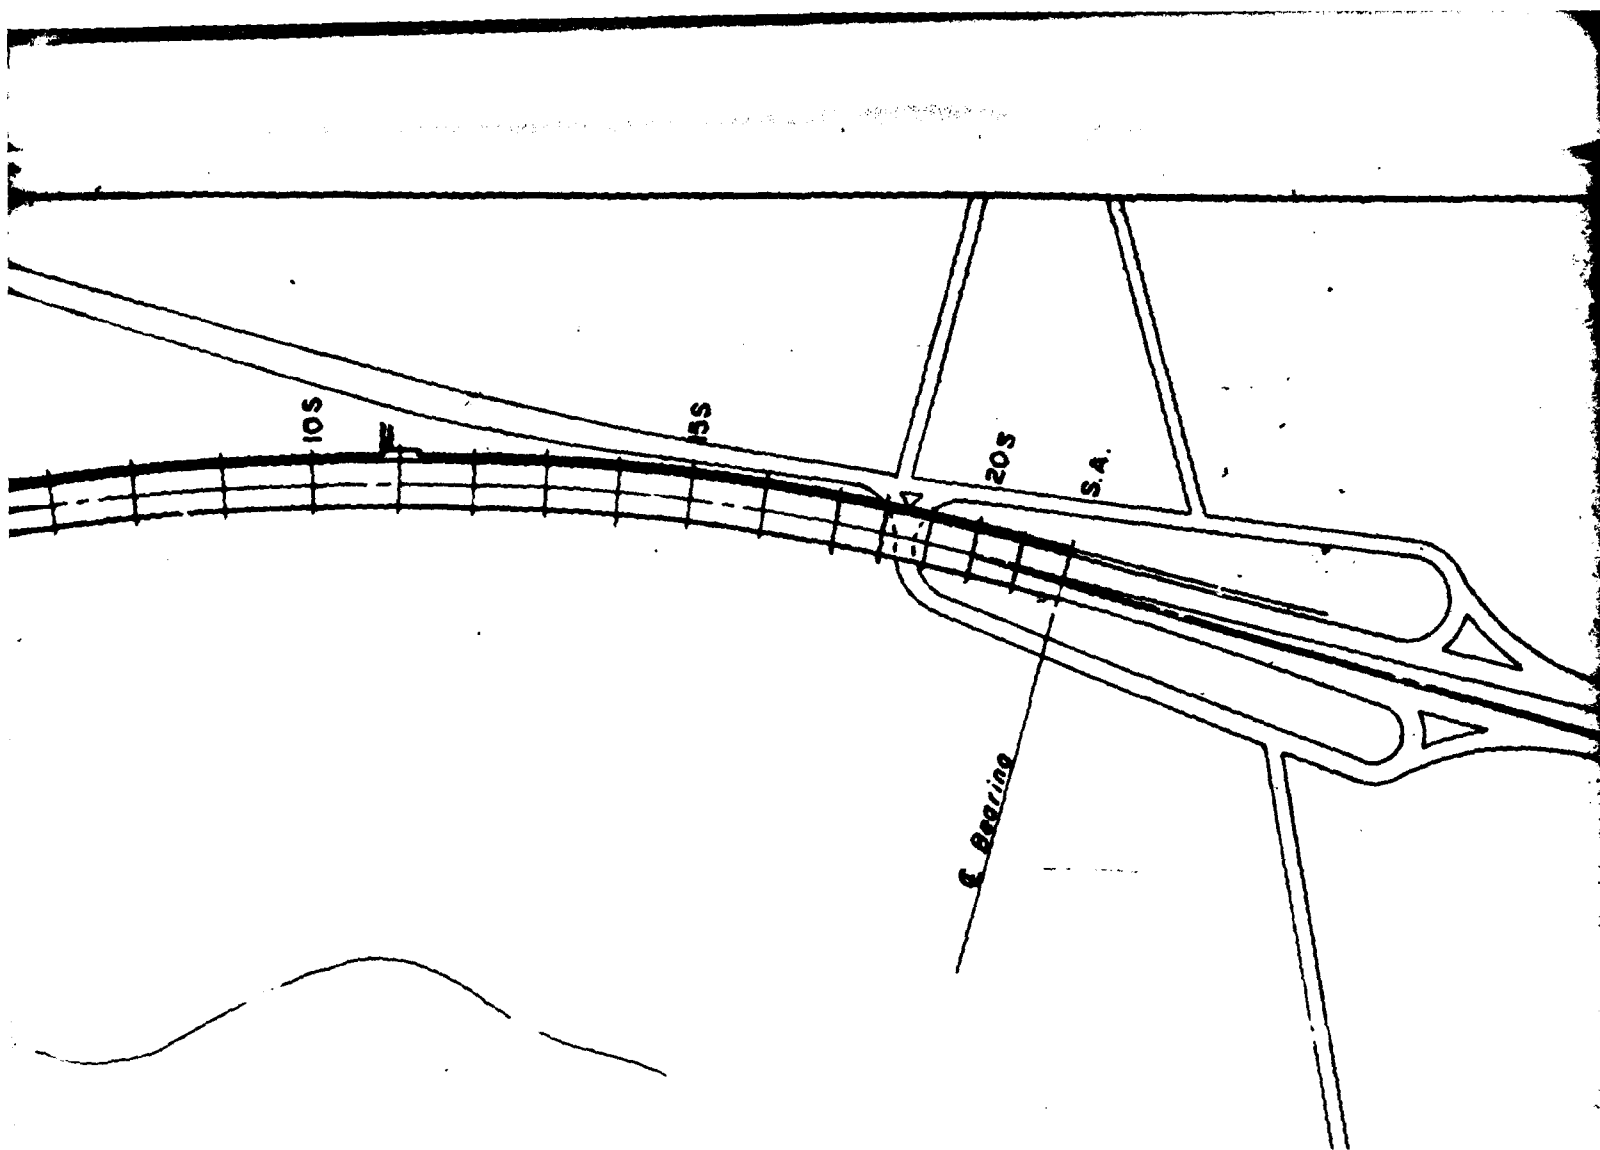
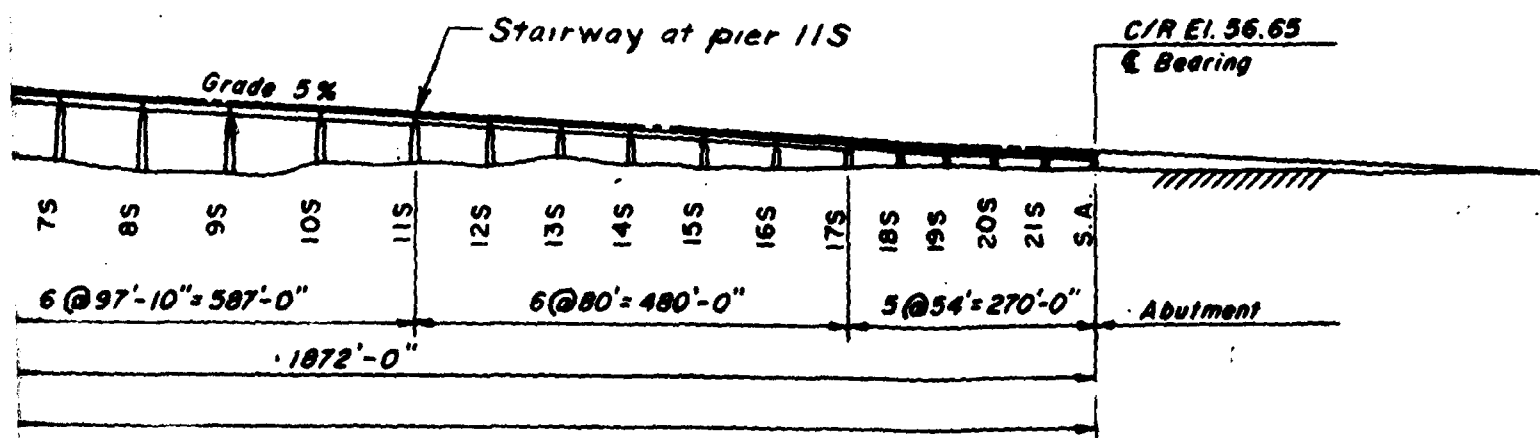
DRAWING F-1

C & D CANAL  
BRIDGE INSPECTION REPAIR  
ST. GEORGE'S BRIDGE  
PLAN AND ELEVATION

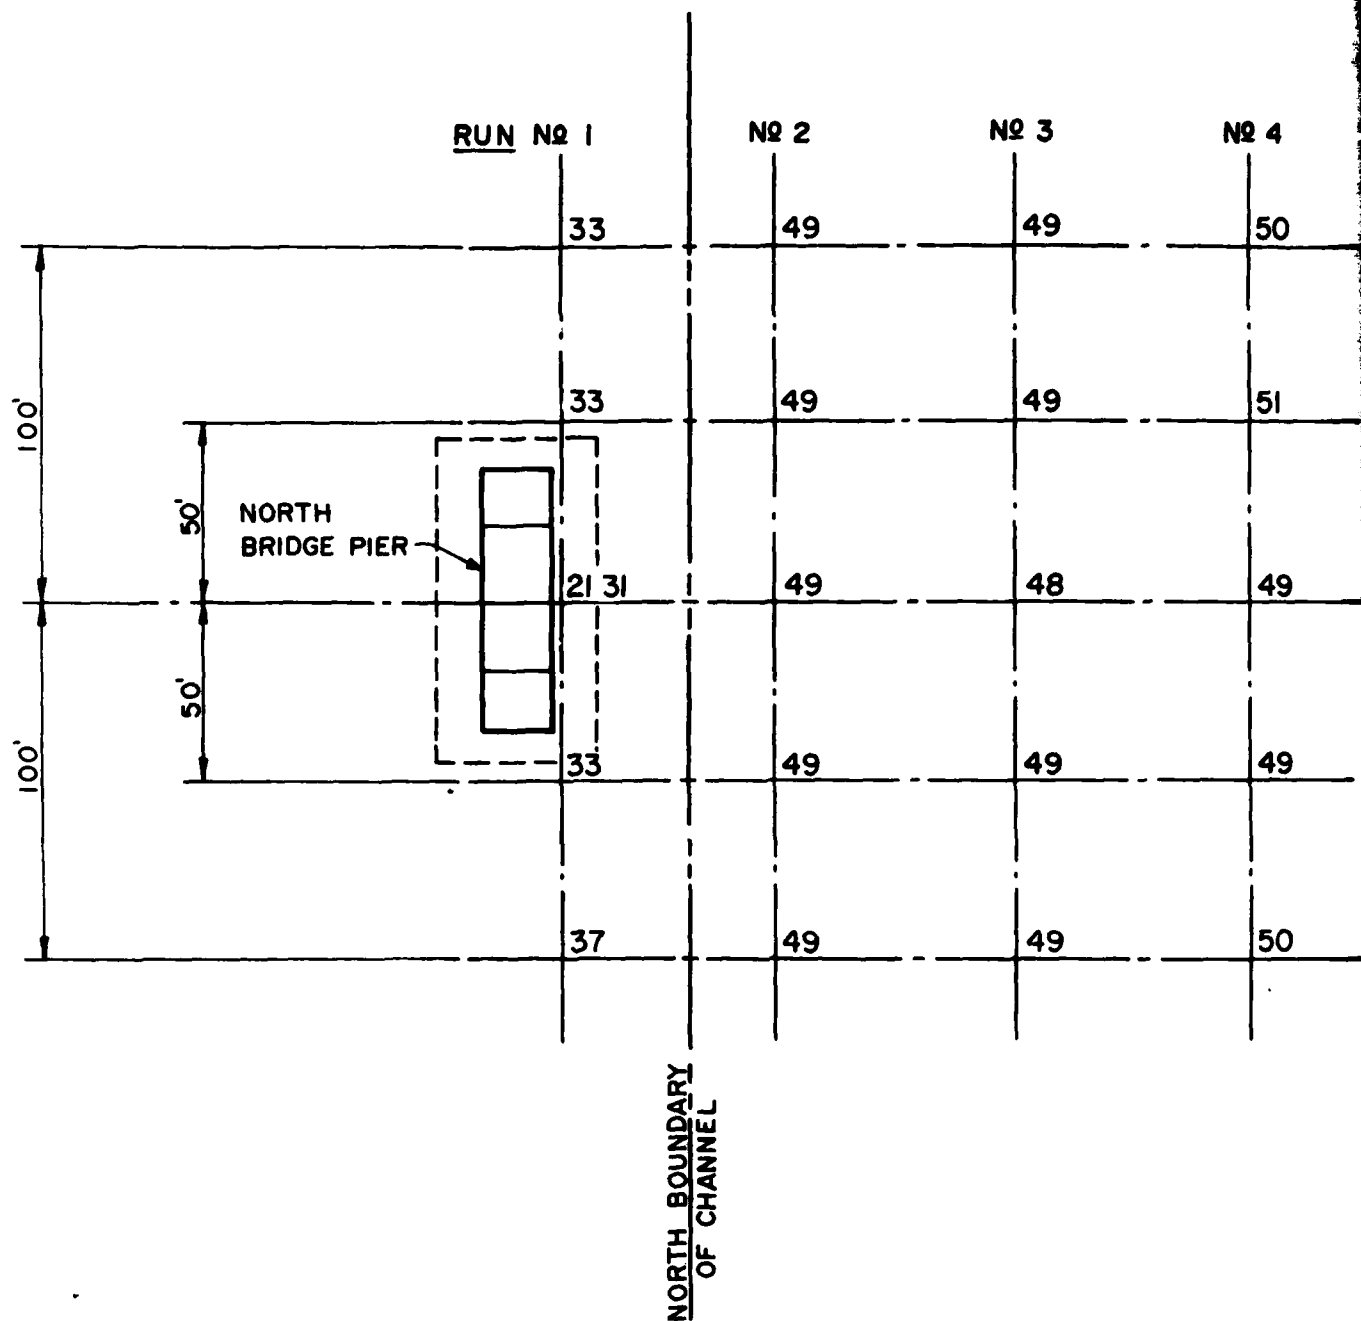
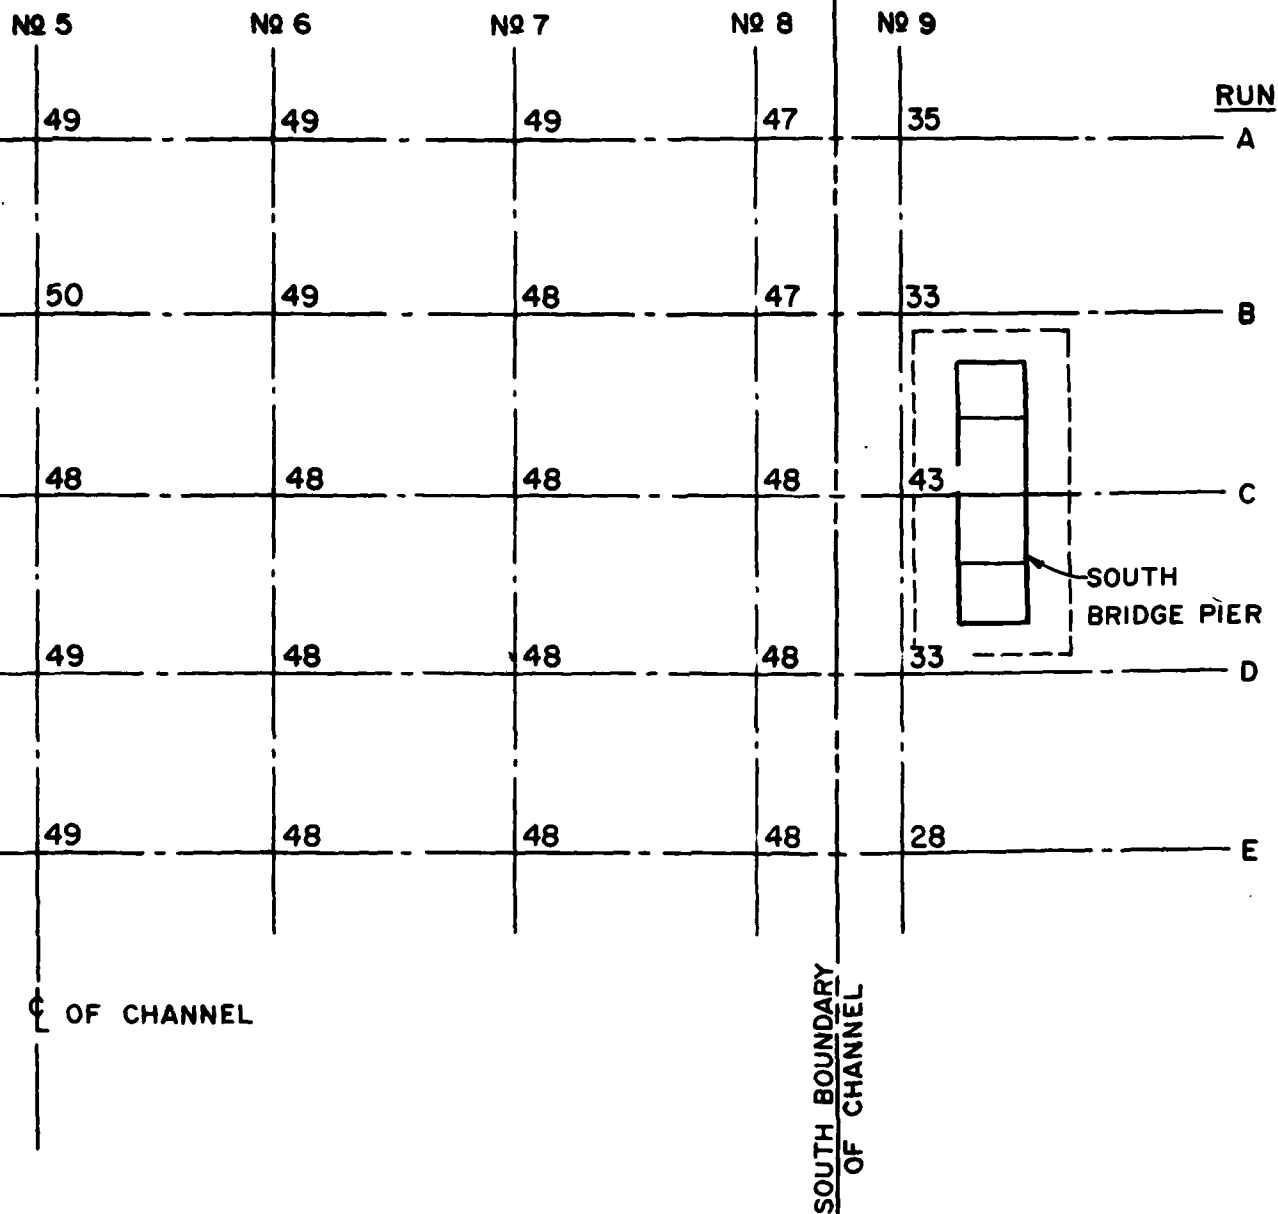
WING 1-2

VEY PERFORMED BY CALDWELL'S  
T. II, 1979  
ET FROM THE CANAL BOTTOM

D CANAL  
CTION REPORT NO.11A  
GES BRIDGE  
TER SURVEY
