Special Report 80-13

## EXTENDING THE USEFUL LIFE OF DYE-2 TO 1986

PART II: 1979 FINDINGS AND FINAL RECOMMENDATIONS

Wayne Tobiasson and Philip Tilton

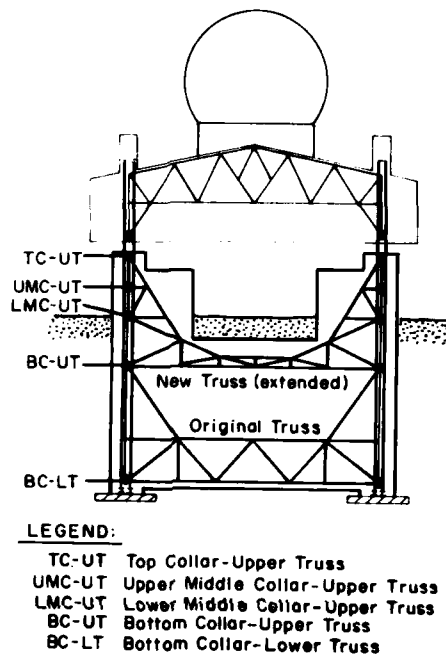
Figure 1. Elevation view of DYE-2.

3. The truss enclosure (see Fig. 1) is the structure's weak link. It is in bad condition below elevation 52.5\* and will not last until 1986. A comprehensive inspection should be made in 1979 to verify this conclusion and to better establish the rate of deterioration.

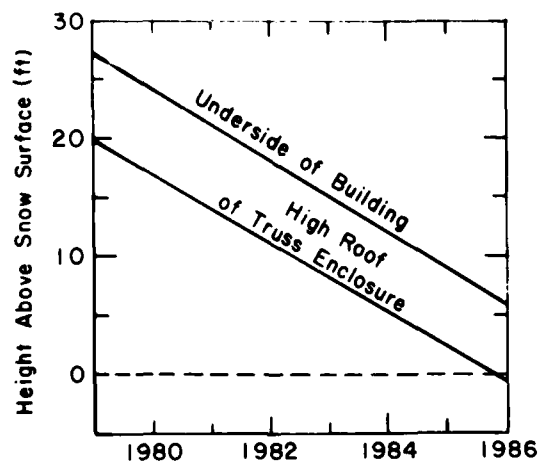
Figure 3. Building and truss enclosure clearances with time.

This is a favorable position but there is no compelling need to increase the height of the mound each passing year relative to the "natural" snow surface. Consequently the DYE-2 life extension can be designed based on a 3-ft/yr build-up rate. At this rate the snow surface would be within 6 ft of the underside of the composite building in 1986 (see Fig. 3). To prevent excessive snow drifting around the facility the building should

be maintained 15 ft or more above the snow surface. Using this criterion the building should be raised no later than 1983.

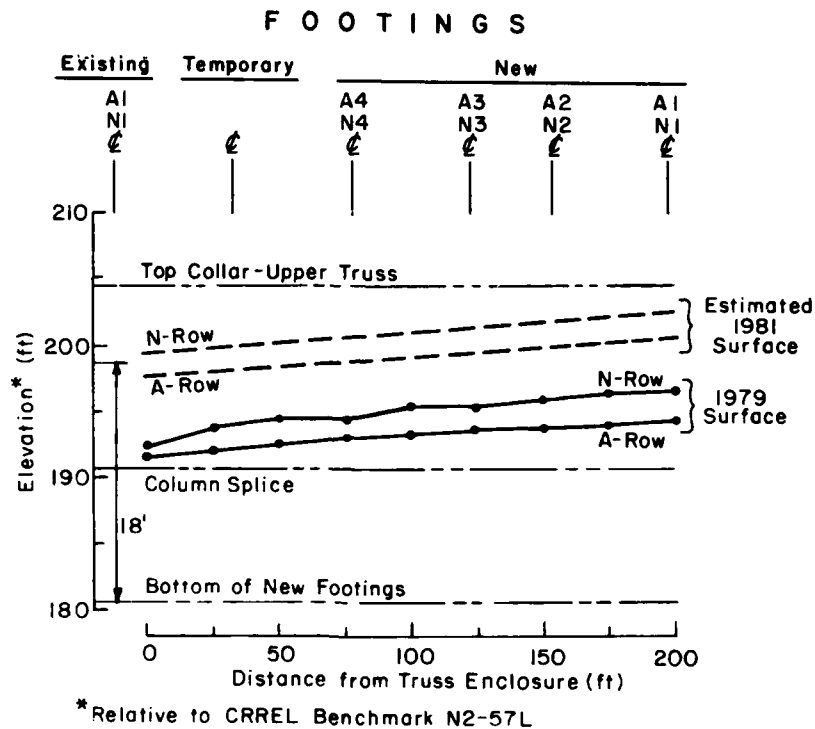
Figure 4. Elevations along the track of a sideways move.

The position of the snow surface is also an important consideration if the building is to be moved sideways in 1981 or 1982. Figure 4 shows snow surface elevations along the track of a sideways move, the estimated 1981 snow surface along the tracks, and the elevation of the column splice that corresponds to the splice separated for the DYE-3 move. If the snow surface permits, DYE-2 should be separated at this splice since the DYE-3 design could then be reused without much modification. Figure 4 also shows the elevation of the footings based on the footing-girder geometry used for the DYE-3 move. At this elevation the new footings would be at least 17 ft below the 1981 snow surface. Since a depth of at least 15 ft is desired for load bearing and thermal protection and a depth of less than 20 ft is desired to minimize costs, the DYE-3 sideways move geometry is appropriate to reuse at DYE-2. If the move is delayed until 1982, 3 to 3 1/2 ft of additional excavation will be necessary for the footings. This would be acceptable and would add little to the cost of the move.

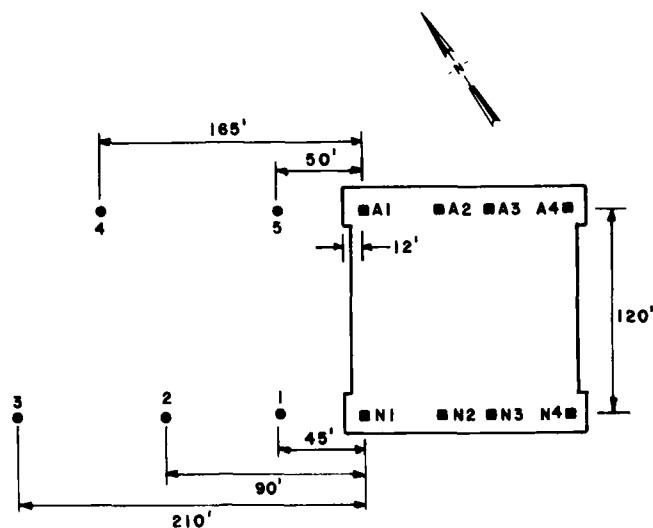
Figure 5. Location of five 1979 boreholes.

Snow studies conducted at DYE-3 prior to the sideways move are summarized by Tobiasson (1979). In 1979 a CRREL coring auger (Ueda et al. 1975) was used to obtain 3-in.-diameter cores of the snow to a depth of 50 ft at five positions along the track of a potential sideways move at DYE-2. Figure 5 indicates the locations of the five boreholes. Samples were stored at 15°F in the truss enclosure, then sized and tested at 20°F in unconfined compression at a cross-head speed of about 2 in./min. Visually, most of the samples resembled ice more than snow. A few relatively thin, weak granular layers were detected but most of the samples were very strong. Overall the snow that would support DYE-2 during a sideways move was significantly stronger than the snow that supported DYE-3 structure during the sideways move. Based on this information it is considered safe to support the DYE-2 structure on this snow during a sideways move.

Concern for inadvertent warming of the supporting snow during a sideways move was expressed in Part I of this report. It is considered important to create retaining walls and a white fabric cover over the new foundation as shown in Figure 4 of Part I.

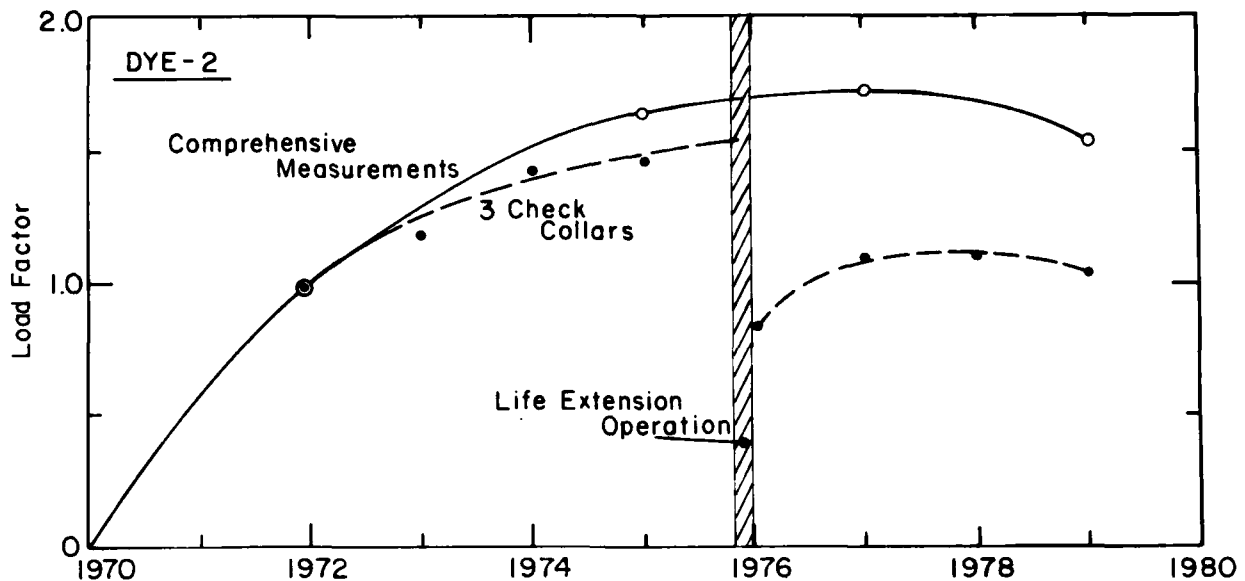
Figure 8. Load factor vs time.

the level of secondary stress in the structural frame. That load, normalized by dividing it by the load measured at all sway bolts in 1972, is presented as a load factor in Figure 8. Since all sway bolts were loosened and the trusses were leveled during the 1970 life-extension operation, it has been assumed that the sway bolts were free of load at that time. The variation in load factor for the three checked collars monitored on more frequent occasions over the past eight years is also presented in Figure 8. It is evident that the level of secondary stress in the structural frame has decreased slightly since 1977. This is fortunate.

The expected benefits of a sway bolt adjustment program prior to an ice backfill operation and the slight decrease in the total sway bolt loads from 1977 to 1979 (see Fig. 8) indicate that there should be no need to sever the DYE-2 columns just above an ice backfill to relieve secondary stresses as would have been necessary at DYE-3. This will greatly simplify the ice backfill alternative for DYE-2.
