MIDDLE FORK SLURRY IMPOUNDMENT

RUSSELL COUNTY, VIRGINIA

VA. NO. 16708

# PHASE I INSPECTION REPORT NATIONAL DAM SAFETY PROGRAM

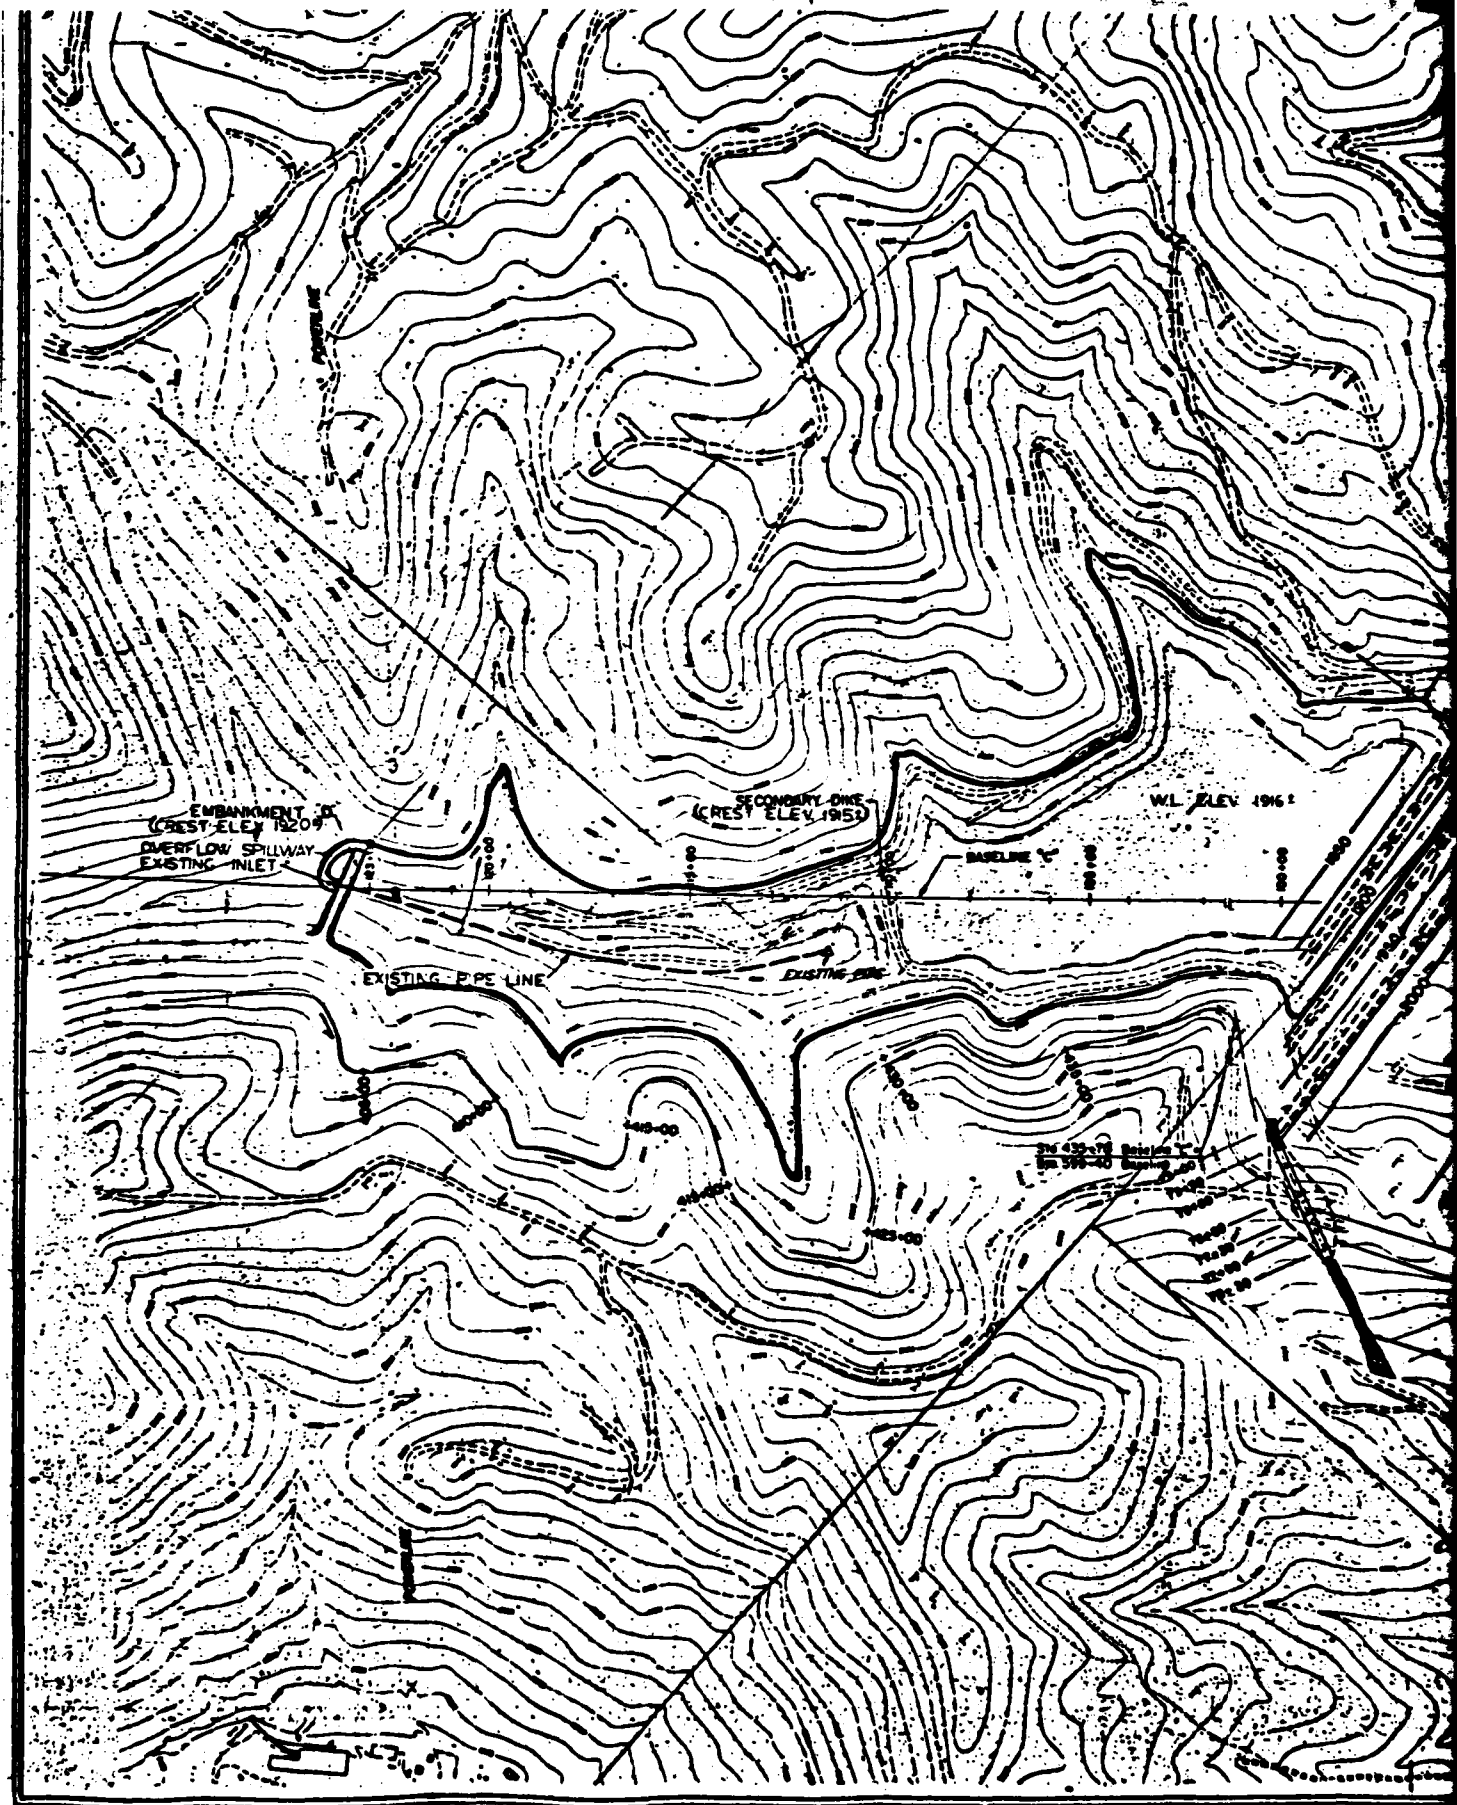
PLATE NO. 2 STAGE 1

1.2.7 Design and Construction History: There was no original design data available; however, the dam was reportedly constructed under the supervision of the Clinchfield Coal Company. Future use and abandonment plans are currently being prepared by the Owner's engineering consultant. An abandonment plan is the filling of the impoundment with refuse and diversion of runoff away from the impoundment. Preliminary engineering studies were performed by L. Robert Kimball and Associates, in 1978; however, Orbital Engineering Inc., Carnegie, Pennsylvania, has since been retained by the Owner to complete the plans. Reports and plans are submitted on an interim basis and the study was not complete at the time of the investigation. Appendix IV includes a brief description of the plan approved in 1978 for upgrading the impoundment. Plate No. 2 of Appendix I includes grading plans for the structure with the present pool level sketched in.

Three piezometers have been recently installed at the locations shown on Plate 2, Appendix I in order to monitor the phreatic level within or beneath the embankment. Readings taken in December 1979 indicate water at elevation 1700± in P-1, which corresponds to the basal portion of the fill. No water was encountered in the other piezometers. Seepage or wet spots described in Section 3 on the downstream slope occur well above elevation 1700± and apparently are caused by surface water seepage along impervious buried surfaces.

The actual embankment structure is presently being graded to conform to the most recent abandonment drawings (See Plate No. 2, Appendix I). The stability analysis performed for the steady seepage case for the existing embankment indicates a factor of safety of 1.22 which is less than the 1.5 requirement of Reference 1, Appendix VIII. Modifications presently in progress will increase the factor of safety of the embankment and no further studies are recommended.

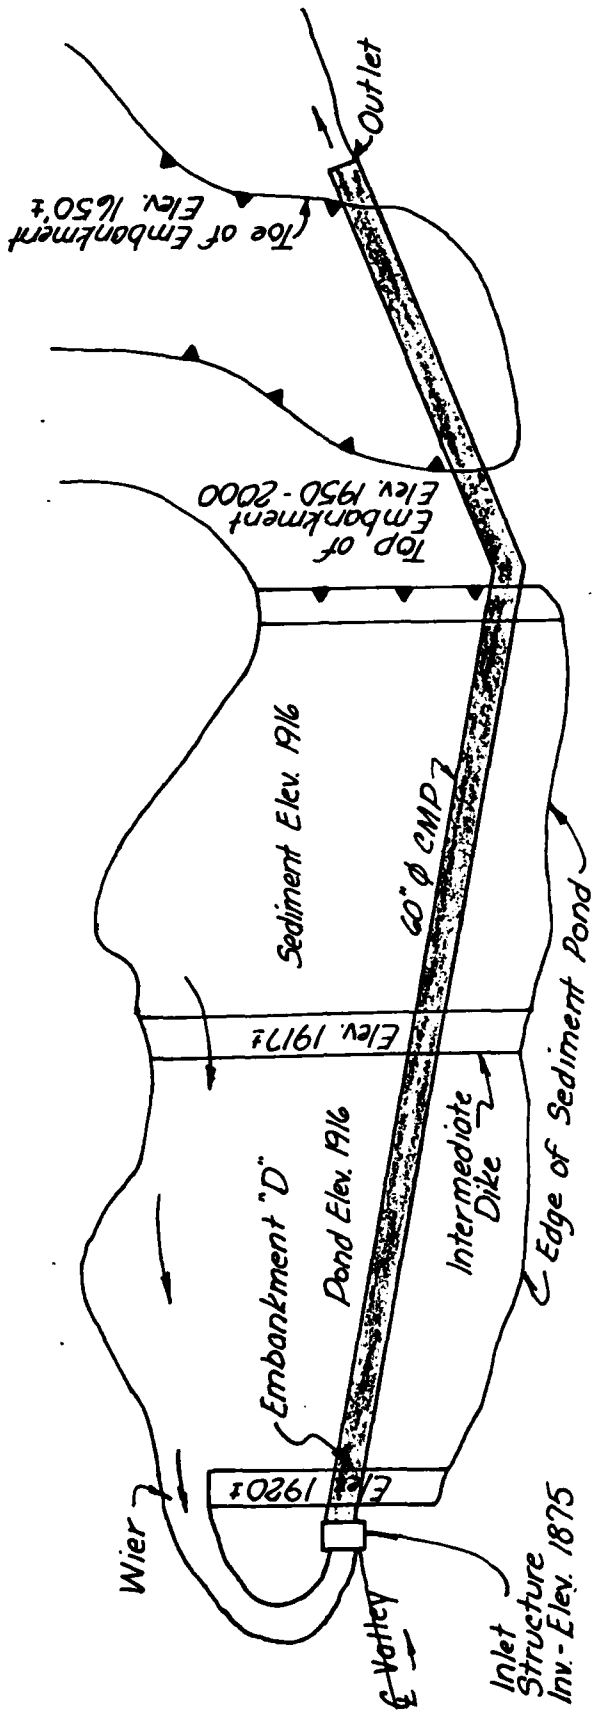
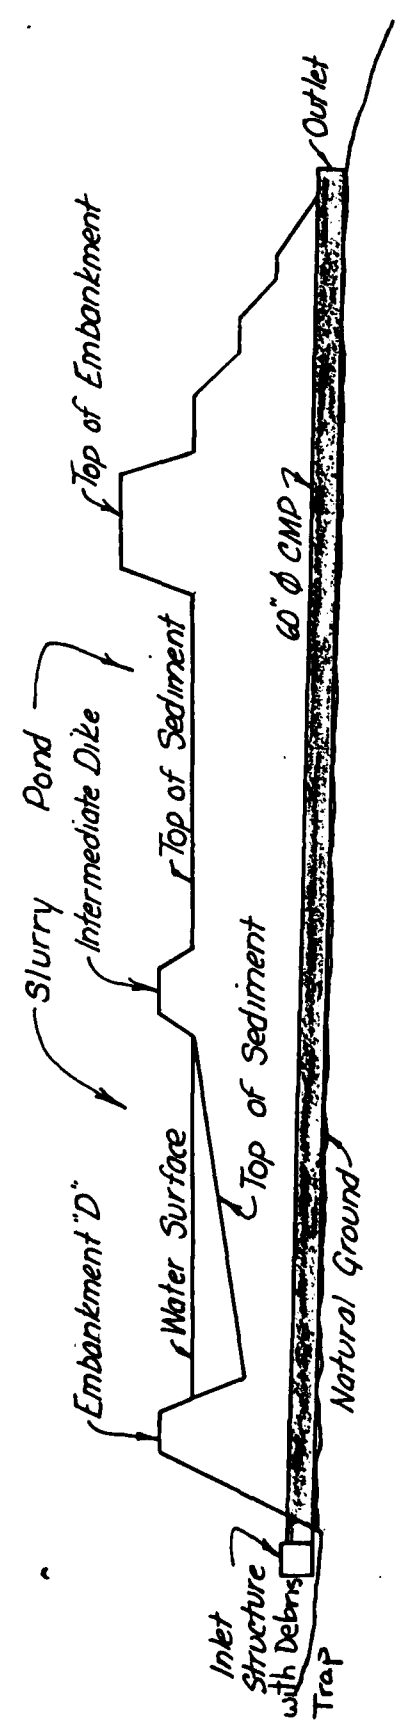
MIDDLE FORK SLURRY IMPOUNDMENT  
OVERALL SCHEMATIC PLATE N°3

The spillway consists of a 60 inch diameter corrugated metal pipe (CMP) used as a diversion channel. The pipe inlet is located upstream of the impoundment at embankment "D", and extends under the impoundment to the toe of the main embankment (See Plate No. 3, Appendix I). The 60 inch pipe discharges into the natural valley stream below the toe of the dam.
