SCHNABEL ENGINEERING ASSOCIATES RICHMOND VA F/6 13/13  
NATIONAL DAM SAFETY PROGRAM, BEAR CREEK RESERVOIR DAM (ID NUMBE--ETC(U)  
MAR 80 R E MARTIN DACW65-79-D-0004  
NL

| REPORT DOCUMENTATION PAGE | | READ INSTRUCTIONS<br>BEFORE COMPLETING FORM |
|---|---|---|
| 4. TITLE (and Subtitle)<br>Phase I Inspection Report<br>National Dam Safety Program<br>BEAR CREEK RESERVOIR DAM<br>WISE COUNTY, VA | | 5. TYPE OF REPORT & PERIOD COVERED<br>9 Final Rpts |

PHASE I INSPECTION REPORT  
NATIONAL DAM SAFETY PROGRAM  
BEAR CREEK RESERVOIR DAM  
VA. NO. 19511

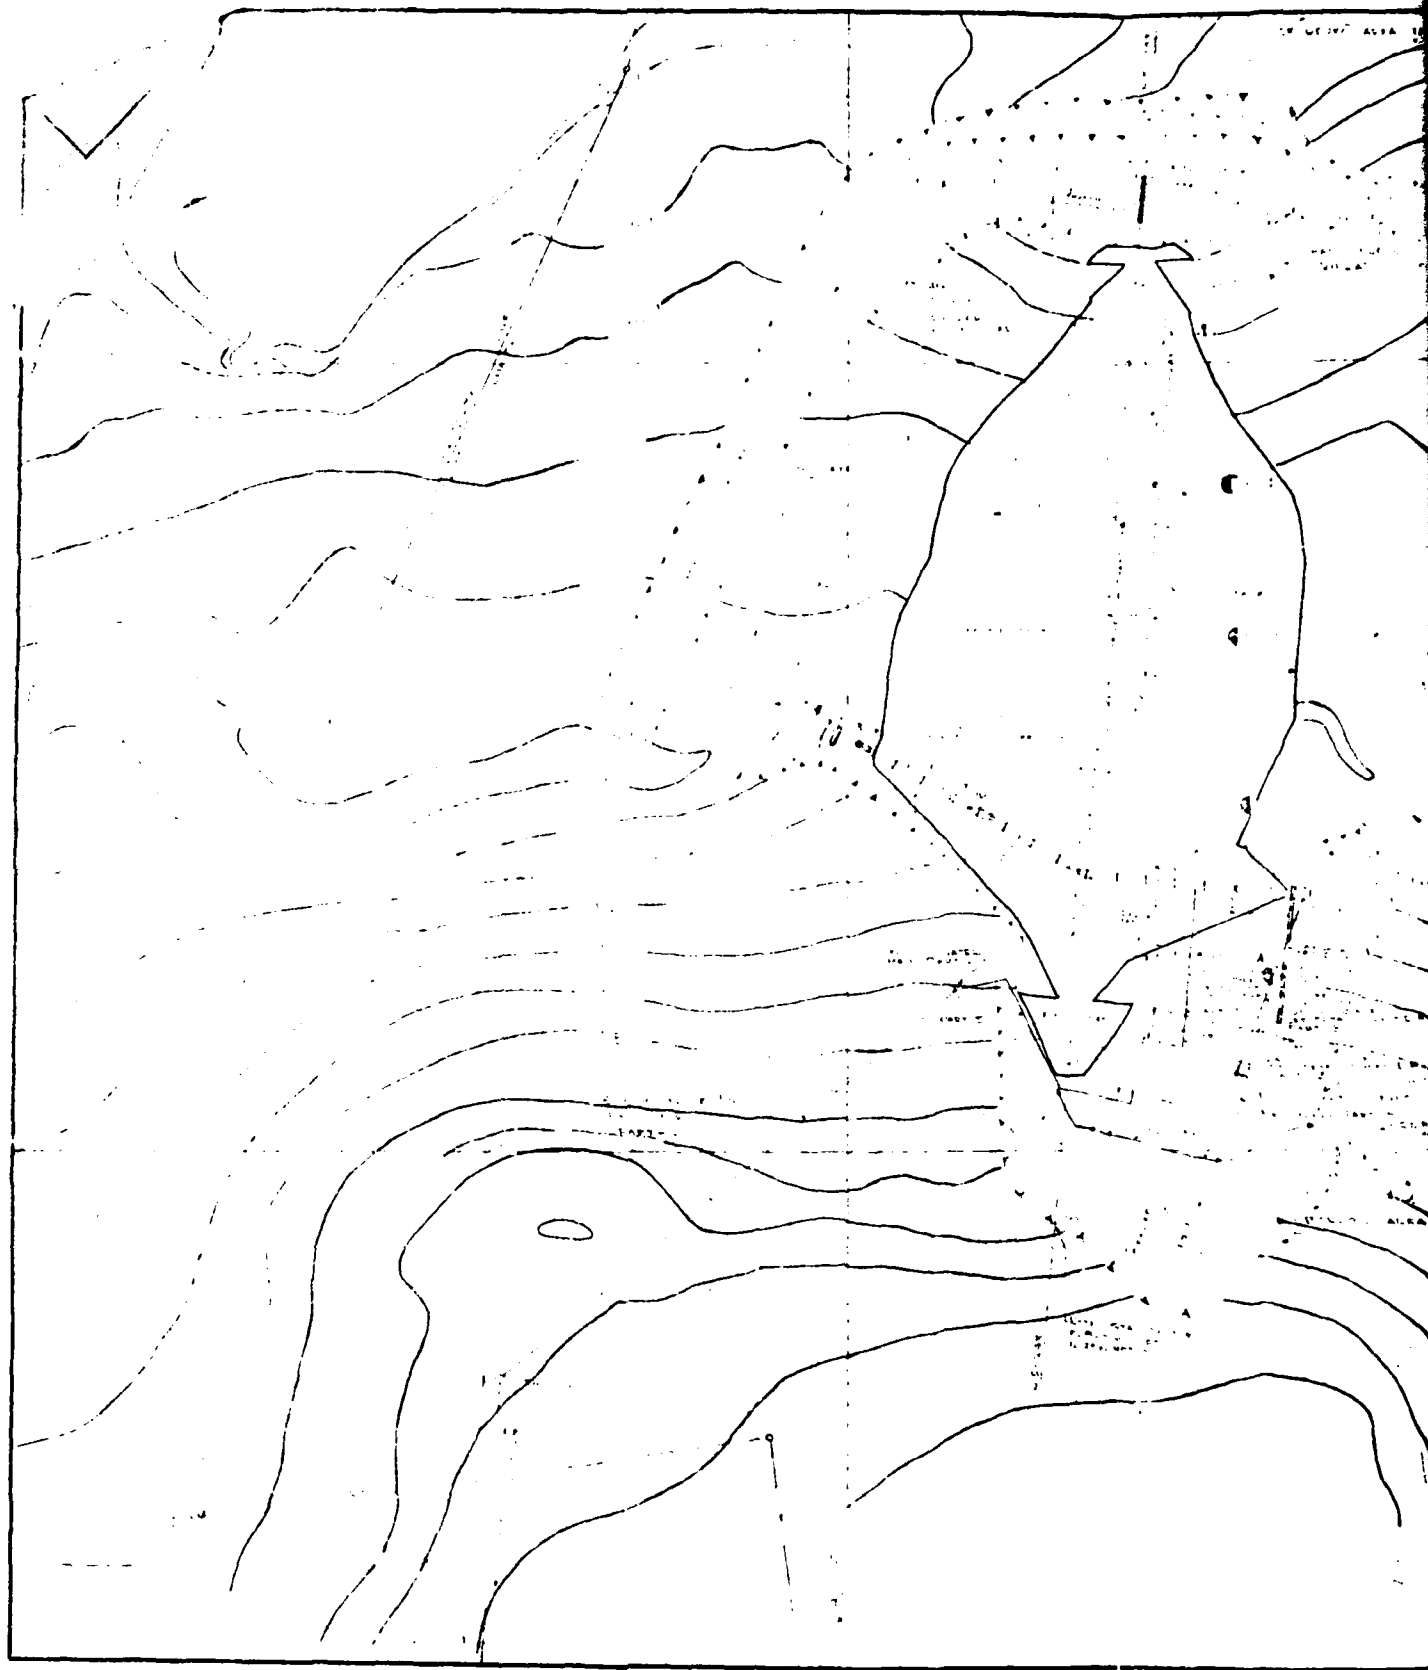
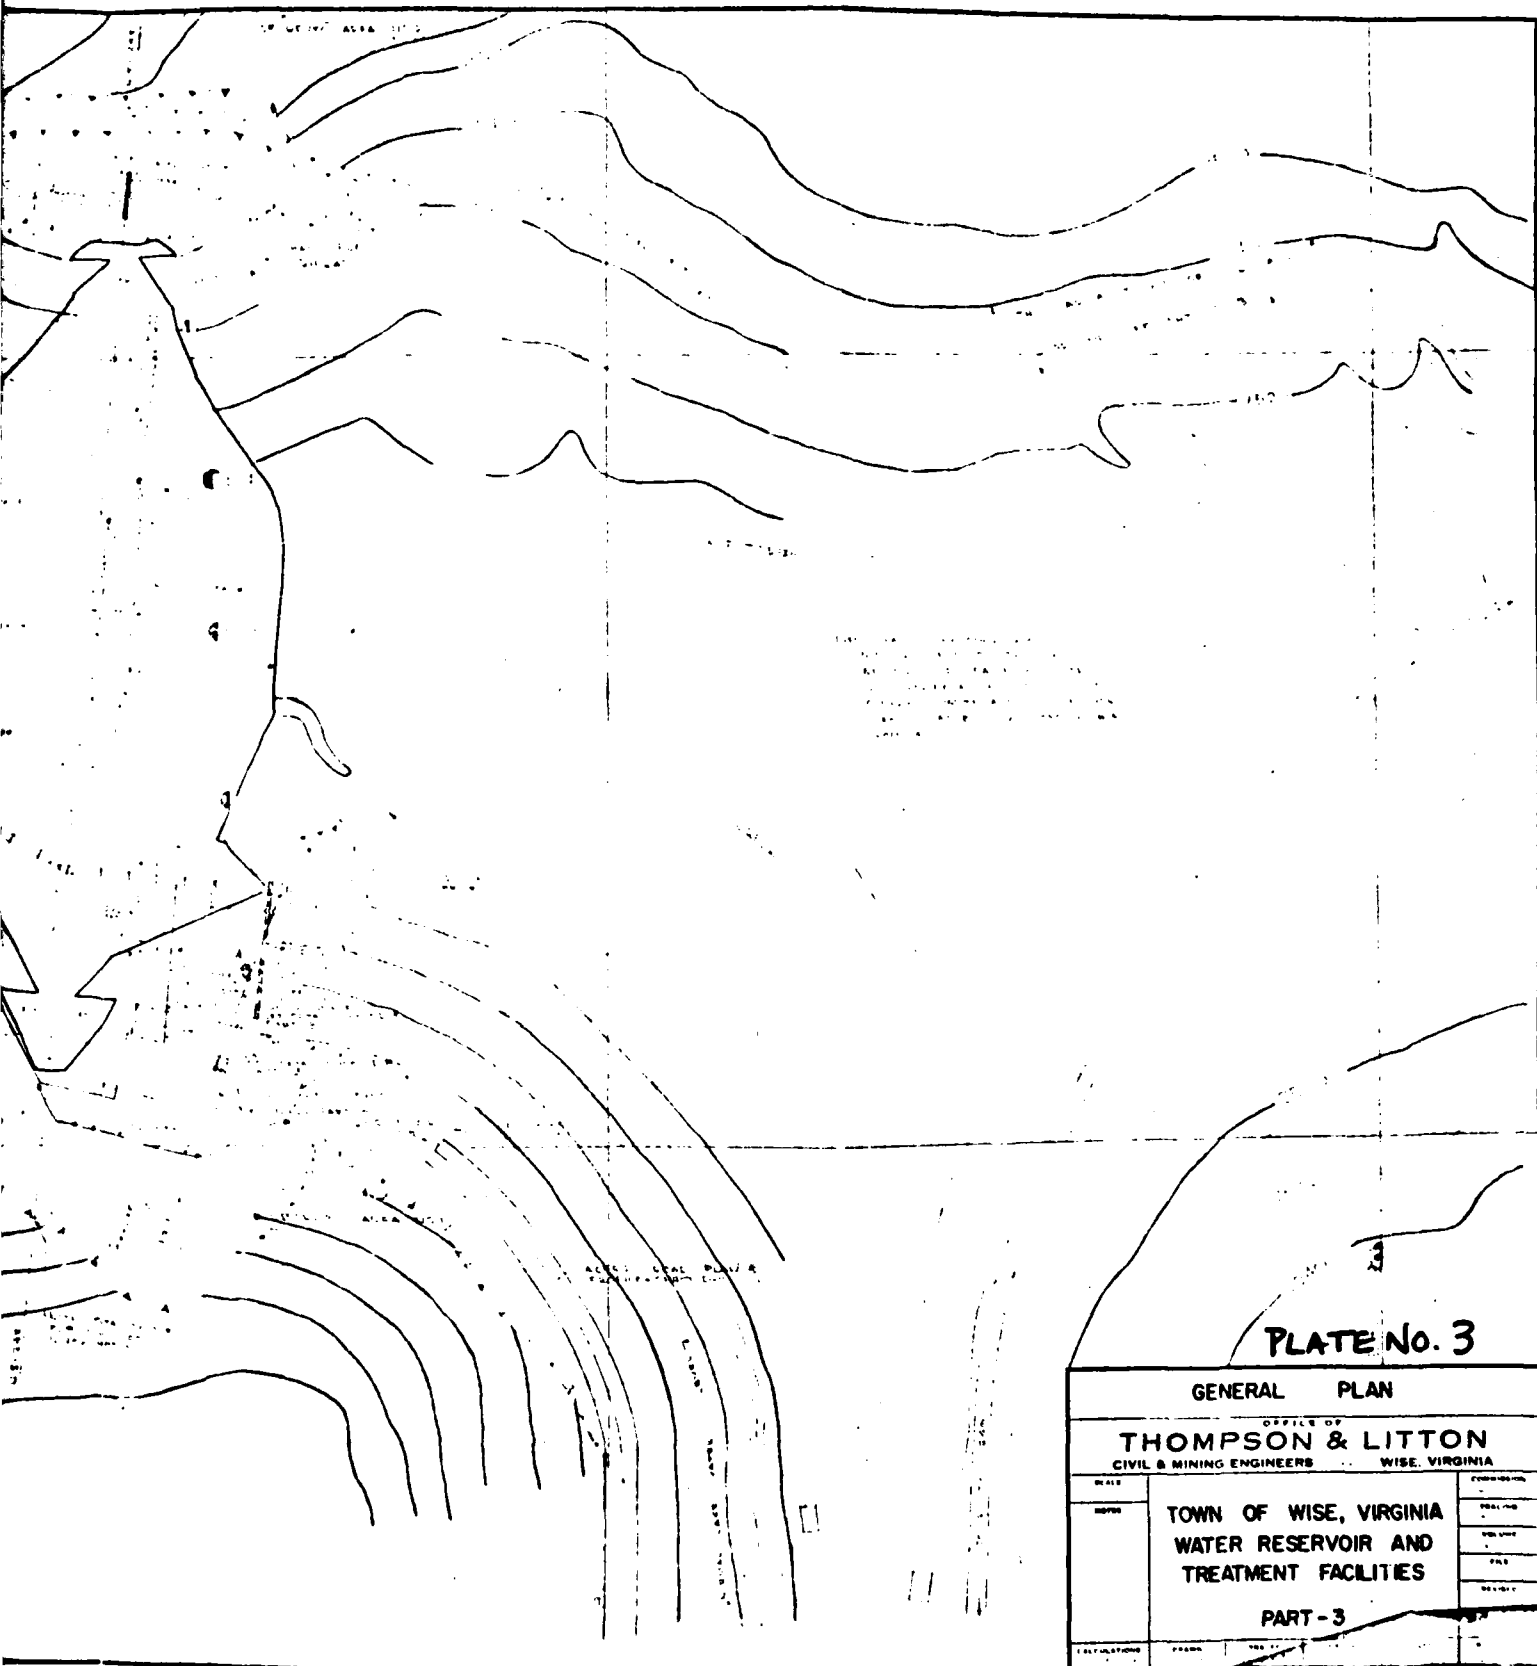
PLATE No. 3

There is an emergency spillway at the right abutment which is a vegetated earth channel with a bottom width of 30 ft and 1.5:1 side slopes. The crest elevation is 2533 msl. The bottom and right side of the emergency spillway is in cut and the left side is in fill. The spillway has a loose section of riprap across the bottom, centered on the control section. (See Plate No. 3, Appendix I)

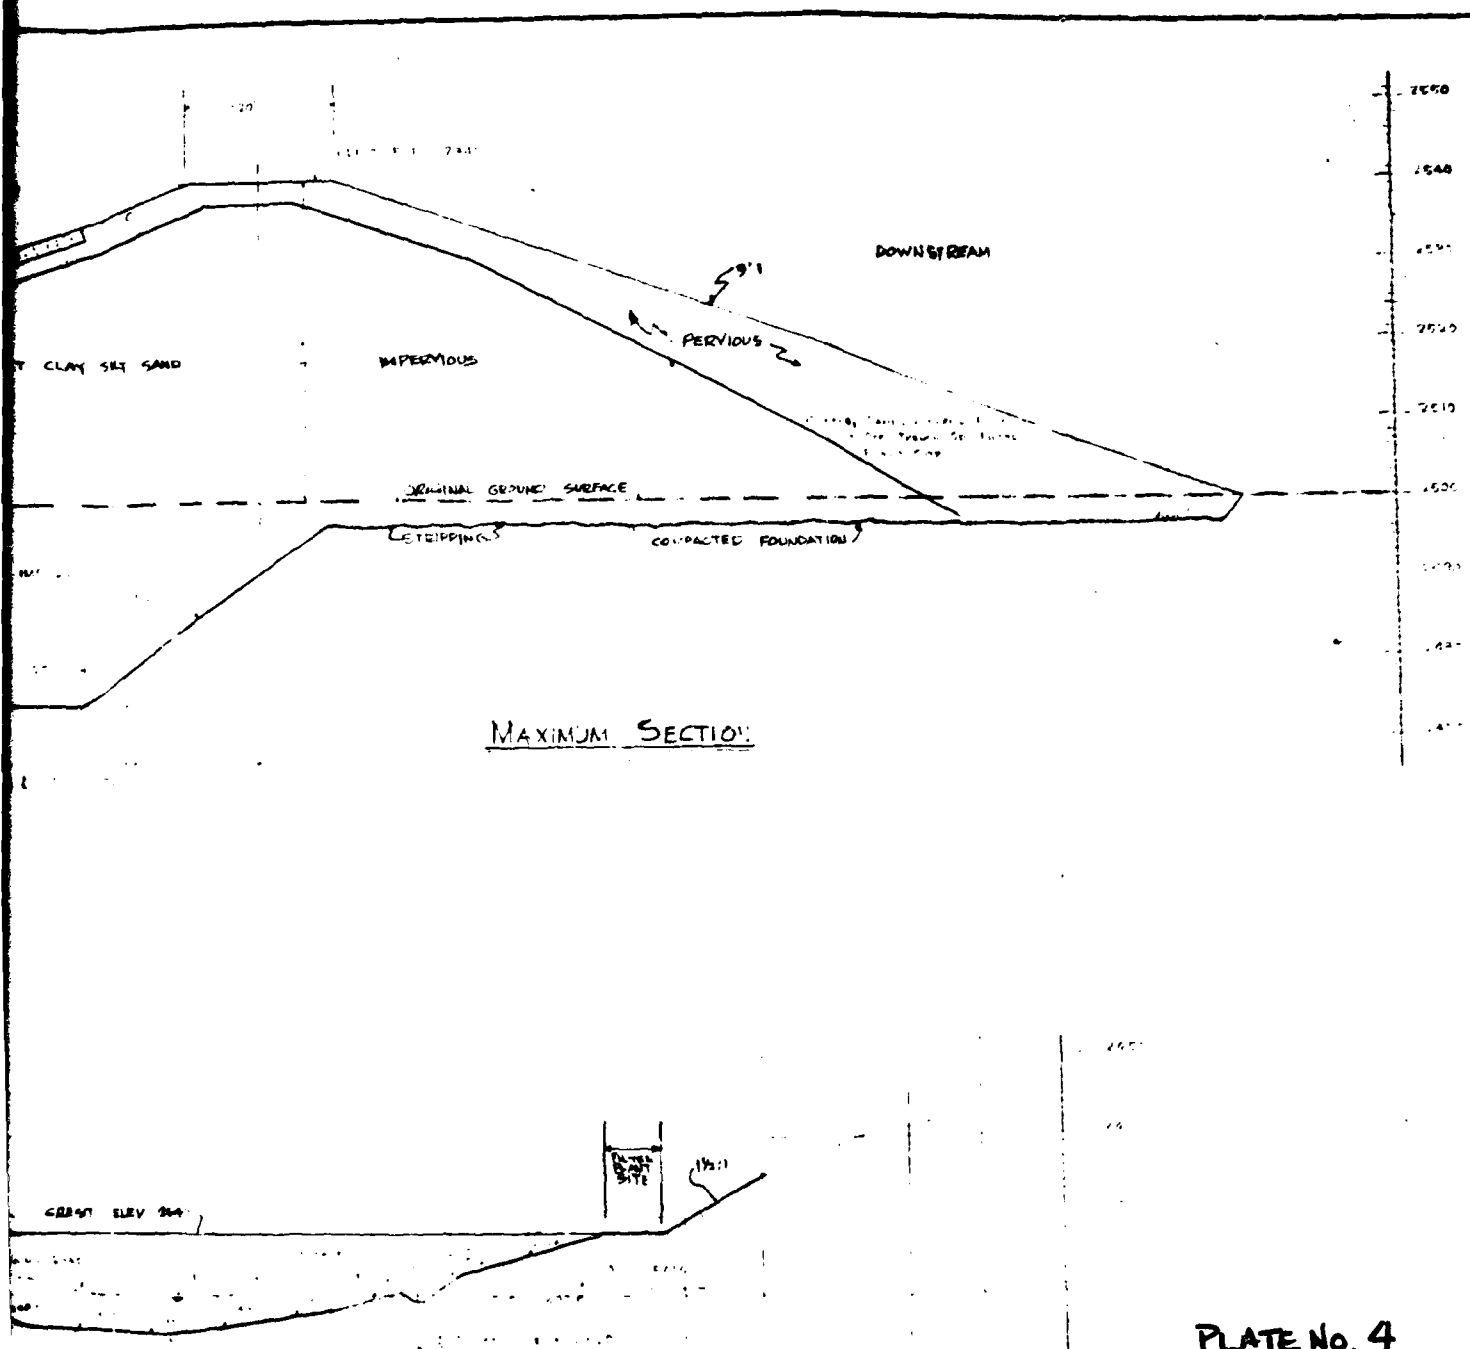
PLATE No. 4

presented on Plates 3 through 6 of Appendix I. According to Thompson and Litton, Inc., all fill was placed in 1 ft± thick layers and compacted with a sheepsfoot roller. Although field density tests were not required to determine the percent compaction, compaction procedures were observed by a full time inspector from Thompson and Litton's office. The "impervious" core was constructed with off-site soils, while on-site materials were used to construct the "pervious" shell. The underlying cutoff trench is approximately 20 ft wide and has side slopes of 1.5 horizontal to 1 vertical. A profile of the cutoff trench is provided on Plate 4 of Appendix I.

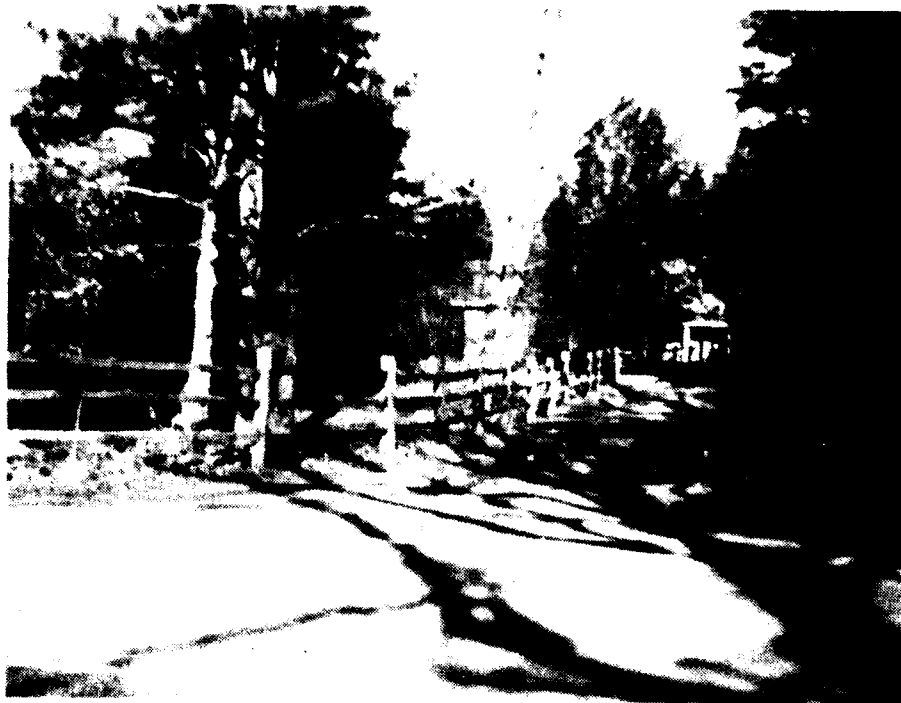
Photograph No. 1  
Downstream flood plain at section 10.  
Stream bed is at left side about  
6 feet below the yard level.
