| REPORT DOCUMENTATION PAGE | | READ INSTRUCTIONS<br>BEFORE COMPLETING FORM |
|---|---|---|
| 4. TITLE (and Subtitle) Phase I Inspection Report<br>National Dam Safety Program<br>BIRDWOOD DAM<br>ALBERMARLE COUNTY, VA | | 5. TYPE OF REPORT & PERIOD COVERED<br>Final |

# PHASE I INSPECTION REPORT NATIONAL DAM SAFETY PROGRAM

Name of Dam: Birdwood Dam  
State: Virginia  
County: Albemarle  
USGS 7.5 Minute Quadrangle: Charlottesville West, VA  
Stream: Morey Creek  
Date of Inspection: 13 November 1979

PHASE I INSPECTION REPORT  
NATIONAL DAM SAFETY PROGRAM  
NAME OF DAM: BIRDWOOD DAM ID# VA 00344

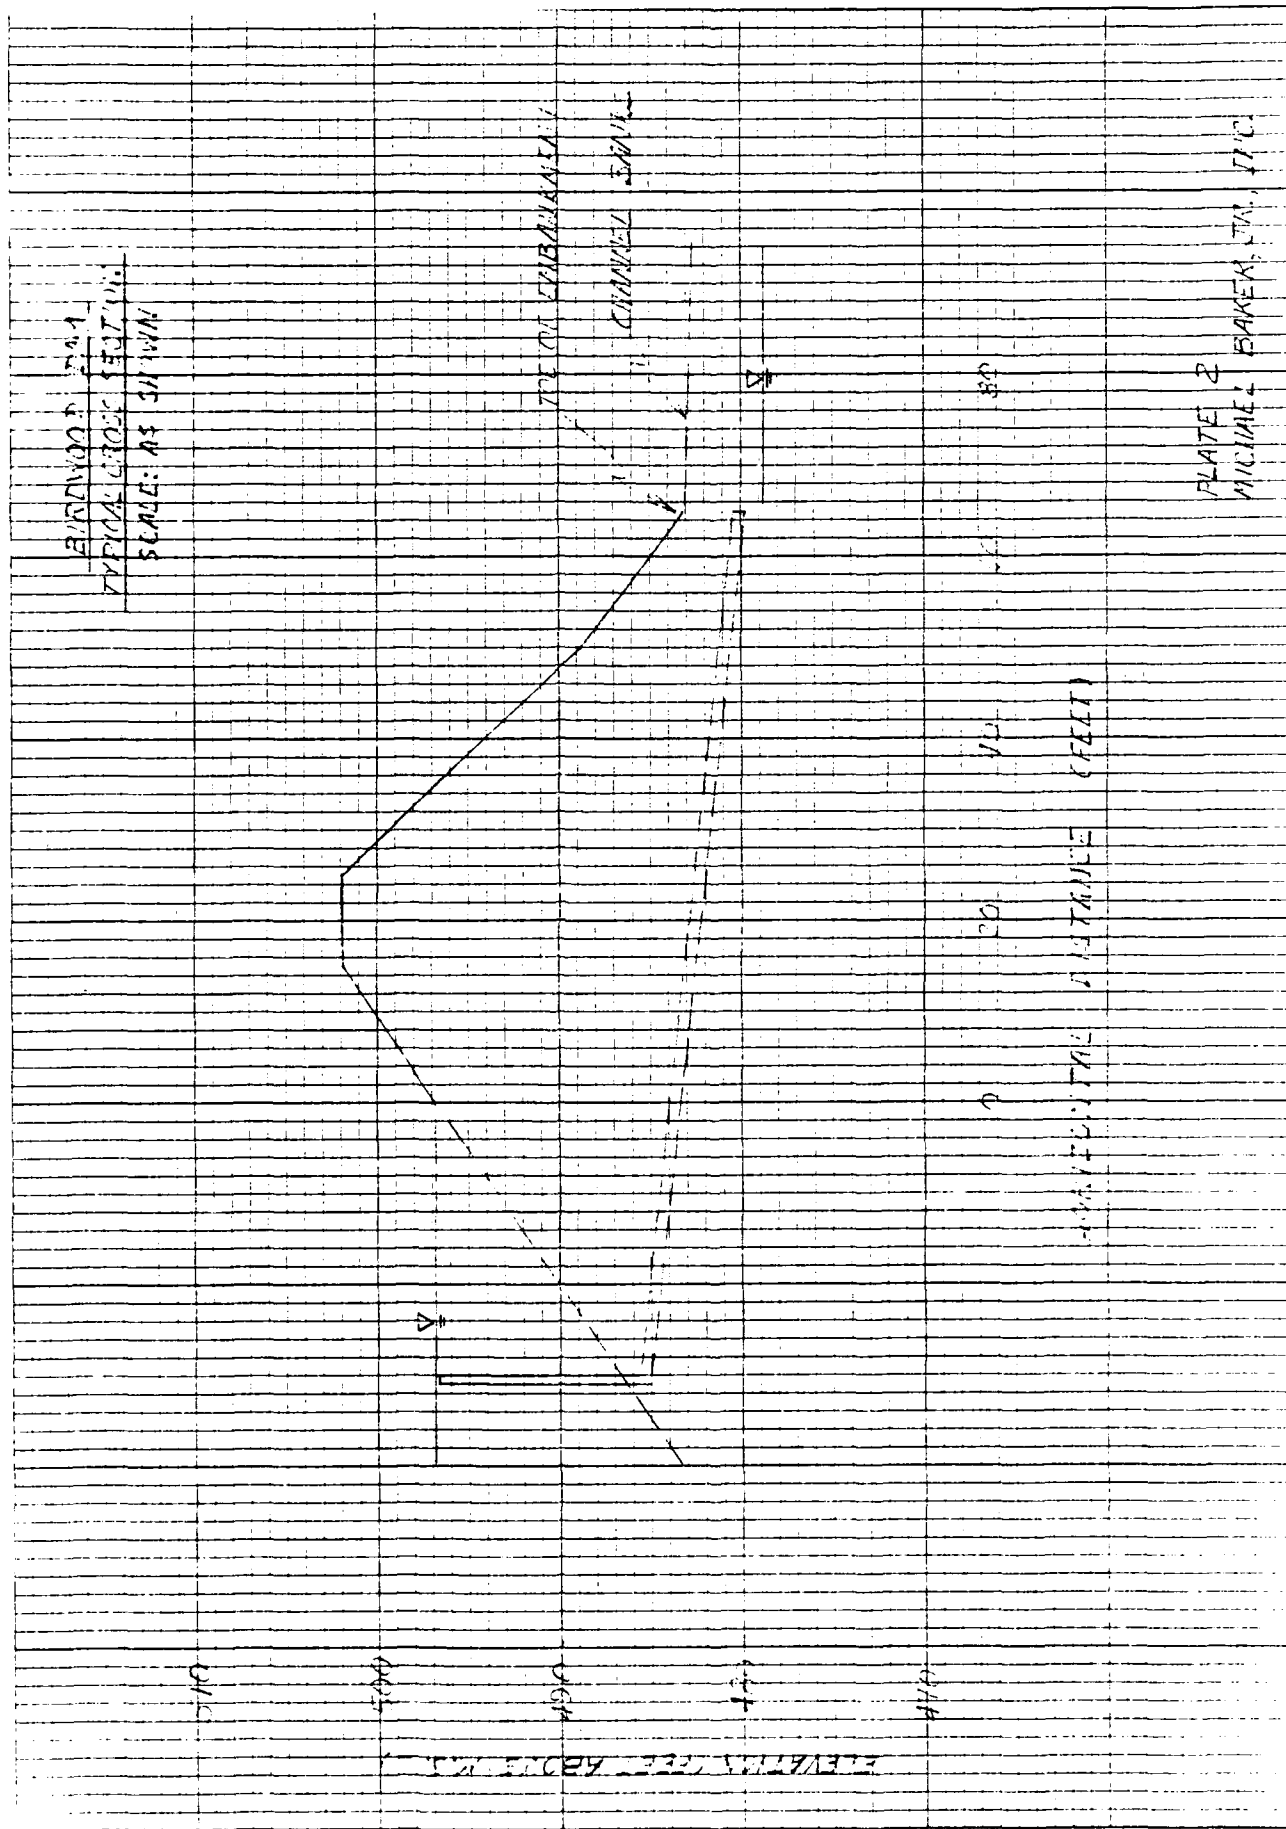
UPSTREAM AND DOWNSTREAM EMBANKMENT, ABUTMENTS, CREST, AND DOWNSTREAM CHANNEL ARE VERY OVERGROWN.  
DOWNSTREAM EMBANKMENT SURFACE SEEMED IRREGULAR - HOWEVER VEGETATION PREVENTED BETTER OBSERVATION.  
NO KNOWN TOE DRAINS.
