INTERIM REPORT OF FIELD TEST  
OF EXPEDIENT PAVEMENT REPAIRS  
(TEST ITEMS 1-15).

RAYMOND S. ROLLINGS  
ENGINEERING RESEARCH DIVISION

MARCH 1980

ENGINEERING AND SERVICES LABORATORY  
AIR FORCE ENGINEERING AND SERVICES CENTER  
TYNDALL AIR FORCE BASE, FLORIDA 32403

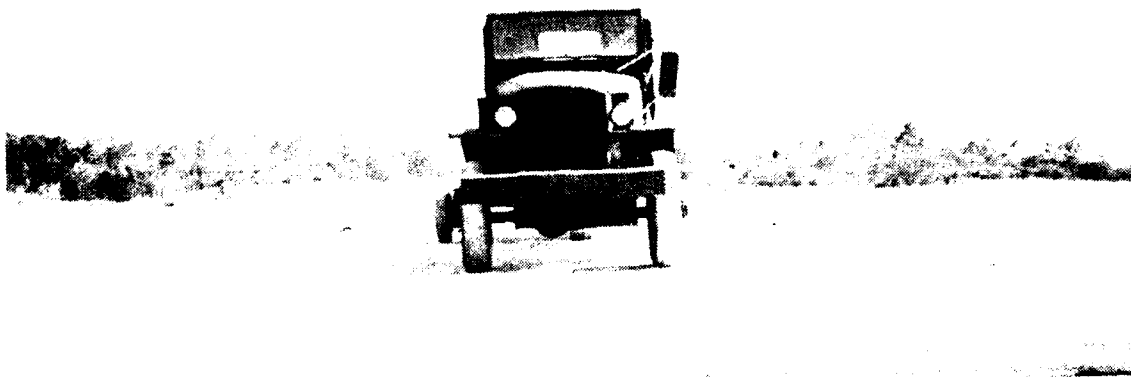
Figure 21. Surface Item 4, 40 Coverages

Rutting began under the F-4 load cart on the sixteenth pass. By the thirtieth coverage the surface had densified, and a general settlement of the repair surface was noticeable. Table 9 shows the progressive increase in maximum permanent deformation and lip height (difference between elevation of concrete and adjacent repair surface). Figure 25 shows the surface profiles along axes at the quarter, centerline, and three-quarter points perpendicular to the traffic and along the longitudinal centerline of the traffic lane.

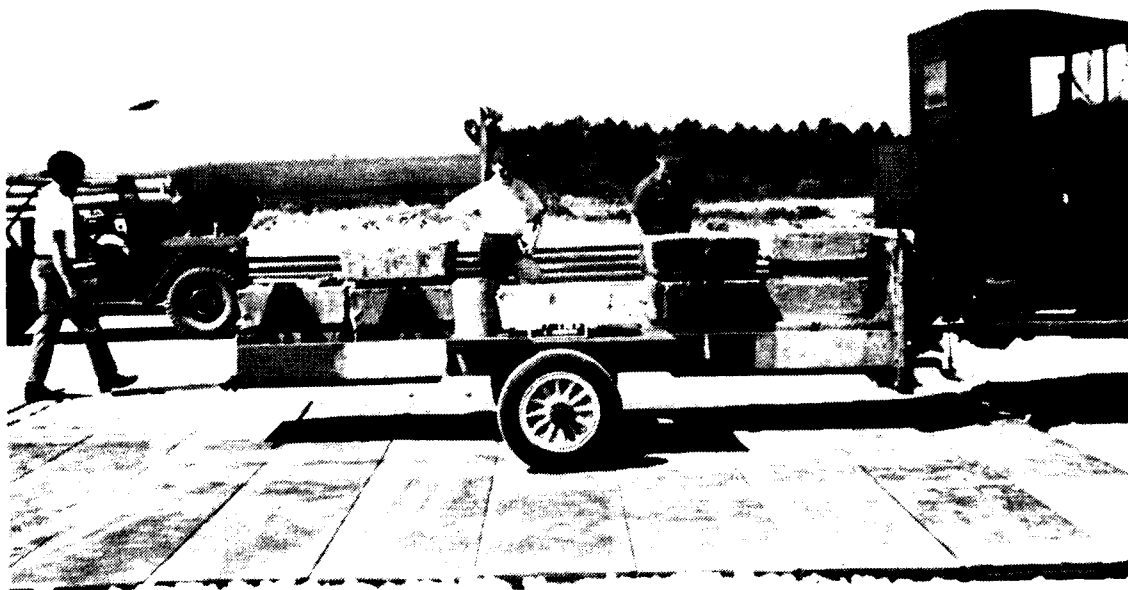
Figure 30. AM-2 Mat, Item 7

Item 7 consisted of a 14-inch base course of 3-inch uniform aggregate placed in the same manner as item 5. The surface was an 18-foot wide by 20-foot long AM-2 landing mat patch. One foot of the 20-foot by 20-foot item was left uncovered parallel to the load cart traffic (Figure 30). It proved impossible to level the large uniform aggregate to provide a patch truly flush with the surrounding pavement. After the mat was placed on the test item, it was settled onto the surface by driving a front end loader over it. The mat was not anchored in any manner.

The mat panels freely rotated about their edge connections so that a bow wave formed ahead of the load cart wheel. An attempt to measure the rise of the mat panels in the bow wave with dial gages failed because of inadequate dial gage capacity. The difference in elevation between leading and trailing edges of one mat panel as the load wheel approached was estimated to be in excess of 0.75 inch. After 4 coverages the item was considered failed because the base course under the mat had rapidly settled and a 1.8-inch lip had formed between the mat and pavement. The mat panels did not conform exactly to the underlying surface and bridged over some depressions. The mat would be depressed under the load tire and then would rebound when the load was removed. The mat surface settled a maximum of 1.32 inches under traffic. Profiles of the mat surface before and after traffic are shown in Figure 31. All profiles are from the unloaded surface.

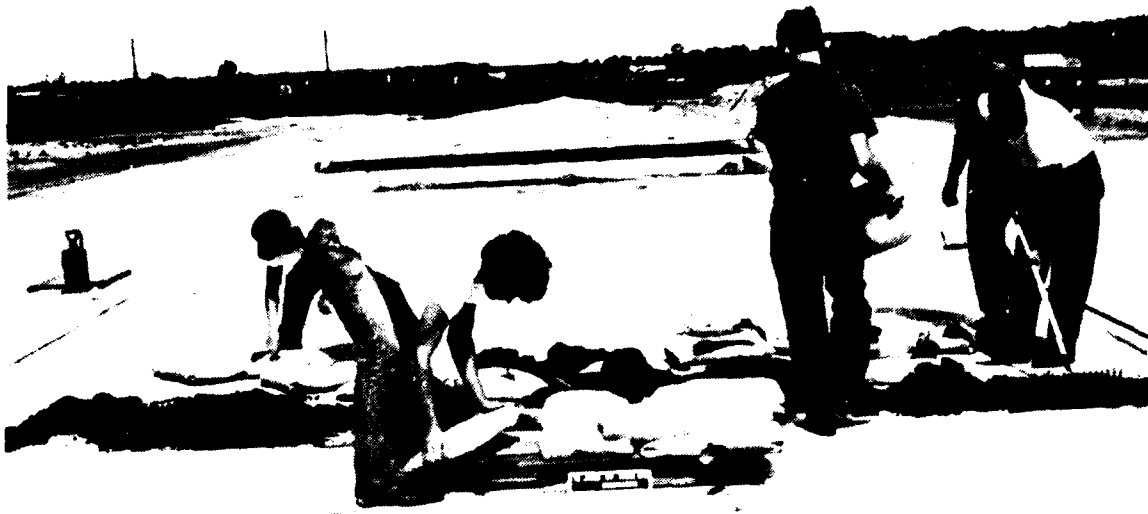
Figure 47. Placement of Almalgapave® , Item 11

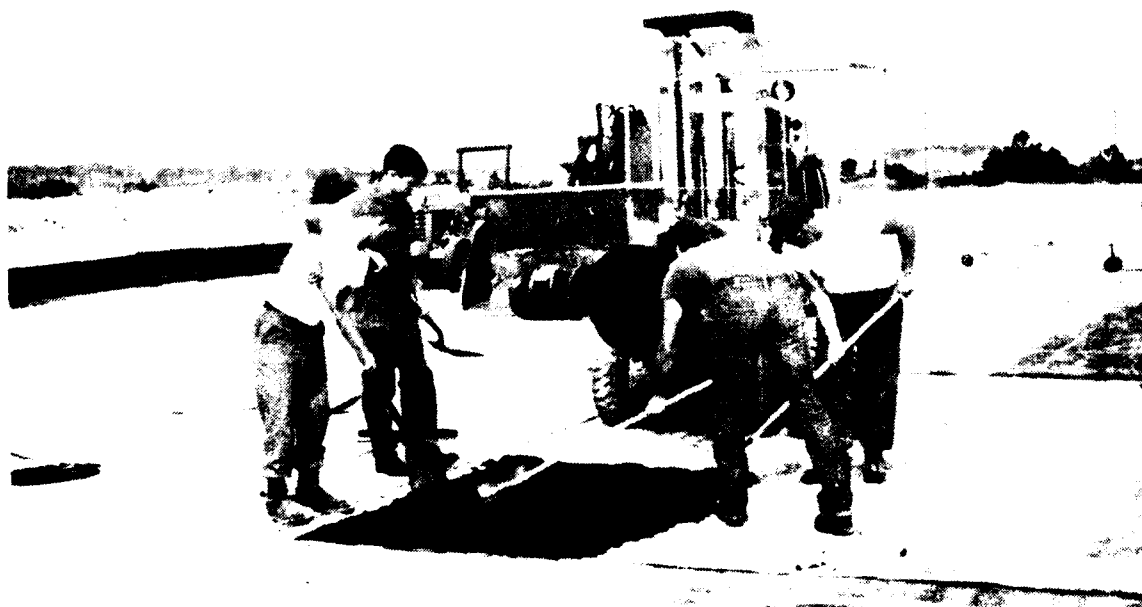
Figure 50. Placement of Zor-x<sup>®</sup>, Item 12

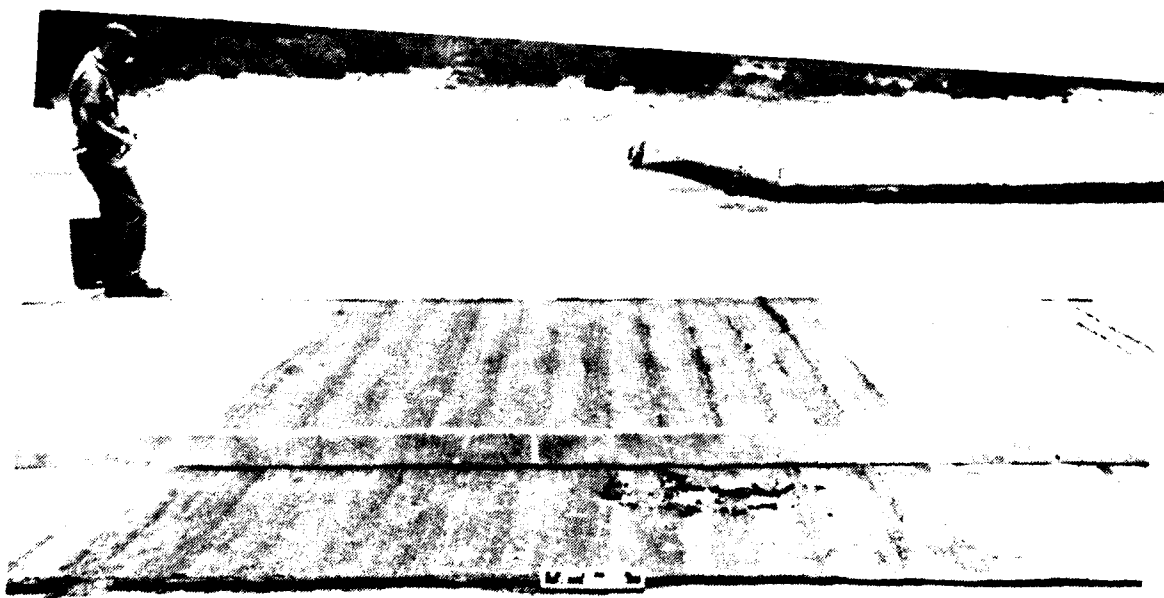
Figure 52. Zor-x<sup>®</sup> Surface After Traffic, Item 12

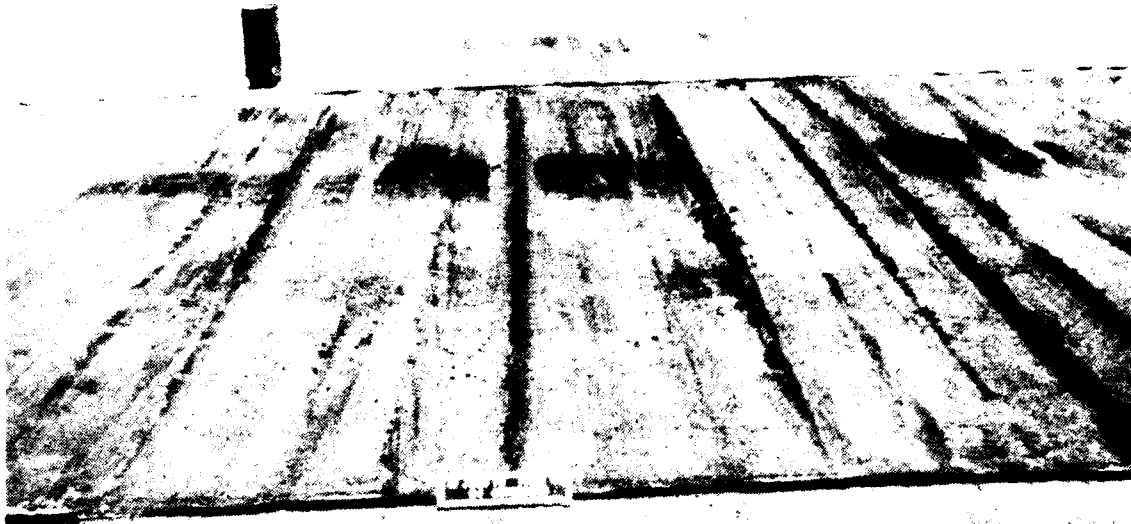
The Amalgapave® was unstable under the F-4 load cart traffic. A total of 24 coverages of traffic were applied to the item, but the surface was judged to be unsuitable due to shoving and rutting under initial traffic. The Amalgapave® did not work out of the repair area as it did in item 11. The surface of item 11A after 20 coverages is shown in Figure 53. Table 18 shows the results of soil tests for item 11A. The density for the base course was determined from a nuclear gage wet density with the source probe at a 6-inch depth, and moisture contents were determined from oven dried moisture samples. In addition to item 11A, this same base course had been used for items 11 and 12 and was subjected to 58 coverages of traffic. Profiles of the clay subgrade in item 11A after traffic were unchanged from profiles made before traffic in Item 11.

Figure 53. Almalgapave® Surface After 20 Coverages, Item 11A

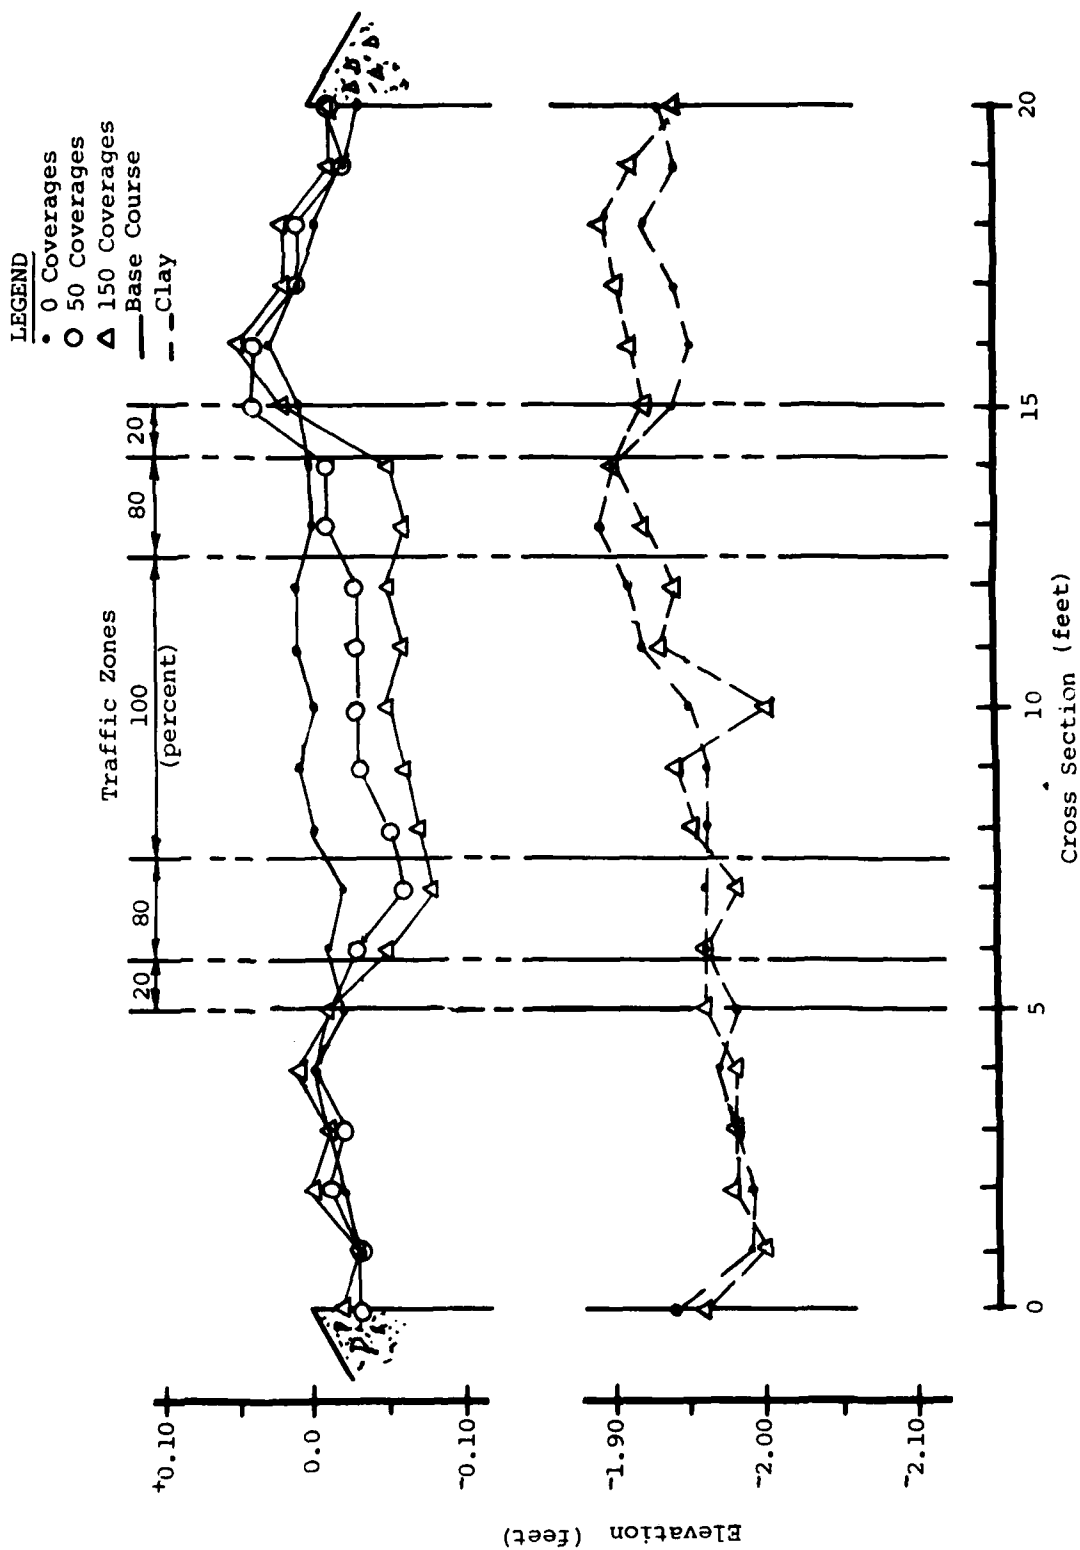
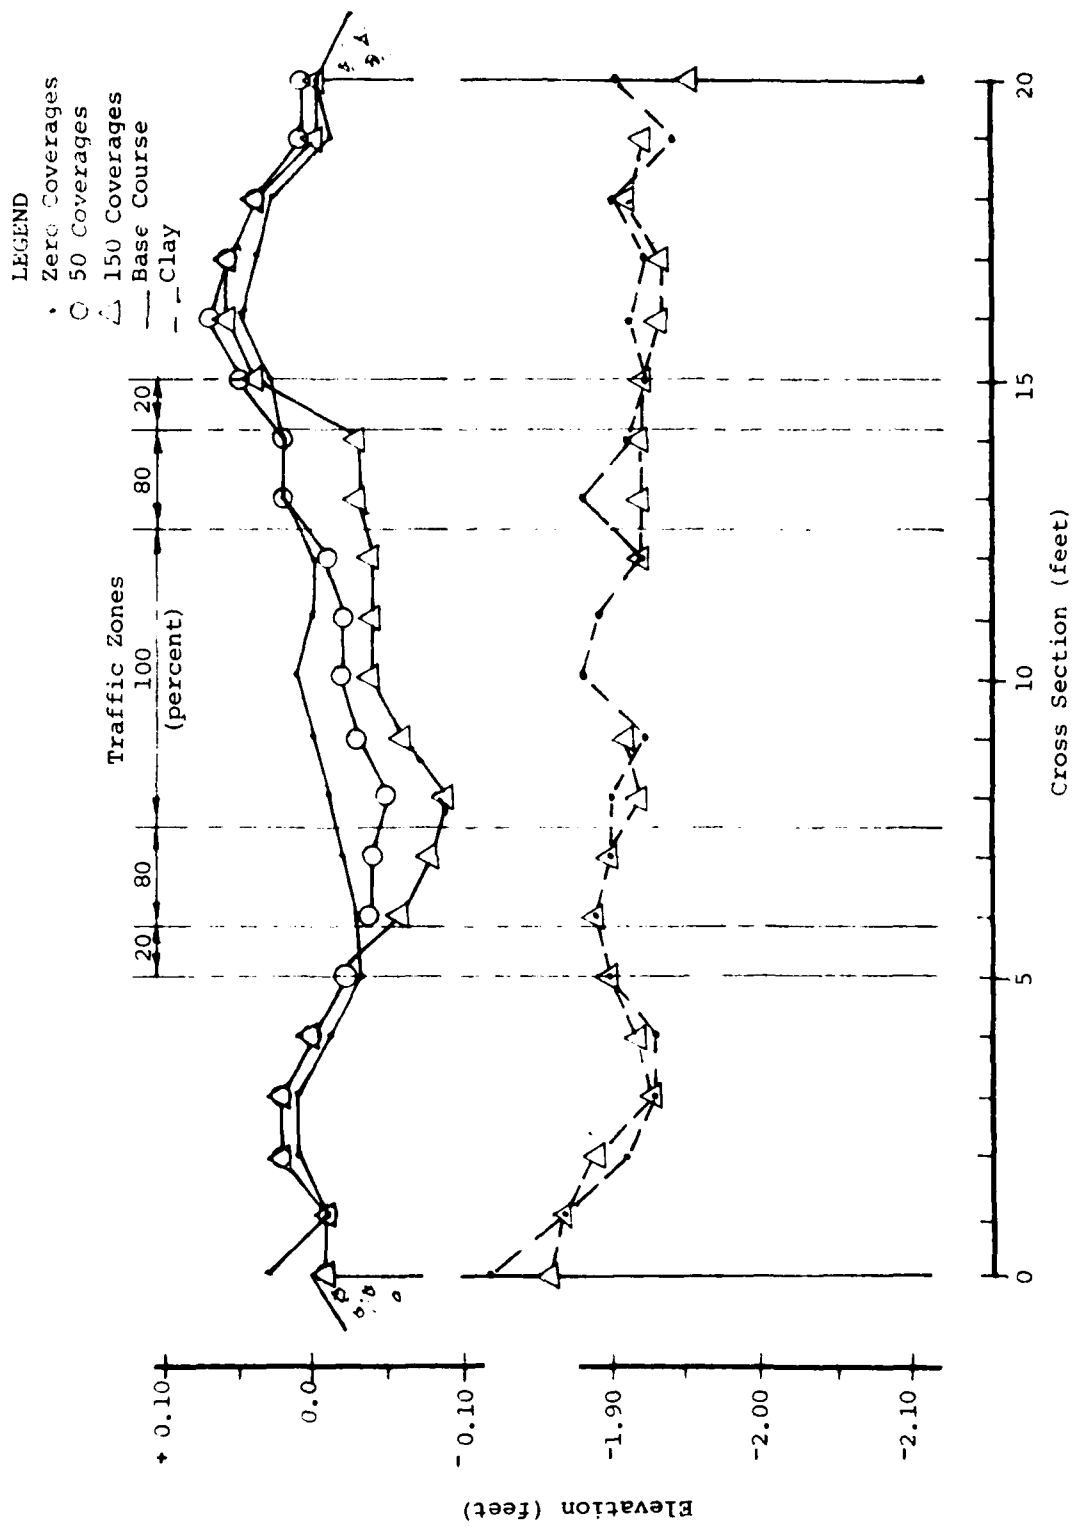
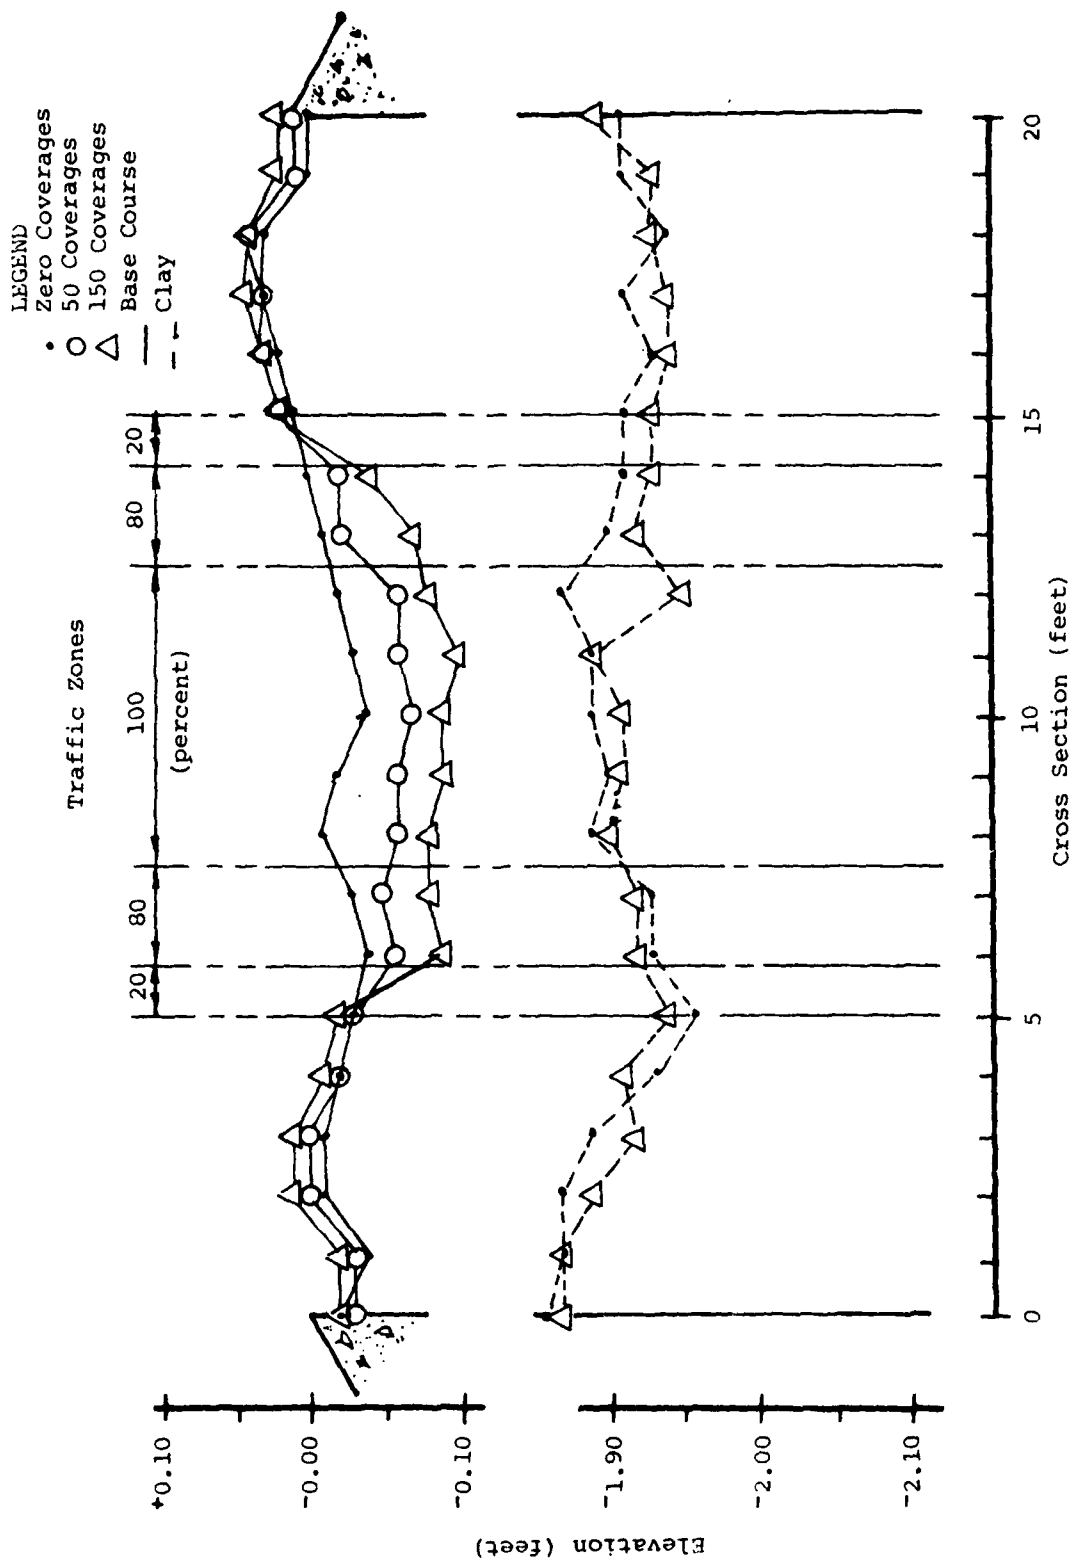
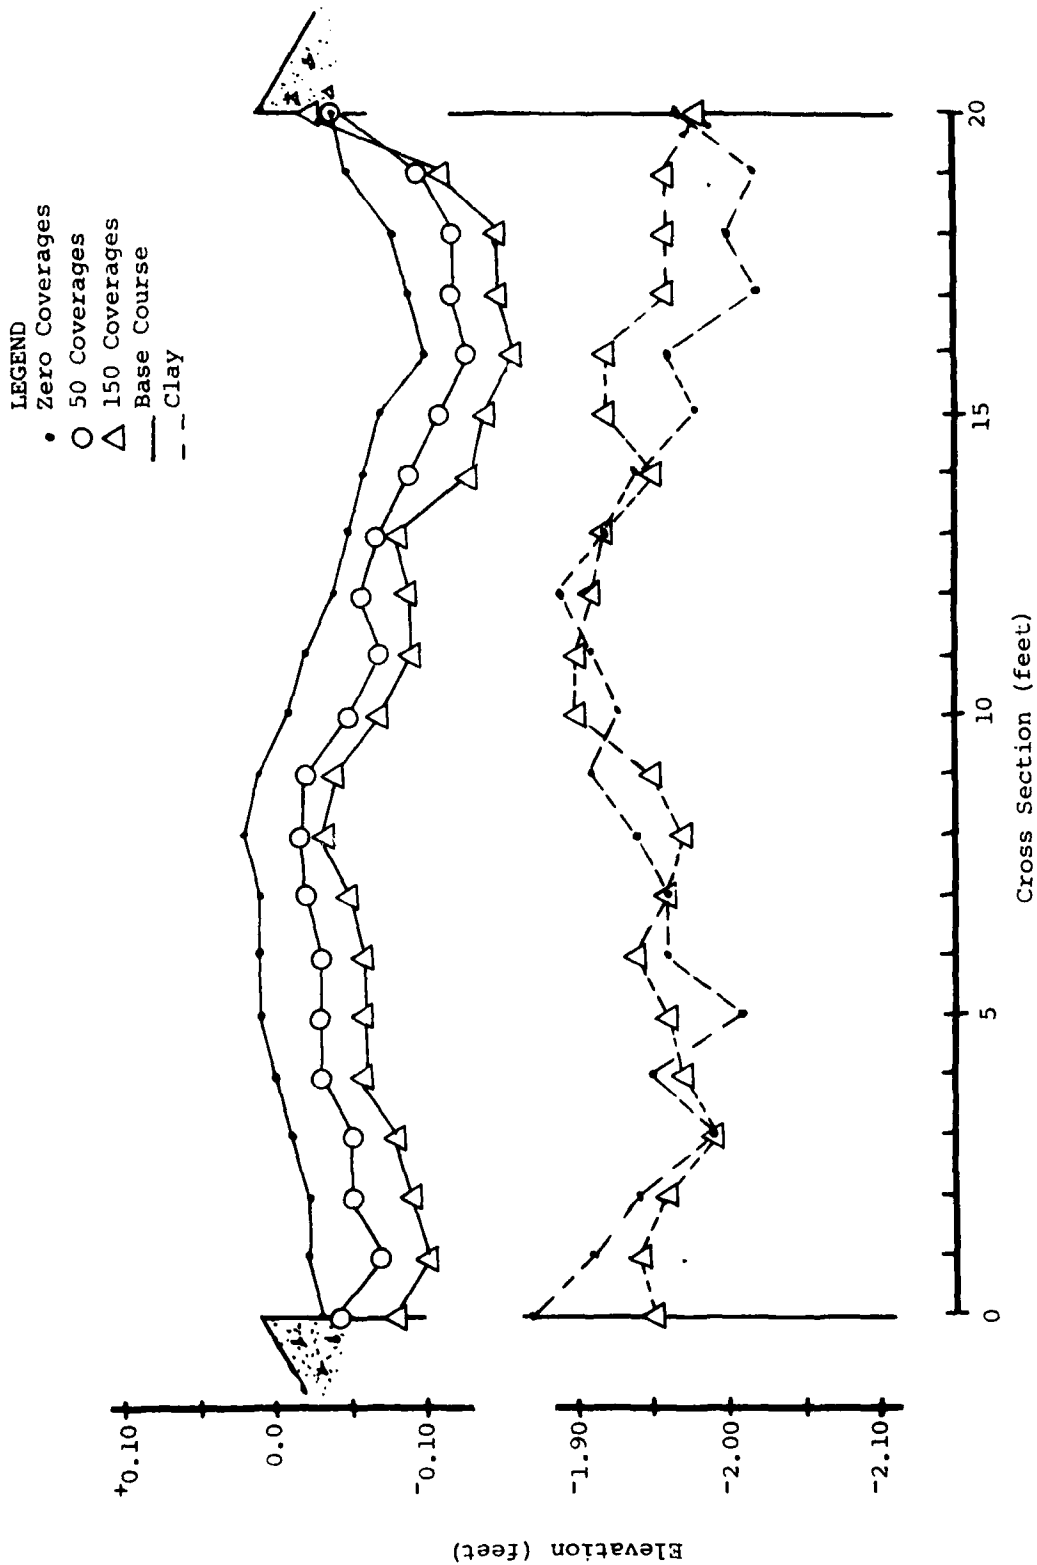
Profiles of the clay subgrade and base course surface at various levels of traffic are shown in Figures 55 through 58. The lack of upheaval at the edge of the traffic lane indicates densification rather than shear deformation was the cause of the surface settlement. Maximum deformation reached 1 inch at 150 coverages. The maximum deformation at various levels of traffic is shown in Figure 59. Results of soil tests are shown in Table 20. Densities were determined from a nuclear gage wet density with the source probe at a depth of 6 inches, and moisture contents were determined from oven dried moisture samples.

Figure 55. Lateral Quarter Point Profiles, Item 13A

Figure 56. Lateral Centerline Profiles, Item 13A

Figure 57. Lateral Three-Quarter Point Profiles, Item 13A

Figure 58. Longitudinal Centerline Profiles, Item 13A

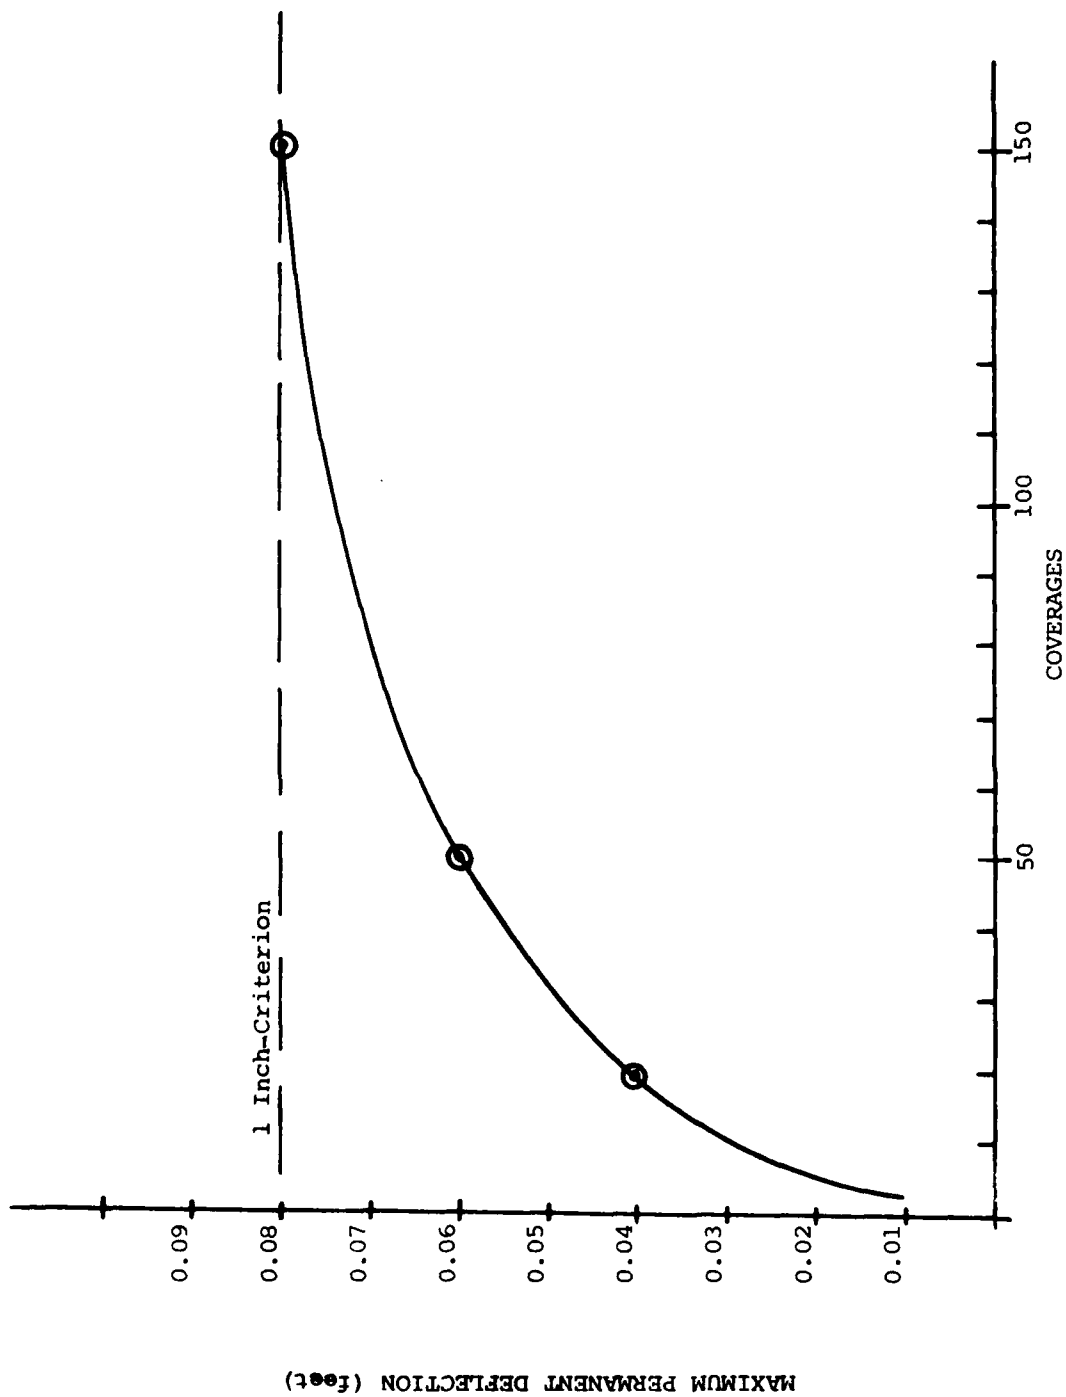
Figure 59. Load Cart Coverage and Deformation Relationship, Item 13A

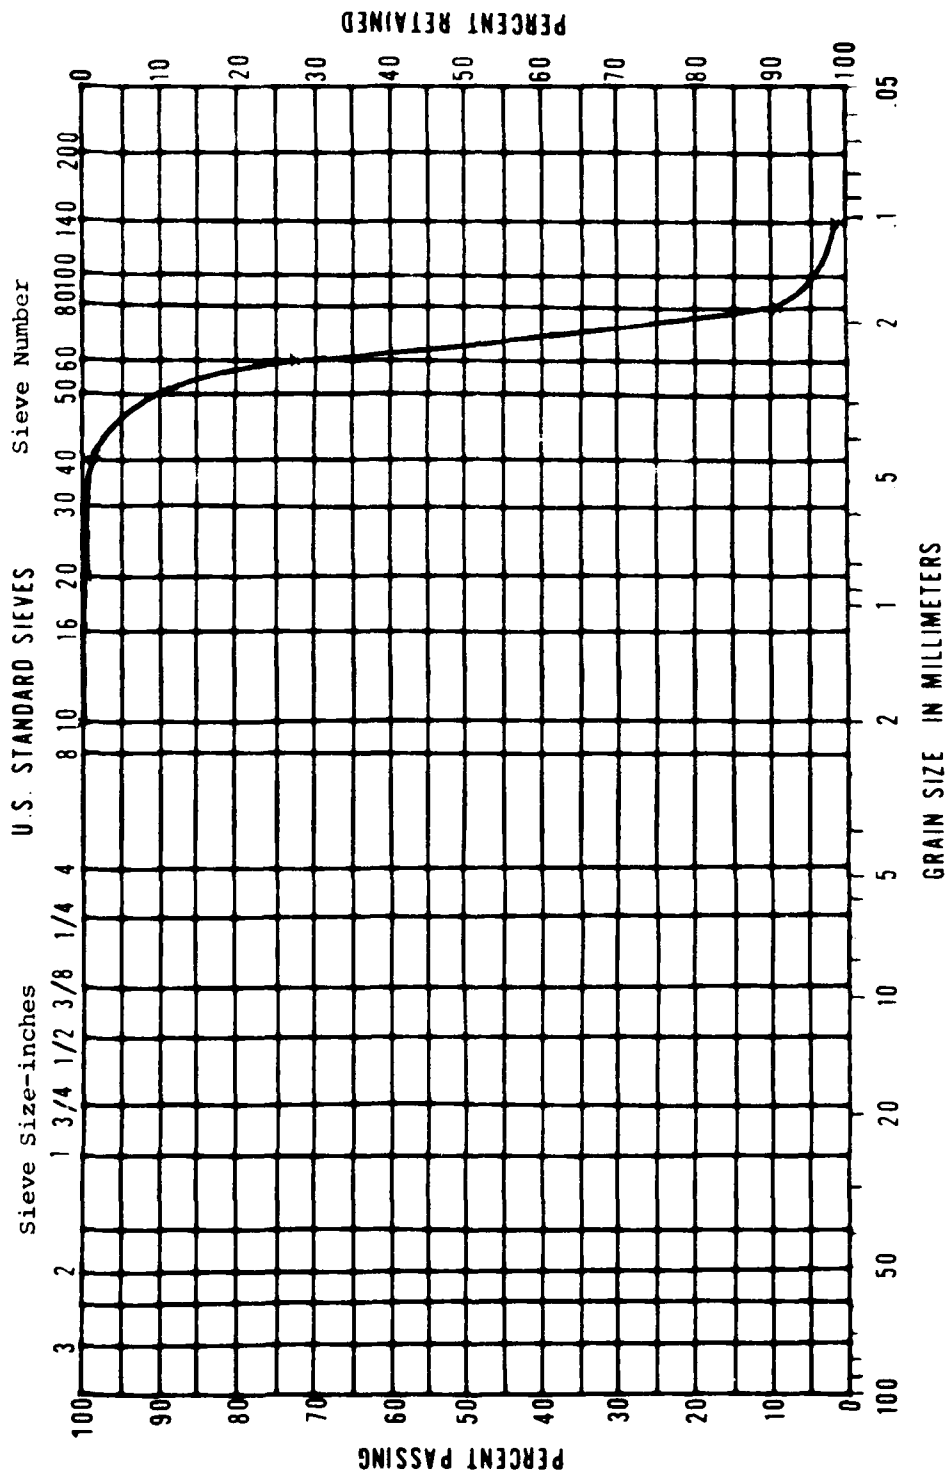
Item 15 consisted of a 6-inch base course of well graded, crushed stone and an 18-inch subbase of a local dune sand. The gradation of the sand is shown in Figure 60. A CE-55 compaction curve and a CBR curve are shown in Figure 61.

Figure 60. Gradation of Dune Sand, Item 15

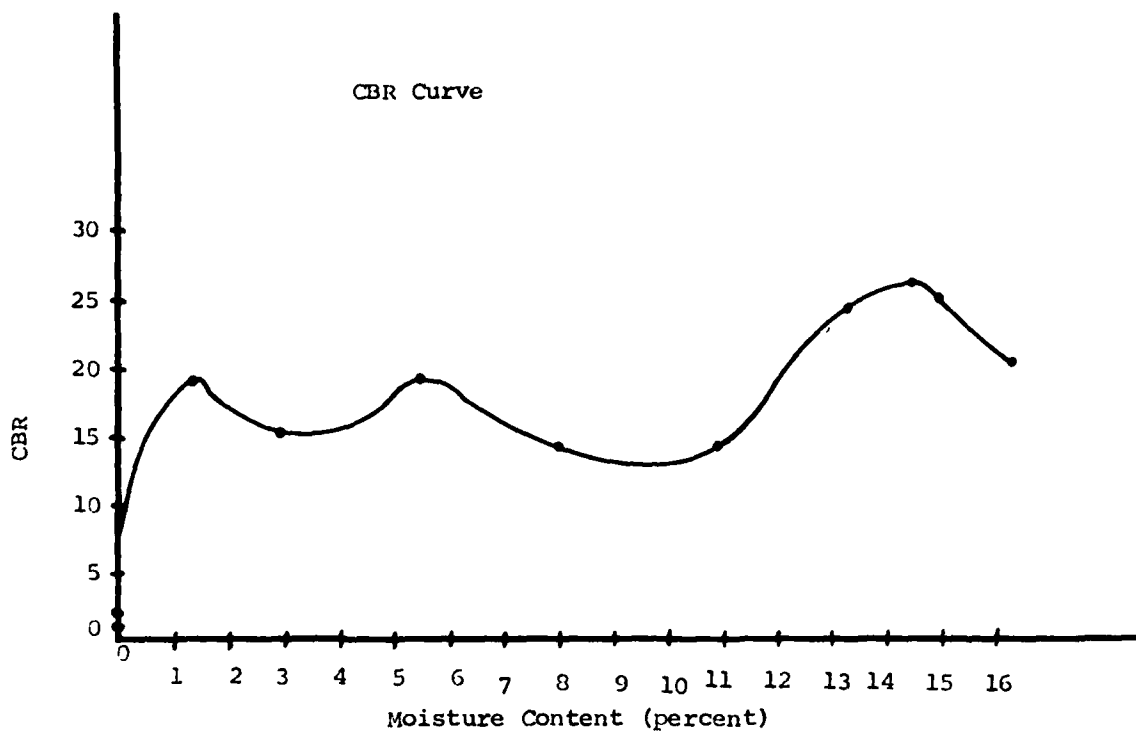
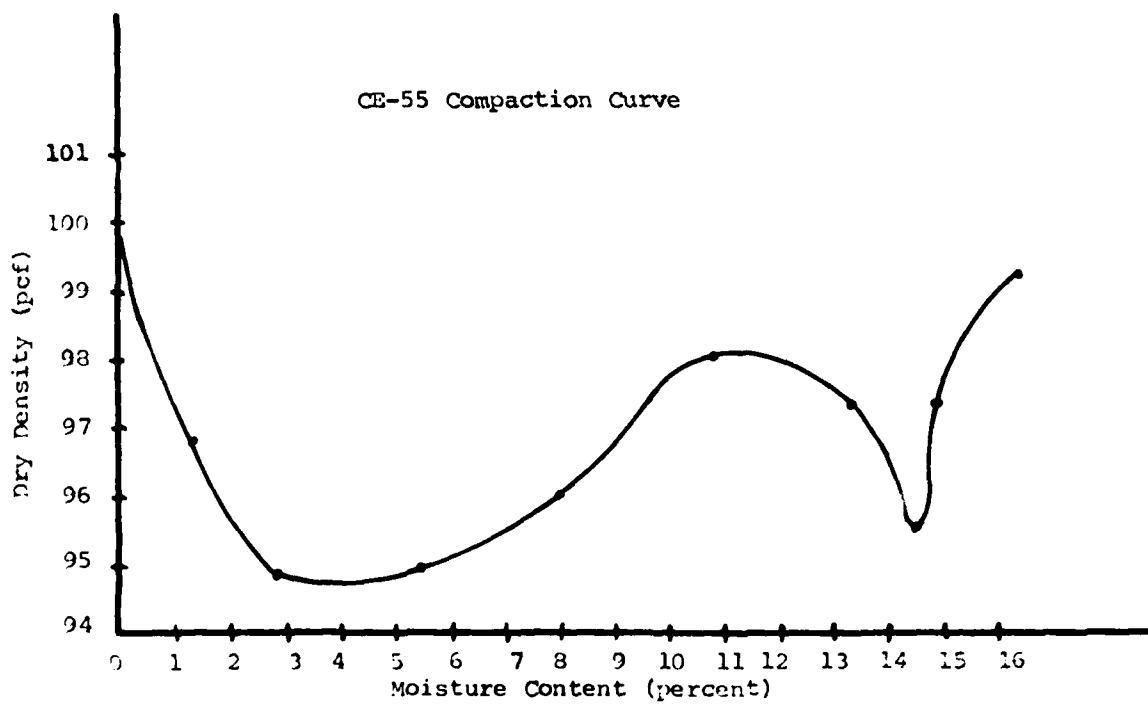
Figure 61. CE-55 Compaction Curve and CBR Curve for Dune Sand, Item 15

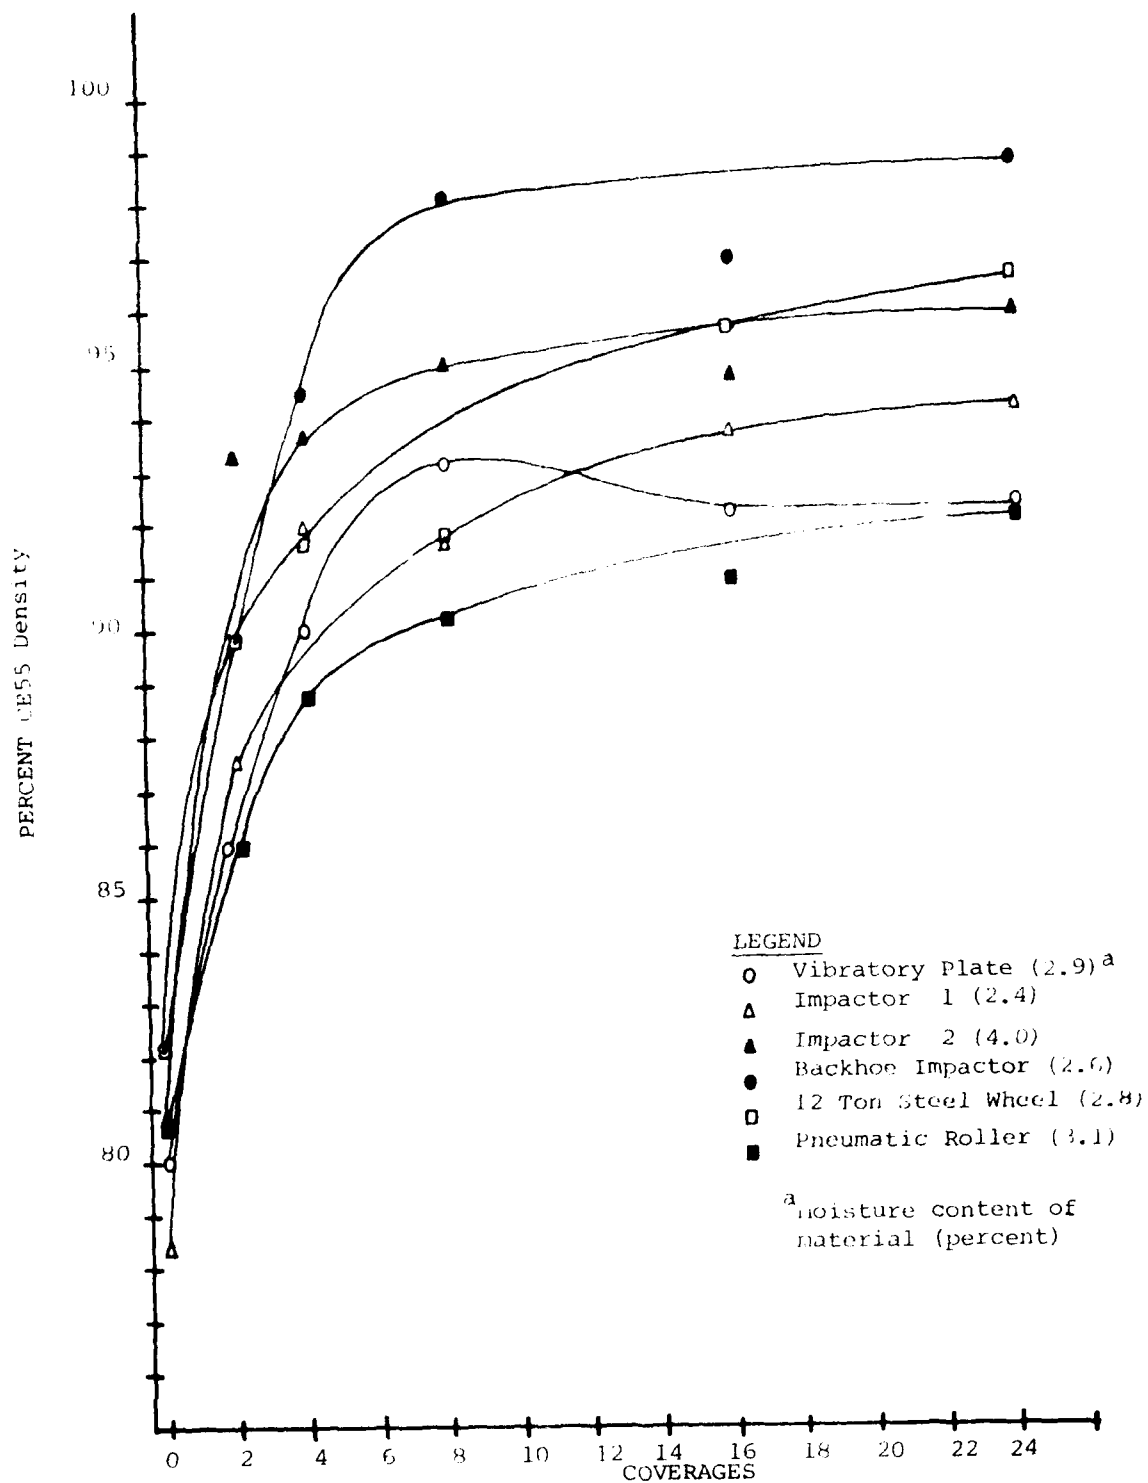
Density was recorded with a nuclear gage after 0, 2, 4, 8, 16, and 24 coverages of each piece of compaction equipment. Density and moisture content were recorded with the radioactive source probe at a 6-inch depth. Results are shown in Figure 66.

Of the two hand impact compactors, the smaller compactor (impactor 2 in Figure 66) obtained better results. However, this compactor was also compacting material closer to the optimum moisture content (moisture content shown in parentheses in the legend of Figure 66) which may account for this difference.

the steel wheel roller because it is no longer necessary to get into the hole. All of the equipment listed in Figure 66 required a large number of coverages (and hence large amount of time) to reach the required density.

Figure 66. Compaction Results of Various Compactors

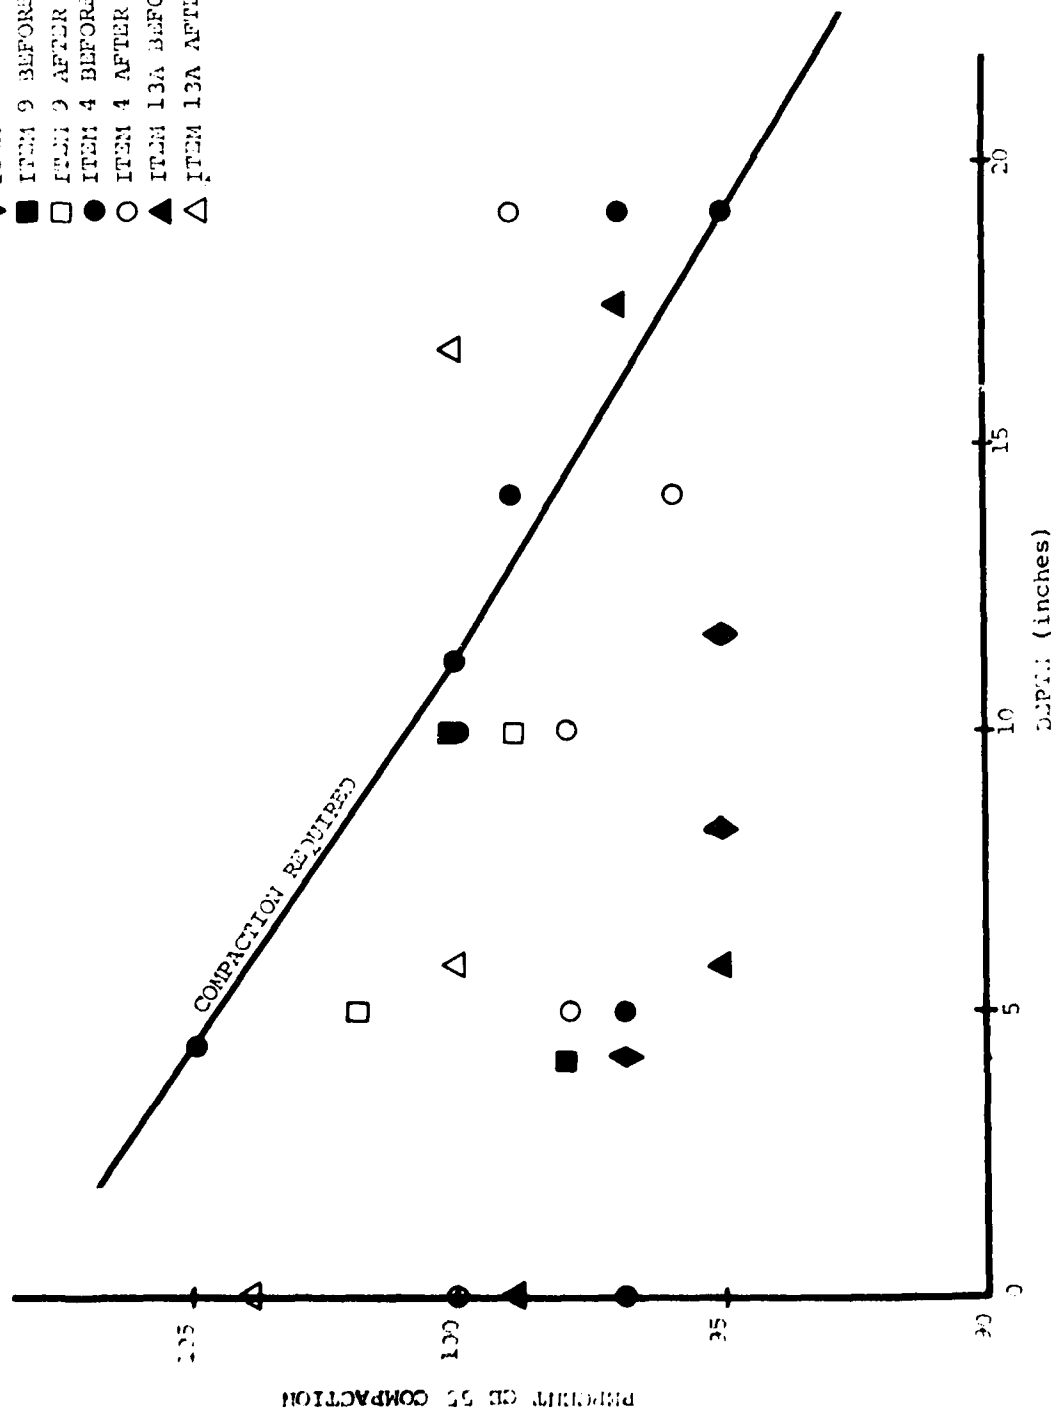
Adequate compaction provides shear strength to a soil and reduces densification of the soil under traffic. The Corps of Engineers has established standard levels of compaction for soil components under flexible pavements to prevent densification under traffic based on a survey of densities in various airfield pavements and test sections (Reference 27). The compaction requirement for a 60,000-pound gross load F-4 on cohesionless soil is shown in Figure 67 with data from items 4, 9, 13 and 13A. Only the lower sections of items 4 and 13A met the compaction requirements. Items 4, 9, and 13A all gave satisfactory performance, but their initial densities were not much greater than that of item 13 which failed. It can be concluded that the compaction requirements can be reduced somewhat, but there is only a narrow range for error. Considering the expedient nature of these repairs, Figure 67 suggests that compaction requirements for the upper foot of the repair can be relaxed to 100 percent of CE-55 density for 150 coverages of an F-4.

Figure 67. Compaction Requirements

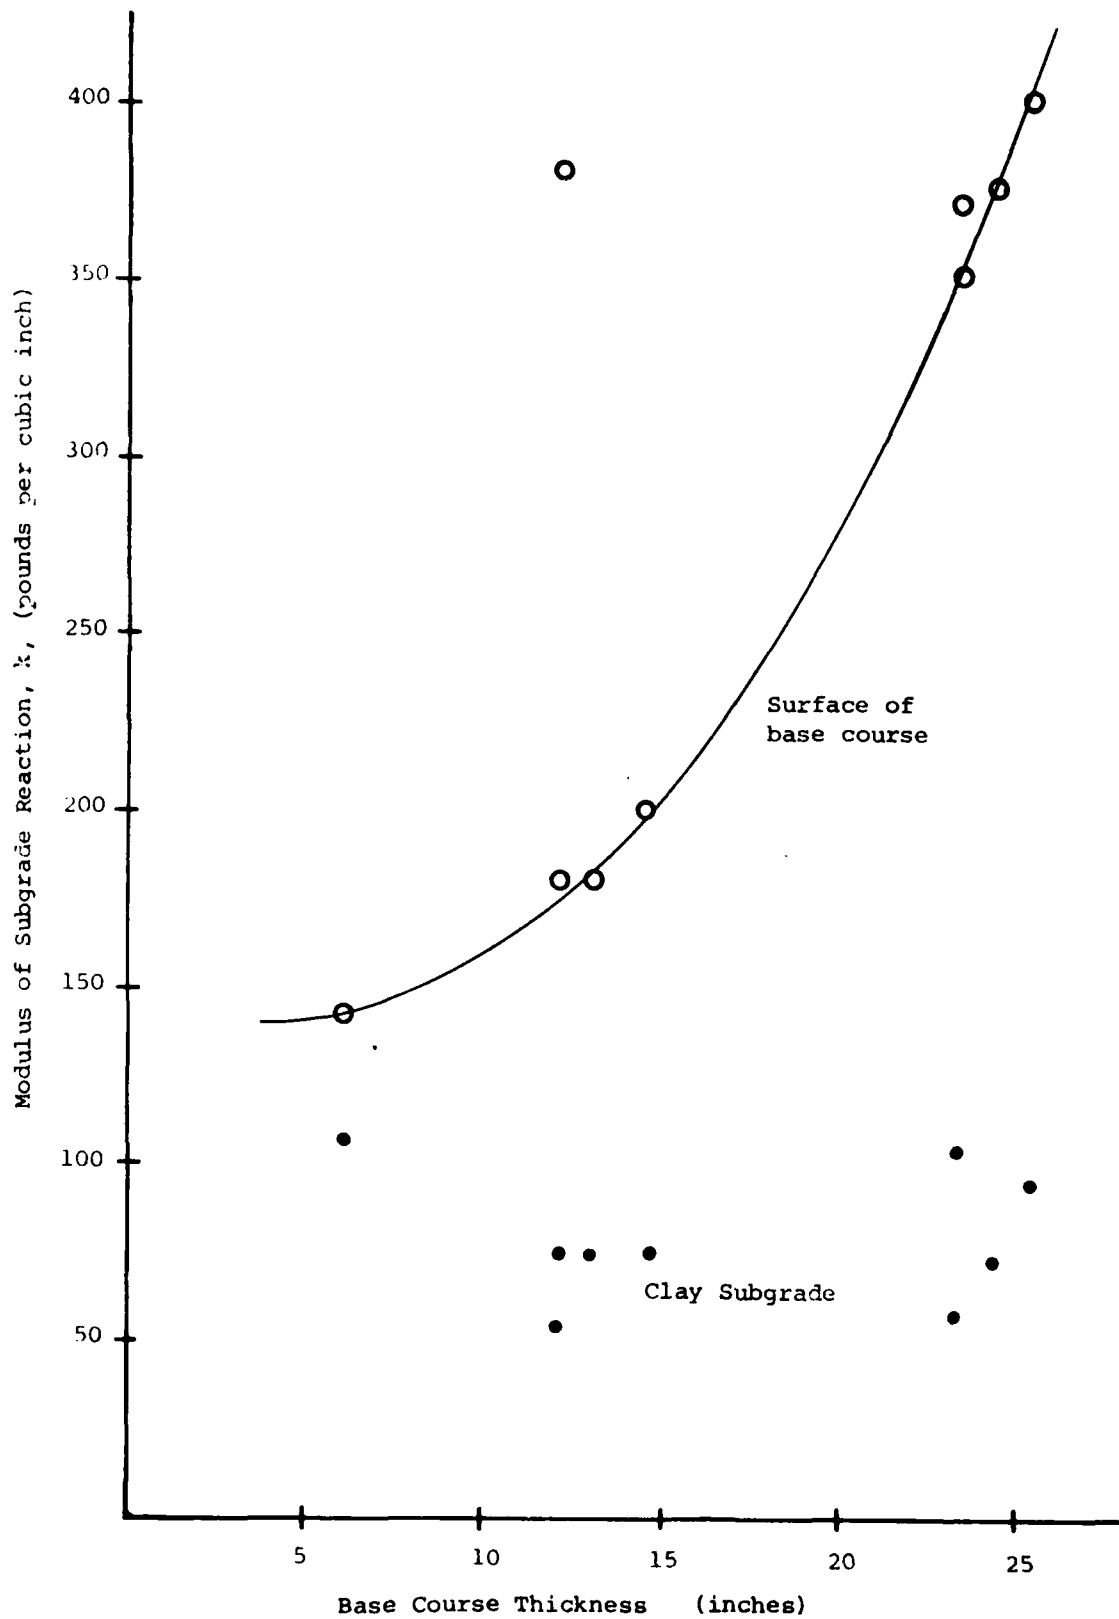
The current method of debris backfill for craters results in a weak, compressible subgrade. Figure 68 shows the influence of thickness of the base course on the modulus of subgrade reaction. A 6-inch base had little influence, and 20 to 25 inches of base were required to raise the modulus to high levels.

Figure 68. Effect of Base Course Thickness on Modulus of Subgrade Reaction (K)
