INTERIM REPORT OF FIELD TEST  
OF EXPEDIENT PAVEMENT REPAIRS  
(TEST ITEMS 1-15).

RAYMOND S. ROLLINGS  
ENGINEERING RESEARCH DIVISION

MARCH 1980

ENGINEERING AND SERVICES LABORATORY  
AIR FORCE ENGINEERING AND SERVICES CENTER  
TYNDALL AIR FORCE BASE, FLORIDA 32403

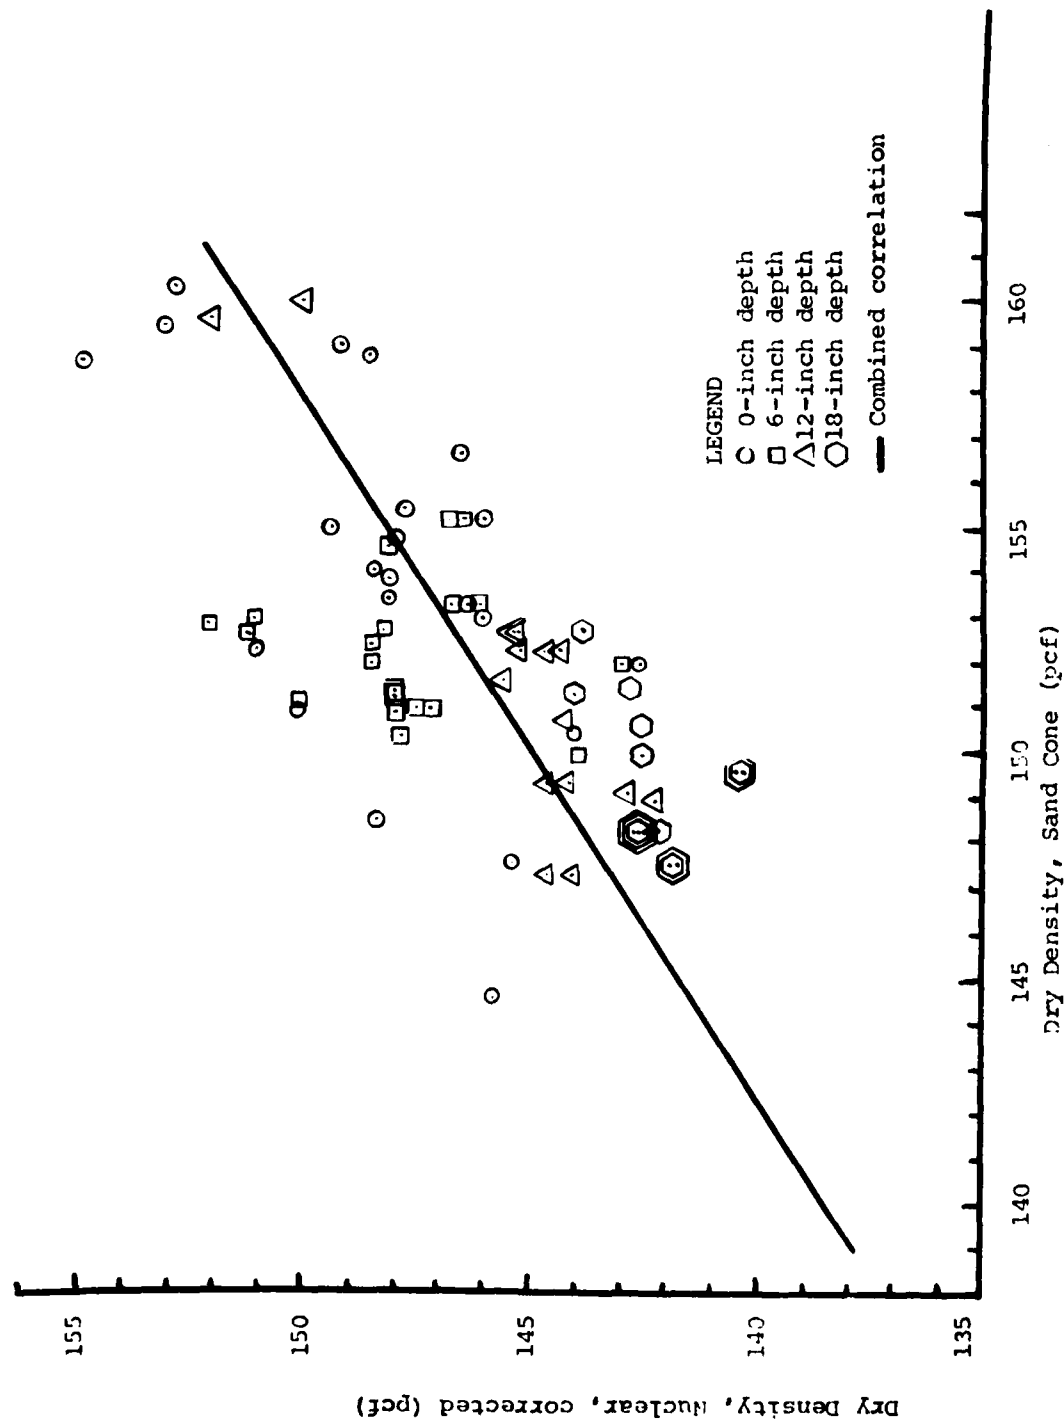
The nuclear gage is believed to provide more reliable density measurements in the base course. The nuclear gage densities were used for all base course measurements for items 11 through 15 and the compaction tests. Sand cone densities on all previous items were reduced using the above correlation.

Figure A-1. Nuclear Gage and Sand Cone Density Correlations
