6 National Dam Inspection Program.  
BEAVER CREEK DAM  
(SCS PA 433).

(NDS I.D. Number PA 88903,  
DER I.D. Number 15-301)

PHASE I INSPECTION REPORT,  
NATIONAL DAM INSPECTION PROGRAM

WOODWARD-CLYDE CONSULTANTS  
5120 Butler Pike  
Plymouth Meeting, Pennsylvania 19462

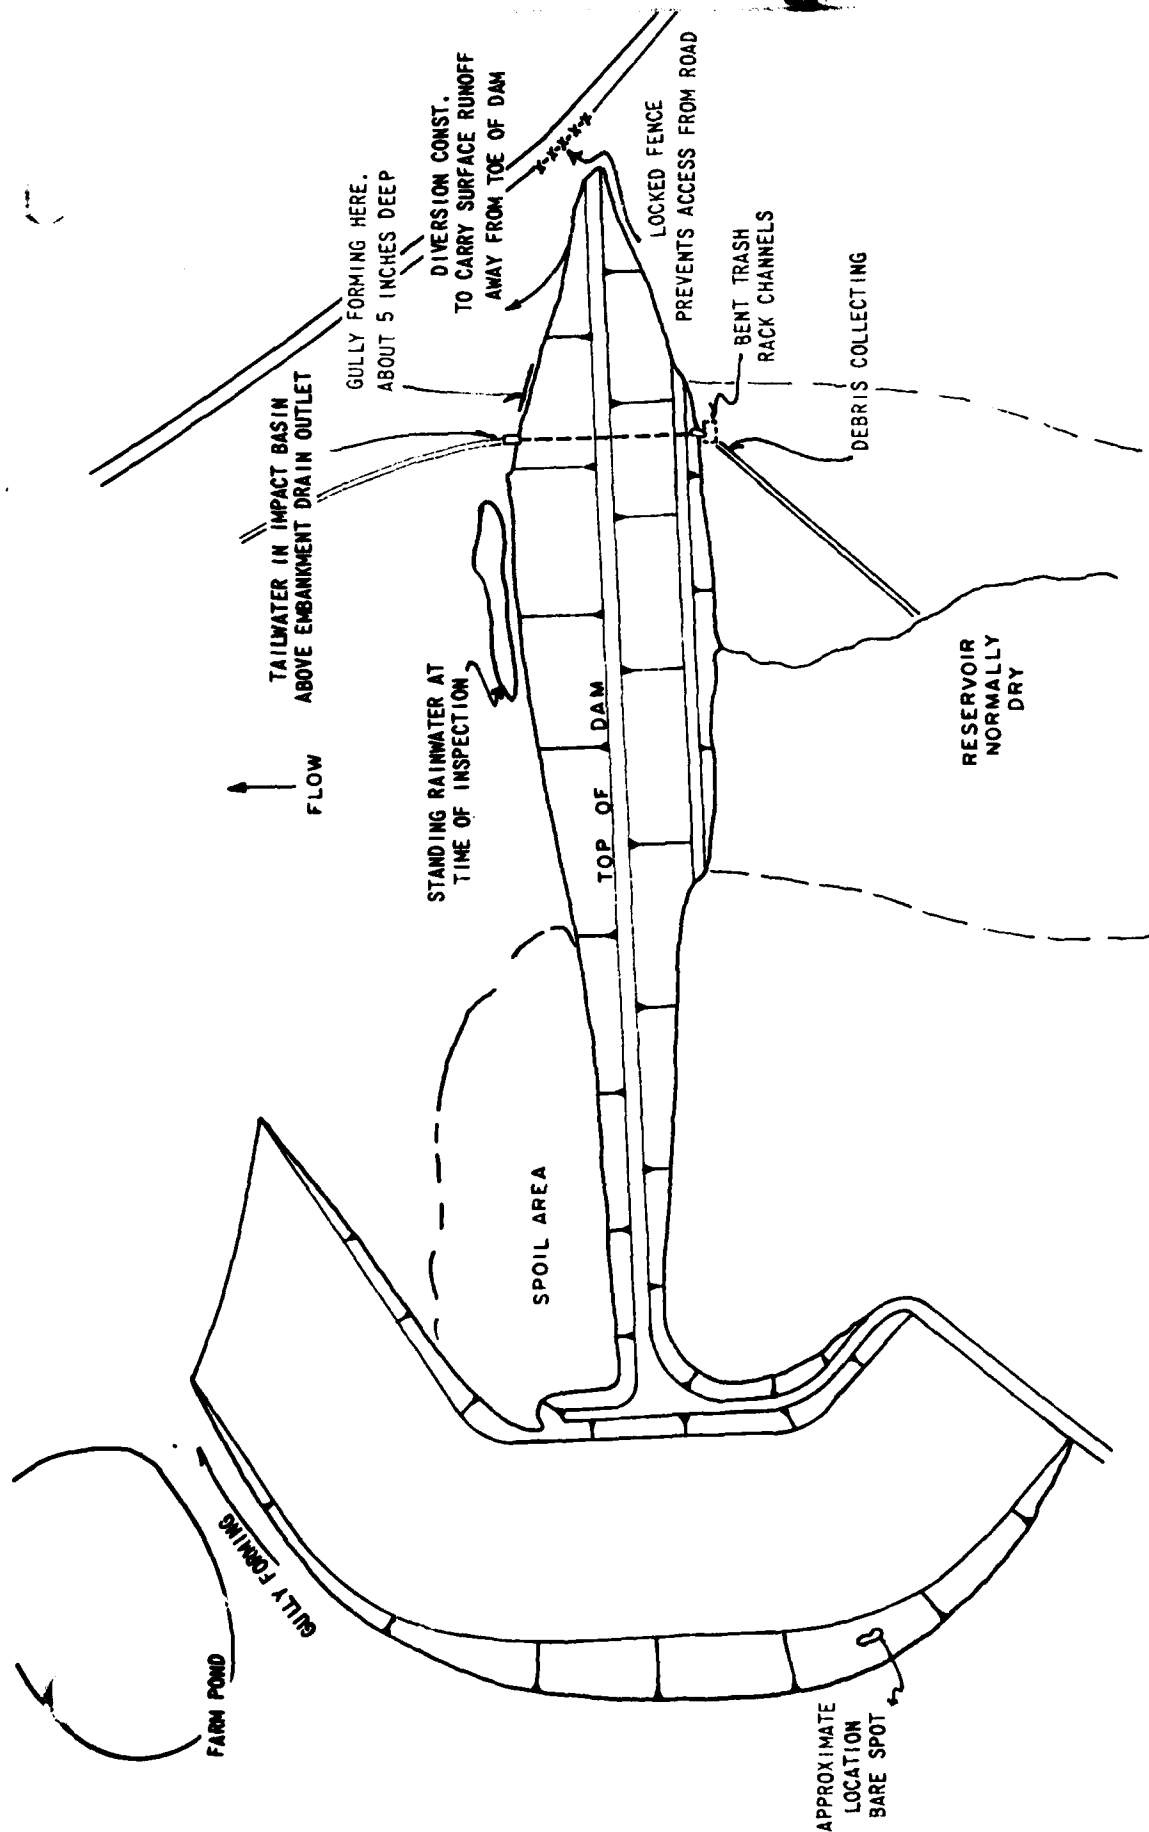
FIELD OBSERVATION PLAN  
BEAVER CREEK DAM

b. Dam. During the visual inspection, there were no indications of distortion in alignment or grade that would be indicative of movement of the embankment or foundation. Crownvetch cover on both the upstream and downstream slopes, although dormant, is considered to be in good condition. A minor amount of first year weedy vegetation was noted. The upstream embankment below the berm was soft and had a small amount of rainwater standing on it. The dam crest was in good condition, with no standing rainwater. No erosion gullies were noted on either the upstream or downstream embankments, or over the edge of the crest. Rainwater was standing in the area beyond the downstream toe of the embankment, which is flat.

The vertical/horizontal alignments were checked and found to be in satisfactory condition across the emergency spillway control section and along the dam crest. The vertical alignment is shown on sheet 5B, Appendix A. The upstream junction of the right abutment and embankment is in good condition, with no paths or erosion noted. A diversion channel is constructed about one-third of the distance down from the top of the dam at the downstream junction of the embankment and right abutment to divert surface runoff away from the toe of the dam. A gully is starting to form in the junction below this diversion, with a scarp about 4 or 5 inches high. The junctions between the embankment and left abutment appear to be in good condition, although paths have been worn through the vegetation. The depth of the water in the impact basin was above the invert of the embankment drain outlets, preventing determination of whether the embankment drains were flowing. The second visit to the site indicated that the water level in the impact basin is normally above the embankment drain inverts.
