KENDA DAM  
WESTMORELAND COUNTY, COMMONWEALTH OF PENNSYLVANIA

(NDI No. PA 00459,  
PennDER No. 65-118), Old River Bridge  
Number

PHASE I INSPECTION REPORT  
NATIONAL DAM SAFETY PROGRAM

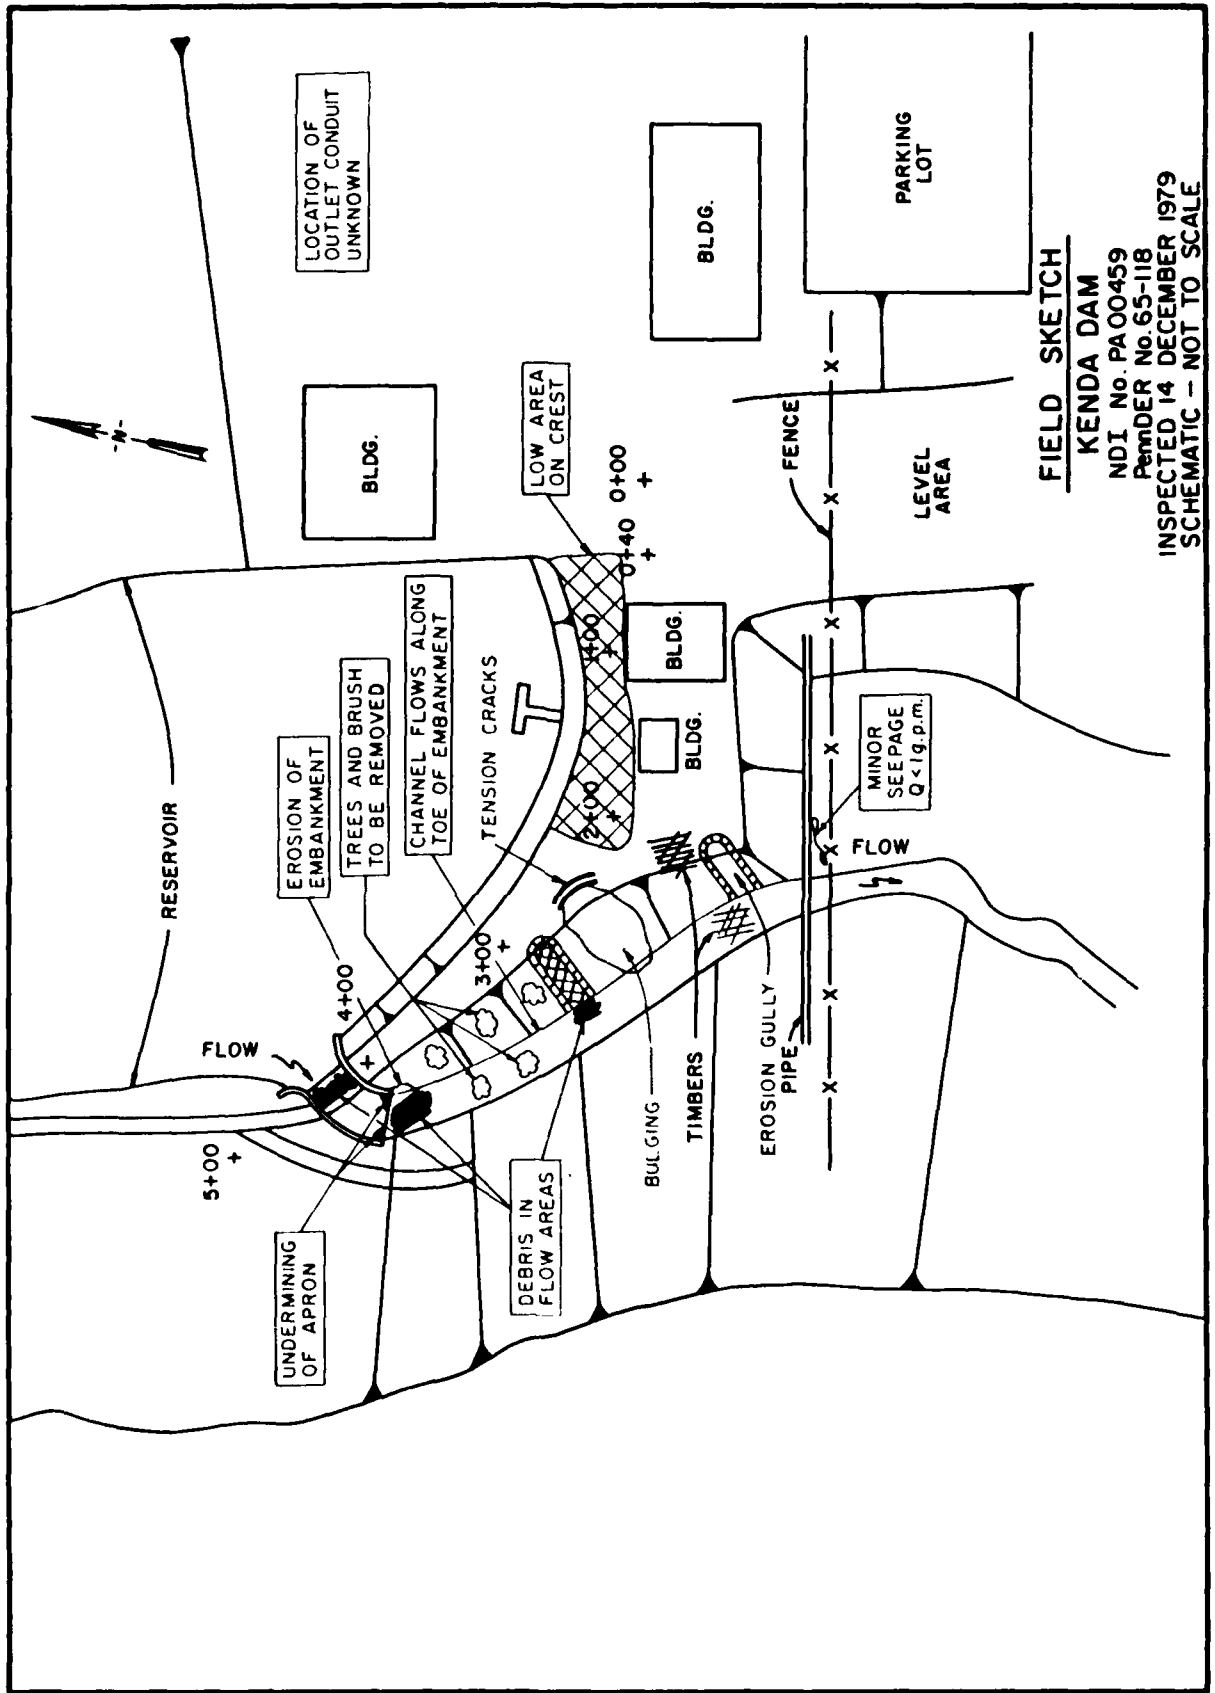
**FIELD SKETCH**

VISUAL EXAMINATION OF	OBSERVATIONS	REMARKS OR RECOMMENDATIONS
CONDITION (OBSTRUCTIONS, DEBRIS, ETC.)	A large amount of debris is clogging the downstream channel. Large timbers stacked on the crest of the dam have fallen into the channel. Other debris, dumped down the downstream face of the dam, is blocking the channel.	Remove all the debris from the downstream channel, including the timbers which have fallen into the channel.
SLOPES	Slopes of the downstream area are moderate and primarily covered by woods.	
APPROXIMATE NO. OF HOMES AND POPULATION	Two residential structures, several warehouses, and a few garages are located approximately 1000 ft. downstream of the dam.
